Appendix A11.1 Baseline Conditions

Table 1: River Garry (WF100) Errochty Water confluence to Loch Faskally (Lower Reach)

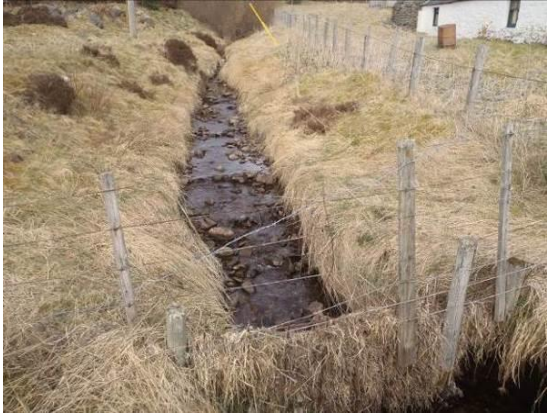
Table 65: WF156

<p>Photograph 66: WF156 – view upstream from the NCR7, adjacent to Dalreoch</p>	Water feature type: Small watercourse
	Catchment area: 0.56km ²
	Key hydraulic connections: Discharges into the upper reach of the River Garry
	Surrounding land use: Forestry, rough pasture
Description of Specific Baseline Conditions	Sensitivity
Hydrology and Flood Risk	
<p>This watercourse has a catchment area of less than 3km² so is not included in the SEPA Flood Map. The watercourse flows through an area of forestry upstream and adjacent to the existing A9 and crosses a local access road. The culvert capacity assessment indicates that the existing A9 could be at risk of indirect and localised flooding during the 0.5% AEP (200-year) plus CC design flood event, due to an undersized culvert. OS mapping shows that a property at Dalreoch is within 10m of the watercourse, and is therefore considered to potentially be at risk of flooding during the design event.</p>	High

Fluvial Geomorphology	
<p>SEPA physical condition status: not classified.</p> <p>A watercourse with an irregularly meandering planform and semi-continuous tree lining through forestry plantation upstream of the existing A9. The channel had bedrock, cobble and gravel substrate, and a step-pool sequence. Downstream of the existing A9, the channel widened to approximately 1.5m, and there was no tree cover.</p> <p>The watercourse is culverted under the existing A9 and a local access track. Analysis of historical mapping shows that some minor changes to the planform were made to the south of access track between 1988 and the present day.</p> <p>For a more detailed description of the watercourse, refer to Appendix A11.5 (Fluvial Geomorphology).</p>	Medium
Water Quality	
<p>SEPA water quality status: not classified.</p> <p>Potential pollutant sources:</p> <ul style="list-style-type: none"> diffuse rural sources including biological pollutants from grazing livestock; diffuse run-off of contaminants associated with A9 traffic (PGG-C2 Existing A9 –crosses watercourse); and KP-C77 Dalreoch with potential contaminants from a septic tank – within 30m of watercourse. 	Medium

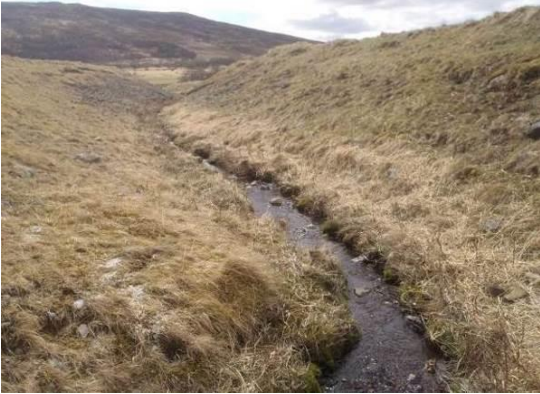
Table 66: WF157

<p>Photograph 67: WF157 – view downstream from the existing A9 culvert</p>	Water feature type: Small watercourse
	Catchment area: 0.12km ²
	Key hydraulic connections: Discharges into the upper reach of the River Garry
	Surrounding land use: Predominantly rough pasture, scrubland
Description of Specific Baseline Conditions	Sensitivity
Hydrology and Flood Risk	
This watercourse has a catchment area of less than 3km ² and so is not included in the SEPA Flood Map. This watercourse runs through rough pasture and scrubland and partly adjacent to the A9 with no residential properties noted. The culvert capacity assessment indicates that the existing A9 is not at risk of flooding during the 0.5% AEP (200-year) plus CC flood event.	Low
Fluvial Geomorphology	
SEPA physical condition status: not classified. A drainage channel with a predominantly straight planform. The channel measured approximately 0.5m wide and was incising in the upstream reach. The watercourse had a cobble and pebble bed. Approximately 60m upstream of River Garry confluence, the channel had been redirected with large floats. The channel is culverted under the existing A9 and a local access road. The watercourse is first shown on historical mapping in 1974, and the planform of the channel has not changed significantly since.	Low

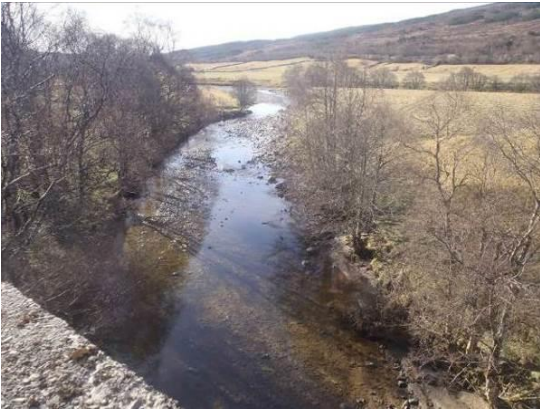
Table 67: WF158 (Allt Anndeir)

<p>Photograph 68: Allt Anndeir – view downstream, from Dalnamein Bridge, which runs parallel to existing A9 bridge</p>	Water feature type: Large watercourse
	Catchment area: 61.41km ²
	Key hydraulic connections: Tributary of the upper reach of the River Garry
	Surrounding land use: Rough pasture, forestry and moorland
	SEPA overall status: Bad Ecological Potential
Description of Specific Baseline Conditions	Sensitivity
Hydrology and Flood Risk	
<p>The Allt Anndeir (WF158) is a larger watercourse and tributary to the River Garry. The SEPA Flood Map identifies a 0.5% AEP (200-year) floodplain, which is generally narrow and well-defined. The existing A9 bridge structure has been assessed as having sufficient capacity to convey the 0.5% AEP (200-year) plus CC event. The watercourse also crosses a local access road downstream of the existing A9 and just upstream of its confluence with the River Garry, however it is raised at this location and is not considered to be at risk of flooding. There may be potential for flooding within the vicinity of this watercourse, including flooding of utilisable agricultural land.</p>	Medium

Fluvial Geomorphology	
<p>SEPA physical condition status: High (2015).</p> <p>A large watercourse with a stable meandering planform and a wider river corridor consisting of gravels, pebbles and cobbles. The channel in the downstream reach below the existing A9 had a bedrock bed and step-pool sequence. There were also several small cascades within this reach.</p> <p>The watercourse is bridged by the existing A9 and a number of access tracks. Analysis of historical mapping shows that WF158 has laterally adjusted in the past.</p> <p>For a more detailed description of the watercourse, refer to Appendix A11.5 (Fluvial Geomorphology).</p>	High
Water Quality	
<p>SEPA water quality status: High (2015).</p> <p>Potential pollutant sources:</p> <ul style="list-style-type: none"> • diffuse rural sources including biological pollutants from grazing livestock and suspended sediment inputs from forestry; • PGG-C2 Existing A9 with potential for contaminants associated with traffic – crosses watercourse; and • PGG-C4 Disused Quarry with potential for contaminants associated with infill material – within 20m of watercourse. 	High

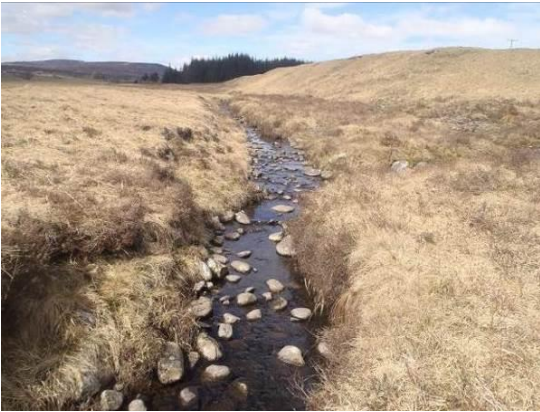
Table 68: WF159

<p>Photograph 69: WF159 – view upstream, parallel to the existing A9 southbound carriageway</p>	Water feature type: Small watercourse
	Catchment area: 0.47km ²
	Key hydraulic connections: Discharges into the upper reach of the River Garry
	Surrounding land use: Rough grazing, arable and forestry
Description of Specific Baseline Conditions	Sensitivity
Hydrology and Flood Risk	
<p>This watercourse has a catchment area of less than 3km² and so is not included in the SEPA Flood Map. The watercourse is shown by OS mapping to flow in relatively close proximity to an underpass in the vicinity of the existing A9, flowing towards the River Garry and crossing a local access road. While the culvert capacity assessment indicates that WF159 does not pose a flood risk to the existing A9 during 0.5% AEP plus CC event, due to it sitting approximately 5m above the watercourse, it indicates out of bank flooding may occur. Given that there are two properties within approximately 20m of the watercourse, although these are separated from the watercourse by the local access road, both the road and the properties may be at minor risk of flooding. This watercourse also passes through utilisable agricultural land, which may be at a potential risk of minor and localised flooding during the design flood event.</p>	High

Fluvial Geomorphology	
<p>SEPA physical condition status: not classified.</p> <p>A watercourse that consists of a series of smaller drains with straight planforms and a wetland area identified as a Groundwater Dependent Terrestrial Ecosystem (GWDTE) (refer to Appendix A10.2: Ecological Receptors with a Potential Groundwater Component) feeding into a wider defined channel. The watercourse had a straight planform with evidence of channel adjustment and a boulder, cobble and gravel substrate. Morphological features were present, with side bars and undercutting banks. The channel appears to be incising in places. Historical mapping shows that the planform of the watercourse has not changed significantly since first records in 1867.</p> <p>For a more detailed description of the watercourse, refer to Appendix A11.5 (Fluvial Geomorphology).</p>	Medium
Water Quality	
<p>SEPA water quality status: not classified.</p> <p>Potential pollutant sources:</p> <ul style="list-style-type: none"> • diffuse rural sources including biological pollutants from grazing livestock and suspended sediment inputs from forestry; • diffuse run-off of contaminants associated with A9 traffic (PGG-C2 Existing A9 –crosses watercourse); and • PGG-C10 Three septic tanks at Dalnamein with potential for associated contaminants – within 50m of watercourse. 	Medium

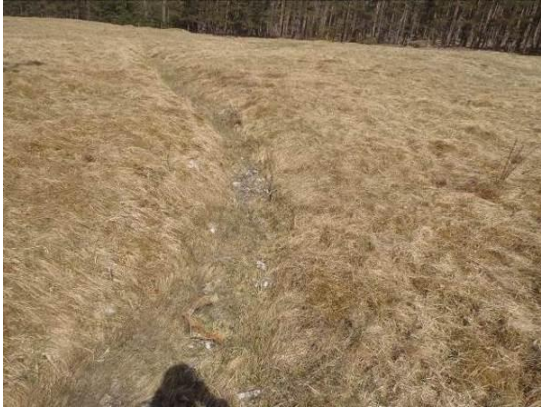
Table 69: WF160

<p>Photograph 70: WF160 – view upstream, towards Dalnamein Forest</p>	Water feature type: Drainage channel
	Catchment area: 0.28km ²
	Key hydraulic connections: Discharges into WF159, which discharges to the River Garry
	Surrounding land use: Predominantly rough grazing and forestry
Description of Specific Baseline Conditions	Sensitivity
Hydrology and Flood Risk	
This watercourse has a catchment area less than 3km ² and so is not included in the SEPA Flood Map. OS mapping indicates this watercourse crosses a local access road before its confluence with WF159. The culvert capacity assessment indicates that WF160 does not pose a flood risk to the existing A9 during 0.5% AEP plus CC event, with flow being simulated to remain in bank upstream of the culvert.	Low
Fluvial Geomorphology	
SEPA physical condition status: not classified. A small, uniform drainage channel with straight planform and no vegetated riparian corridor zone. The watercourse was dry at time of survey. The concrete channel present upstream of the culvert under the existing A9 has been undermined. The watercourse is first shown on historical mapping in 1975, and the planform of the channel has not changed significantly since.	Low

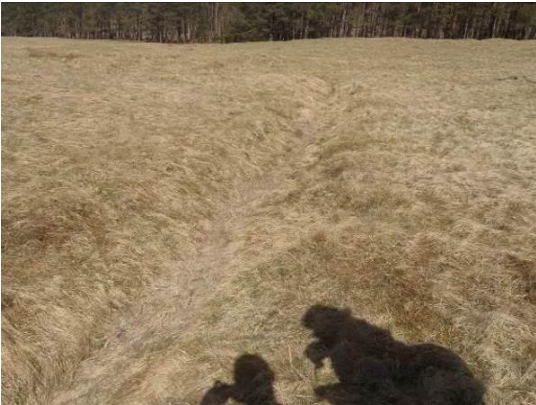
Table 70: WF161

<p>Photograph 71: WF161 – view upstream, towards Dalnamein Forest</p>	Water feature type: Drainage channel
	Catchment area: 0.27km ²
	Key hydraulic connections: Discharges into WF159, which discharges to the River Garry
	Surrounding land use: Rough pasture
Description of Specific Baseline Conditions	Sensitivity
Hydrology and Flood Risk	
This watercourse has a catchment area of less than 3km ² and so is not included in the SEPA Flood Map. This watercourse flows into WF160 before crossing a local access road. The culvert capacity assessment indicates that the existing A9 is not at risk of flooding during the 0.5% AEP (200-year) plus CC flood event. OS mapping shows that there is a property within 10m of the watercourse (Tigh-na-Coille) which is considered to potentially be at risk of flooding during the design event.	High
Fluvial Geomorphology	
SEPA physical condition status: not classified. A small, uniform drainage channel with straight planform and no vegetated riparian corridor zone, apart from some scattered trees. The watercourse was dry at time of survey. The watercourse is first shown on historical mapping in 1975. The planform of the channel has not change significantly since.	Low

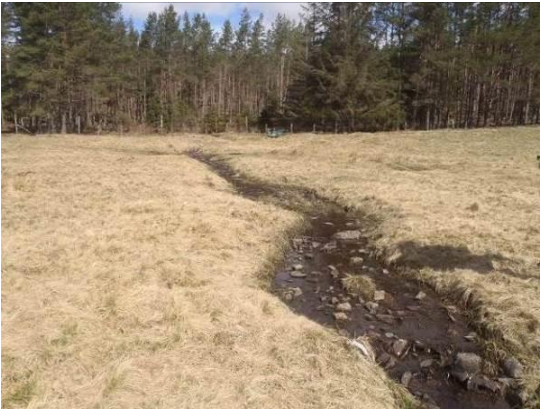
Table 71: WF162

<p>Photograph 72: WF162 – view upstream, towards Dalnamein Forest</p>	Water feature type: Small watercourse
	Catchment area: 0.22km ²
	Key hydraulic connections: Discharges into WF159, which discharges to the River Garry
	Surrounding land use: Forestry and rough pasture
Description of Specific Baseline Conditions	
Sensitivity	
Hydrology and Flood Risk	
<p>This watercourse has a catchment area of less than 3km² and so is not included in the SEPA Flood Map. OS mapping indicates this watercourse crosses a local access road before its confluence with WF159. The culvert capacity assessment indicates that WF162 does not pose a flood risk to the existing A9 during 0.5 % (200-year) AEP plus CC event, with flow being simulated to remain in bank with no risk of flooding to residential properties during the design event.</p>	Low
Fluvial Geomorphology	
<p>SEPA physical condition status: not classified.</p> <p>A small drainage channel with a straight planform. The watercourse had a uniform cross-section and no vegetated riparian corridor zone. At the boundary of the woodland, fine sediment was being trapped by tarpaulin on the fence which crosses the channel.</p> <p>The watercourse is first shown on historical mapping in 1975, and the planform of the channel has not changed significantly since.</p>	Low

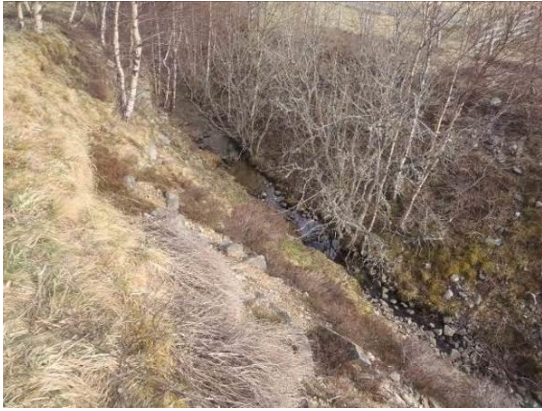
Table 72: WF163

<p>Photograph 73: WF163 – view upstream, to the south of the existing A9</p>	Water feature type: Small watercourse
	Catchment area: 0.16km ²
	Key hydraulic connections: Discharges into the upper reach of the River Garry
	Surrounding land use: Rough grazing and forestry
Description of Specific Baseline Conditions	Sensitivity
Hydrology and Flood Risk	
<p>This watercourse has a catchment area of less than 3km² and so is not included in the SEPA Flood Map. OS mapping indicates the watercourse flows through an area of forestry upstream of the existing A9. The watercourse then crosses the road via a pre-earthwork drain and culvert, and then flows downstream crossing a local access road just upstream of its confluence with the River Garry. The culvert capacity assessment indicates that WF163 does not pose a flood risk to the existing A9 during the 0.5 % AEP plus CC event, with flow being simulated to remain in bank.</p>	Low

Fluvial Geomorphology	
<p>SEPA physical condition status: not classified.</p> <p>A man-made channel with a uniform trapezoidal cross-section and straight planform. The channel had steep banks which were lined with trees. The water was stagnant at the time of survey.</p> <p>The channel is culverted under the existing A9 and a local access track. The watercourse is first shown on historical mapping in 1980, and the planform of the channel has not changed significantly since.</p>	Low
Water Quality	
<p>SEPA water quality status: not classified.</p> <p>Potential pollutant sources:</p> <ul style="list-style-type: none"> diffuse rural sources including biological pollutants from grazing livestock and suspended sediment inputs from forestry; and diffuse run-off of contaminants associated with A9 traffic (PGG-C2 Existing A9 –crosses watercourse). 	Low
Dilution and Removal of Waste Products	
CAR Discharges: none.	Low

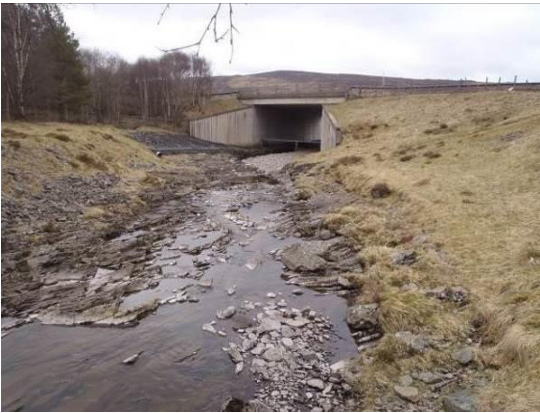
Table 73: WF164 (Allt Geallaidh)

<p>Photograph 74: Allt Geallaidh – view downstream, towards the existing A9 overbridge</p>	Water feature type: Medium watercourse
	Catchment area: 8.80km ²
	Key hydraulic connections: Tributary of the River Garry
	Surrounding land use: Moorland and rough grazing
Description of Specific Baseline Conditions	Sensitivity
Hydrology and Flood Risk	
<p>The Allt Geallaidh (WF164) is a larger watercourse and tributary of the River Garry. Although the SEPA Flood Map identifies a 0.5% AEP (200-year) floodplain, it is largely narrow and well-defined due to the local topography. The existing A9 bridge structure has been estimated to have sufficient capacity to convey the 0.5% AEP (200-year) plus CC flood flow and therefore the risk of flooding to the existing A9 is low. There is one residential property located downstream of the existing A9 road bridge which is on the perimeter SEPA flood extent outline, and is therefore considered to potentially be at risk of flooding during the design flood event.</p>	High

Fluvial Geomorphology	
<p>SEPA physical condition status: not classified.</p> <p>A watercourse with a stable planform and irregular meanders. Upstream of the existing A9 the channel had a bedrock step-pool sequence, with some cobbles. There were a few distinct waterfalls, with water cascading over bedrock. The channel had been reinforced immediately upstream of the existing A9 bridge, with large gabion baskets (some undermined) and a gabion mattress on the left bank upstream of the bridge abutment.</p> <p>Downstream of the existing A9, the channel is straightened and realigned.</p> <p>For a more detailed description of the watercourse, refer to Appendix A11.5 (Fluvial Geomorphology).</p>	High
Water Quality	
<p>SEPA water quality status: not classified.</p> <p>Potential pollutant sources:</p> <ul style="list-style-type: none"> • diffuse rural sources including biological pollutants from grazing livestock and suspended sediment inputs from forestry; and • diffuse run-off of contaminants associated with A9 traffic (PGG-C2 Existing A9 –crosses watercourse). 	Medium

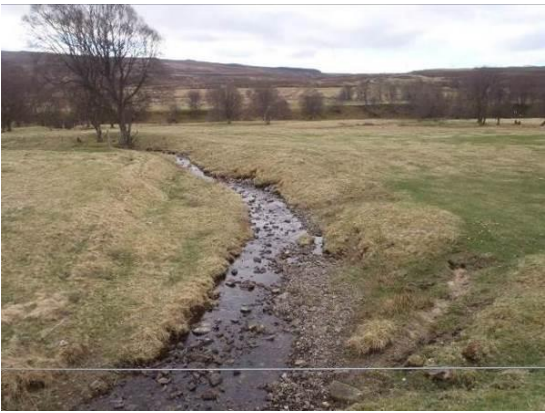
Table 74: WF165 (Allt Carn na Saidhe)

<p>Photograph 75: Allt Carn na Saidhe – view downstream from NCR7 overbridge</p>	Water feature type: Medium watercourse
	Catchment area: 1.53km ²
	Key hydraulic connections: Tributary of the River Garry
	Surrounding land use: Moorland, forestry and rough grazing
Description of Specific Baseline Conditions	Sensitivity
Hydrology and Flood Risk	
This watercourse is not included in the SEPA Flood Map as it has a catchment area of less than 3km ² . OS mapping indicates the watercourse flows through an area of woodland upstream of the existing A9. The watercourse is then culverted under the existing A9 before flowing under a local access road before its confluence with the River Garry downstream. The SEPA map shows no flood risk within the vicinity of this watercourse during the 0.5% (200-year) AEP plus CC event. The existing A9 is already dualled at this crossing location.	Low
Fluvial Geomorphology

SEPA physical condition status: not classified. Upstream of the existing A9, WF165 had a sinuous planform with some areas of deposition. It had a low flow channel, and a cobble and pebble substrate. There was a minimal vegetated riparian corridor, with some individual scattered trees. Downstream of the existing A9, the watercourse had a modified lined trapezoidal channel with few natural features. Analysis of historical mapping shows that WF165 has adjusted laterally since 1867. For a more detailed description of the watercourse, refer to Appendix A11.5 (Fluvial Geomorphology).	Medium
Water Quality	
SEPA water quality status: not classified. Potential pollutant sources: <ul style="list-style-type: none"> • diffuse rural sources including biological pollutants from grazing livestock and suspended sediment inputs from forestry; and • diffuse run-off of contaminants associated with A9 traffic (PGG-C2 Existing A9 –crosses watercourse). 	Medium
