# 9 Effects on Fauna and Flora

- 9.1 The objective of this Ecological Impact Assessment (EcIA) was, initially, to establish the extent and ecological status of the area likely to be impacted by the development of the proposed A8/M8 junction at Bishopton in a scoping exercise. Details of the survey area are shown in Figure 1 of Starling Learning's *A8/M8 Ecological Survey Update* (Appendix 9.2). The area so defined was the subject of desktop and walk-over surveys. Following discussion with Scottish Natural Heritage (SNH) the precise scope and programme of season-specific ecological surveys was formulated and subsequently carried out using qualified and experienced ecological surveyors. The information gathered and conclusions drawn were used to inform the design, to minimise potential impacts upon the ecological receptors identified. None of the information retrieved suggested that the survey needed to be extended beyond the initial survey area. The site assessment was simplified by the nature of the habitat to be lost and disturbed, which is largely farmed fields and managed roadside planting adjacent to the A8 and M8. There would, however, also be disturbance and loss of a small

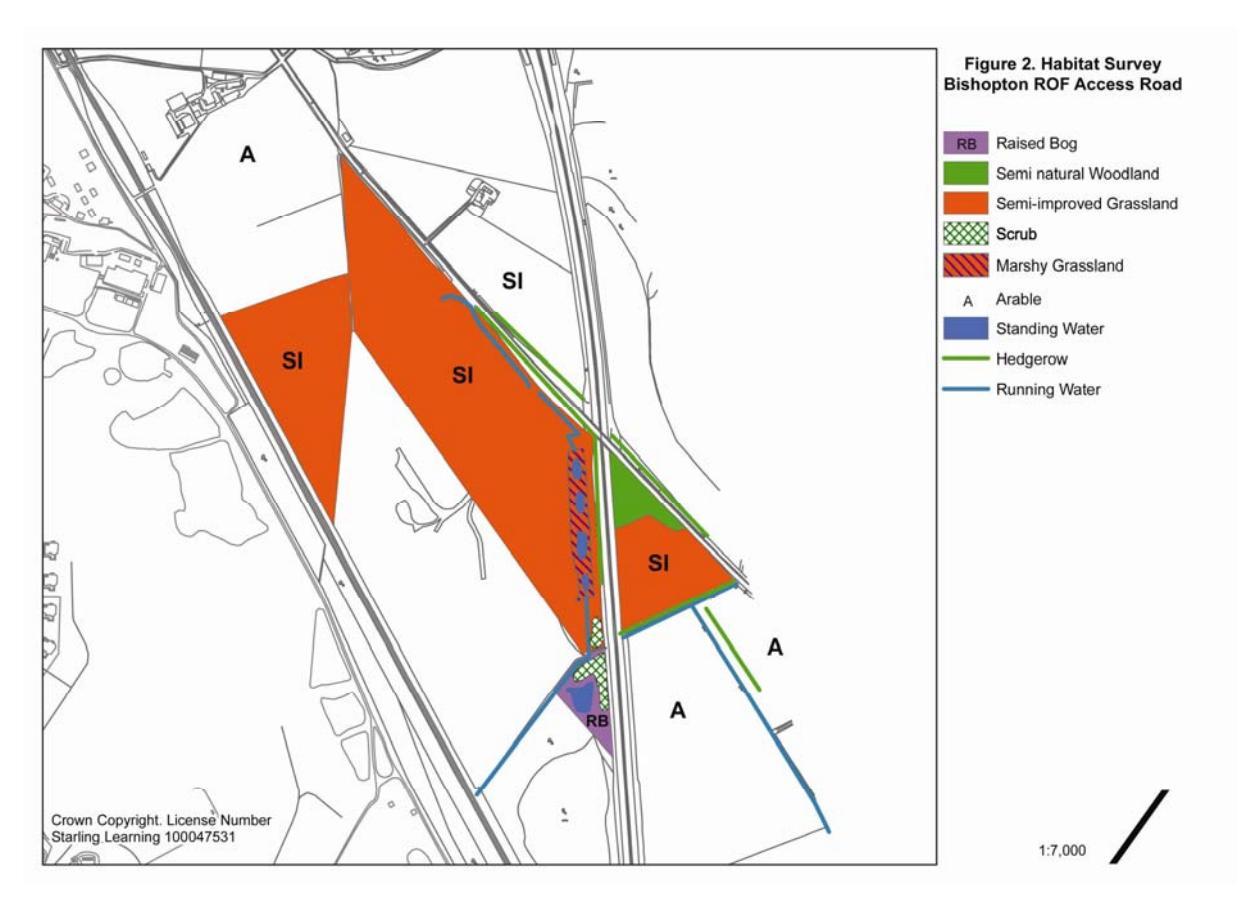
Figure 9.3 Phase I Habitat Survey Map

9.10 The whole site was walked and the habitats mapped. A brief description of the various habitats is given below. The Phase 1 Habitat Survey Map is shown below in an amended version of Starling Learning's Figure 2 (at Appendix 9.2).

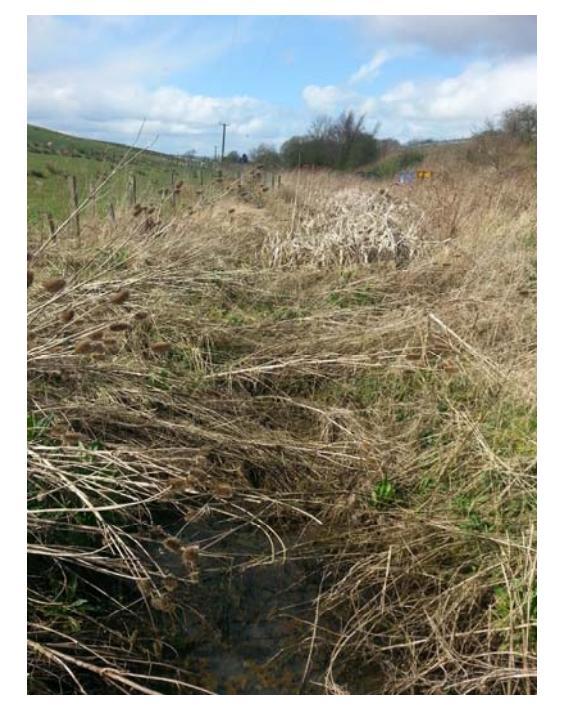
Photo. 9.1 The burn as it flows in a ditch through Site A (2014)

9.11 The burn runs in a ditch with fairly steep sides to the north end of the site (Photo. 9.1). The vegetation varies along its length, with areas of tufted hair grass (*Deschampsia caespitosa*), teasels (*Dipsacus fullonum*), greater willowherb (*Epilobium hirsutum*) and rosebay willowherb (*Chamerion angustifolium*) common throughout this stretch. The small burn has been extended as it flows south through the site into a series of four ponds and associated marsh. Each pond supports a large area of greater reedmace (*Typha latifolia*) (Photo. 9.2). Other

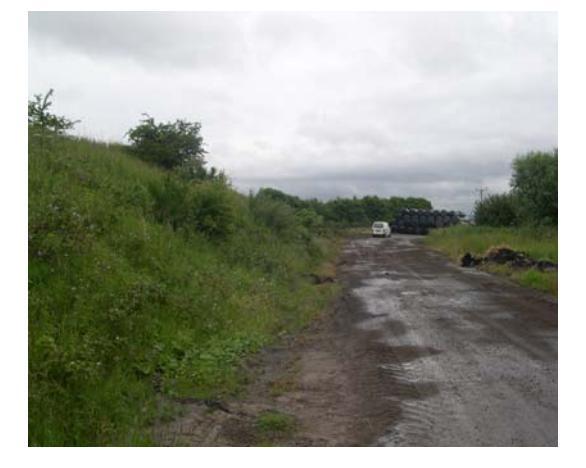
Photo 9.3 Road across Site A, showing area of silage storage

- 9.13 There is an old section of road to the north of the site where rolls of silage are stored (Photo. 9.3). The embankment leading up to the A8 in this area is grassy with ruderal weeds such as rosebay willowherb and cow parsley (*Anthriscus sylvestris*) and scattered hawthorn (*Crataegus monogyna*) and willow (*Salix* spp.) scrub.

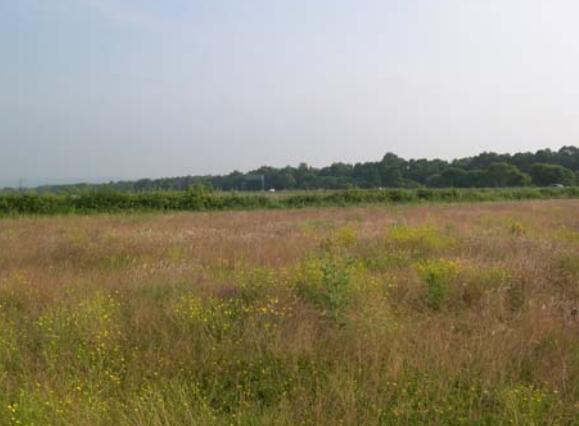
## Photo 9.4. Species-rich grassland to the north of site B.

9.16 Site B comprises agricultural fields and hedgerow and a small area of young woodland/scrub to the existing road embankment. A small, triangular field immediately below the embankment supports a relatively species-rich grassland, including meadow buttercup *(Ranunculus acris)* and field scabious *(Knautia arvensis*) (Photo 9.4).

- 9.58 The impact on the species-rich grassland will be relatively limited as only a small area is to be disturbed for the road construction. However, as part of the mitigation, it may be possible to translocate turves to establish grassland in the isolated area of field adjacent to the motorway.

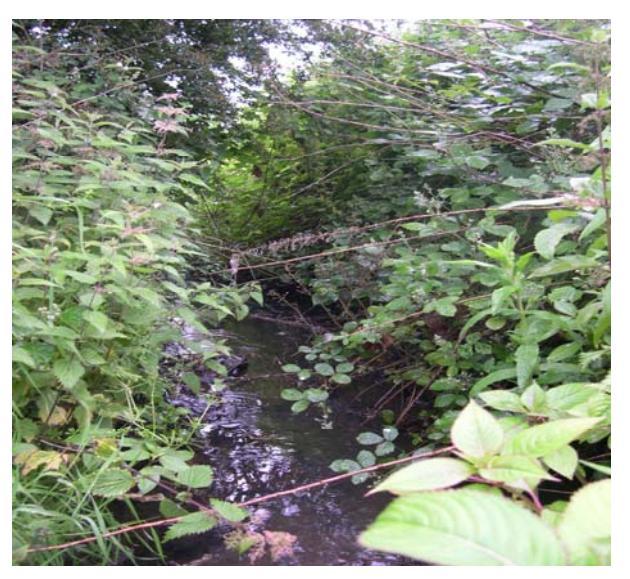
Photo 9.5 Lin burn, in steep, heavily-vegetated banks

9.19 The Lin Burn is culverted to the east side of the A8. After meeting the small burn flowing from under the M8 it flows in a southeast direction in an open channel. The burn is small with a stony substrate and has steep, heavily-vegetated banks.

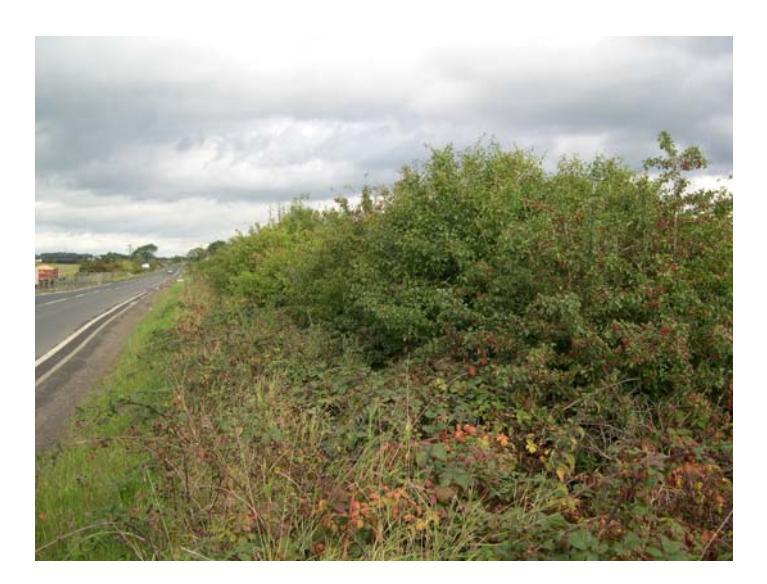
Photo 9.6 Unmanaged hedgerow at Site C

9.21 The proposed new road alignment will cross a mature hawthorn and blackthorn hedgerow at site C. Some of the hedgerow has been left uncut, some of was severely cut in 2006 management works.

- 9.59 The hedgerow will be protected where possible, as this is a mature hedge. While species poor, it provides habitat for wildlife. New hedgerow and trees will be planted to provide alternative habitat. Additionally, an extensive area of gorse (*Ulex europaeus*) and birch shrub is to be provided, as this is particularly attractive to nesting yellow hammers (*Emberiza citronella*) that frequent the area. The excavation and re-planting of hedgerows can be successful especially where the existing hedgerow is well maintained and the space in which the roots extend are restricted (i.e., by physical barriers such as footpaths or roads, or where trimmed by ploughing etc) and should be considered in this instance.

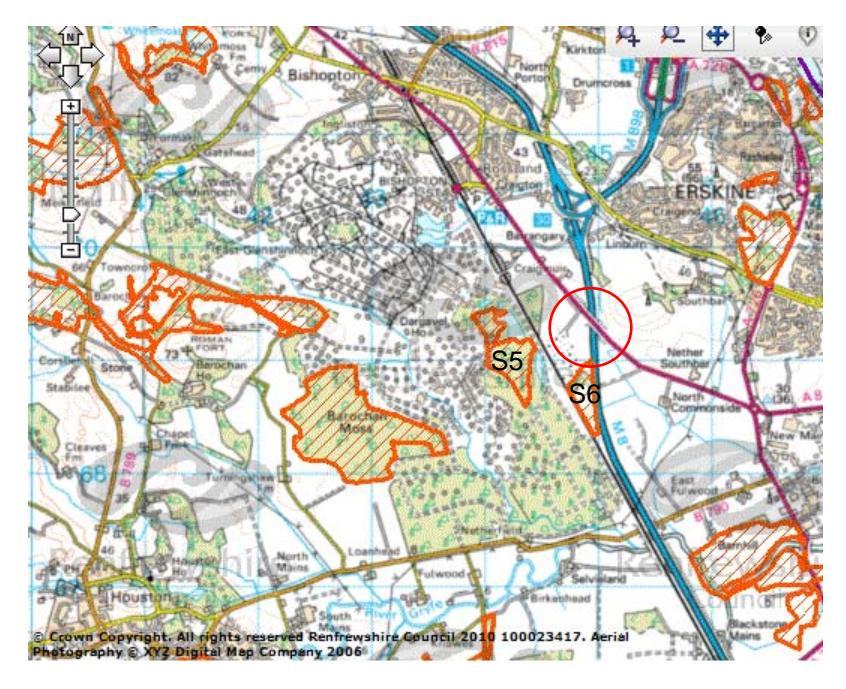
Figure 9.4 SINCs around A8/M8 junction (red circle)

- 9.48 A number of sites of importance for nature conservation (SINCs) lie adjacent to the location of the proposed junction, with two SINCs lying within 200m of the site, as illustrated in Figure 9.4 below.

- 9.49 These SINCs and habitats are:
  - S5: an area of lichen heath/birch scrub lying to the west of the site, beyond the railway line within the BAE Systems's site.
  - S6: East Fulwood Moss, lowland raised bog. Full details of the SINC and its listing are given in Appendix 10.4.
