Rannoch Moor and Glen Coe Bridge Replacements

Geomorphological Report

Babtie Group – October 2006

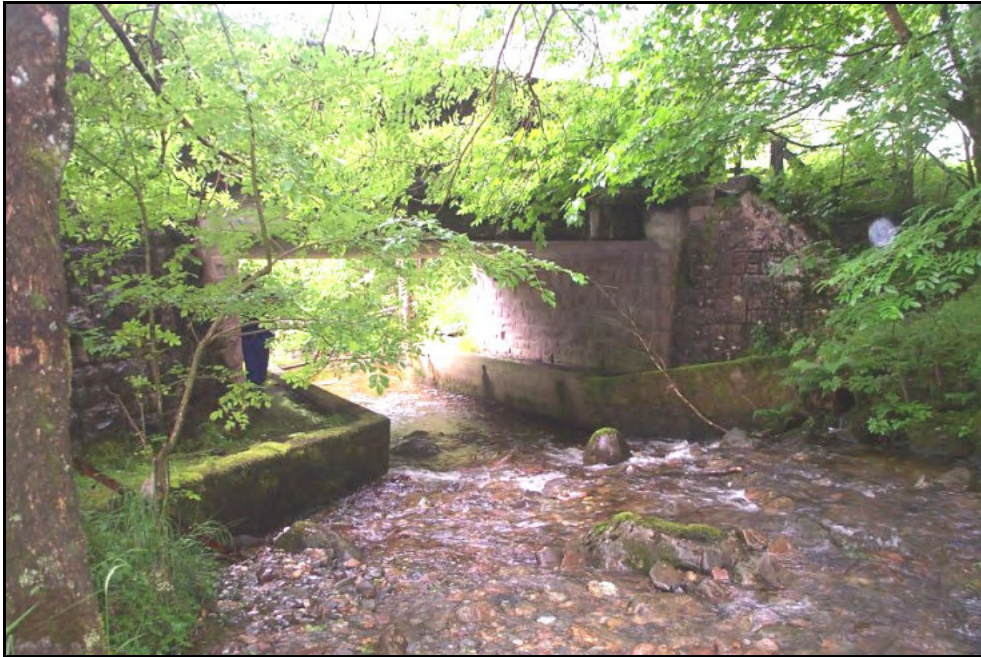
The Allt Fhiodhan bridge confines the river channel in this location, there is a 50% reduction in channel width under the bridge, the channel has adjusted to the existing bridge structure (Figure 3.1). A riffle formed from interlocking cobbles has been pinned by the upstream concrete bridge foundations.

Figure 3.1 View looking downstream to Allt Fhiodhan Bridge, note the reduction in channel capacity and the presence of the riffle within the concrete foundations immediately upstream of the bridge.

The concrete bridge footings act to confine the channel and have resulted in a 50% reduction in channel width, which appears to have influenced the river bed morphology. A riffle composed of interlocking cobbles has been pinned by the bridge footings (Figure 1). Removing the bridge footings will effectively widen the channel in this location and could destabilise this riffle. A phase of bed regrading is likely to occur following any channel widening associated with bridge replacement. Bed regrading is likely to involve some bed sediment movement during high flows, which will continue until a stable bed configuration is achieved. If this adjustment were to occur during replacement works it may complicate the replacement process and necessitate some in channel works which may increase fine sediment transfer downstream. Assuming the new bridge is of the same width as the original bridge the impact of the readjustment is likely to be localised and short lived, being restricted to the period of replacement.

Due to the potential for disturbance to the river bed morphology at the Allt Fhiodhan Bridge it is recommended that replacement does not involve the removal of the entire of the existing concrete bridge footings. It is recognised the load bearing central portions of each are likely to be replaced, however if possible the outer portions of the footings should not be removed as leaving these in place will minimise changes to the existing channel morphology. While this outer portion of the footing will degrade over time and will eventually fail this will occur gradually and will allow this channel time to adjust without a sudden change in the channel stability. The design and construction of the new bridge should take the future loss of the outer bridge footings into consideration, so this does not result in damage to the new bridge. If alterations are to be made to the dimensions of the bridge involving the loss of the footings more detailed geomorphological investigations will be required to determine an appropriate method of replacement.

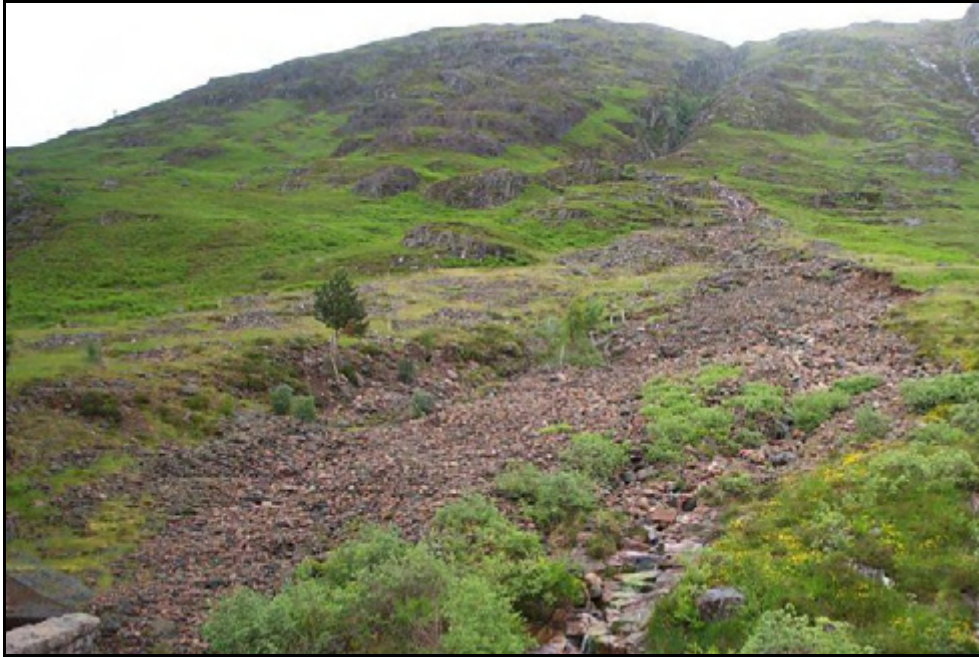
debris fan (Figure 3.2), similar in nature to the slope forms below the Aonach Eagach ridge. The high sediment supply results from the reworking of the sediments contained within the debris fan. The current bridge structure is narrow in comparison to the active width above and below, and as a result debris within the channel has built up against the retaining walls of the road approaches (Figure 3.3).

Figure 3.2 View looking upstream from the Alltanrigh Bridge

The Alltanrigh Bridge confines the channel of a wide and steep boulder-bed mountain stream. There is evidence that the bridge retaining walls are holding back storage sediment. Removal of the bridge might lead to destabilisation of the sediments in the channel, resulting in an increase in coarse sediment transfer and a readjustment of the bed. As flow appears to be ephemeral it is possible that this will only occur if replacement works coincide with a storm event. The magnitude of any readjustment will depend upon the flow conditions and the quantity of material retained by the bridge, and this is likely to vary through time.

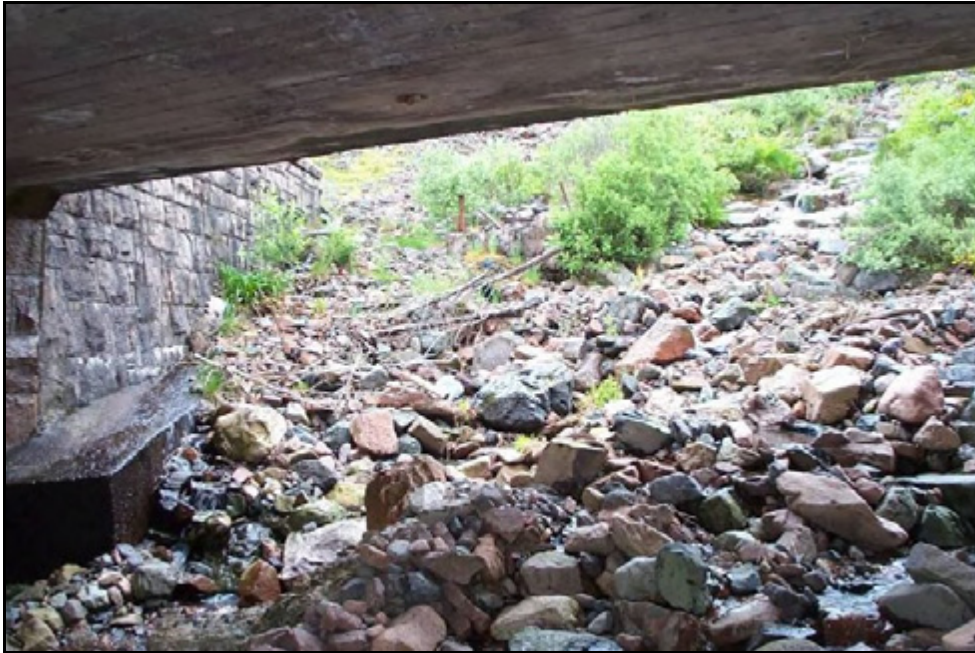
Figure 3.3 View looking upstream from under the Alltanrigh Bridge.

This bridge replacement will have to be conducted with great care to ensure that disturbance to the channel sediments be kept to a minimum. The interaction between the bridge and the channel morphology in this location make some disturbance inevitable if works are not restricted to simply replacing the bridge decking. If alterations to the bridge dimension have to be made either during works or on a permanent basis the channel morphology will be vulnerable to re-adjustment, particularly through bed sediment mobilisation. As the river channel in this location is likely to be particularly vulnerable to bridge replacement it is recommended that further geomorphological investigations be conducted at this site following
