A82(T) Crianlarich Bypass

Visualisations Viewpoint 1

Viewpoint 1 Looking north from Glenfalloch Road

Figure 10.22

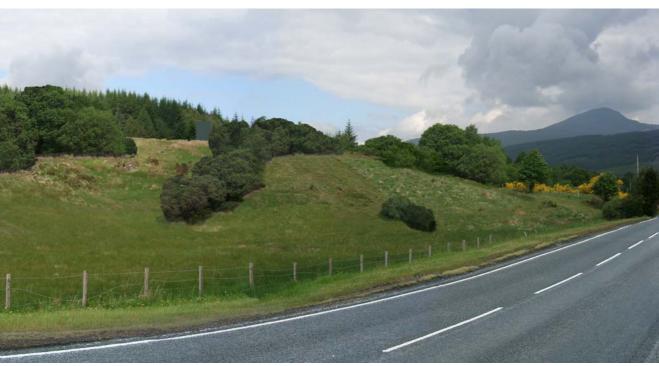
After

The new road and traffic are screened by mounding and planting. The rear of a road sign is visible. The roadside fence in the foreground might be replaced with a deer fence. Some of the foreground would be slightly over-excavated to form a detention pond
