FORTH REPLACEMENT CROSSING

CONSTRUCTION NOISE MONITORING REPORT: MAY 2017

Document number Rev
REP-00323

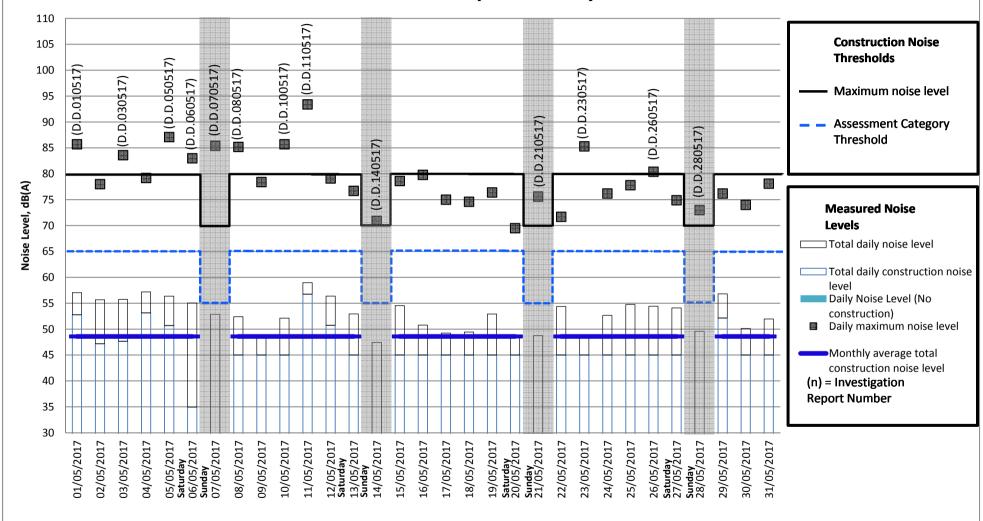
Measured Daytime Noise Levels at Dundas Home Farm Measurement period: May 2017

Note: The grey areas of the chart represent days on which no construction works have been conducted;
