## **A14.1 Baseline Description and Evaluation**

### **1.1 Features of the Existing Water Environment**

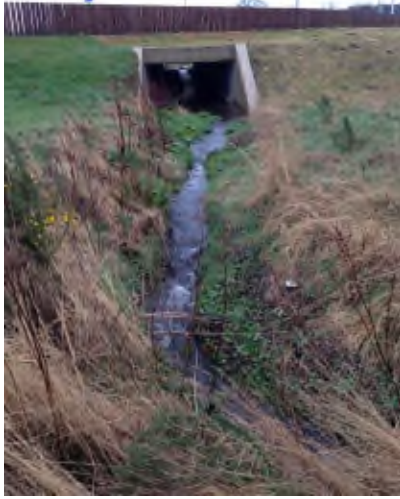
Plate 1: Channel narrowing and laterally adjusting upstream of Highland Main Line

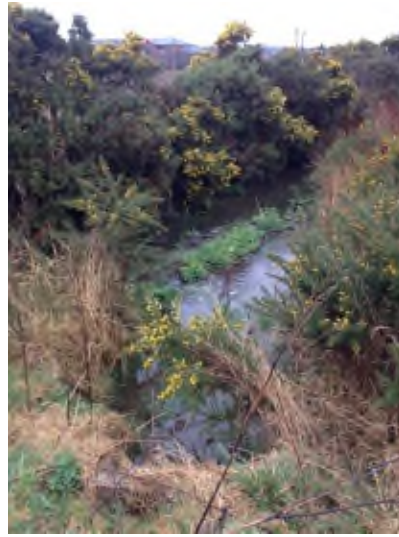
- 1.1.20 The channel has a simple riparian buffer zone consisting predominantly of reeds and grasses, with some sections of shrubs and gorse, particularly upstream of the Highland Main Line (Plate 2). The channel substrate consists predominantly of silt with some gravels and cobbles within the faster flowing sections of the burn. Downstream of the Highland Main Line the channel is slightly wider (approximately 2m wide) for a short section where silt substrate is dominant.

Plate 2: Riparian buffer consisting of gorse and grasses within the upstream section

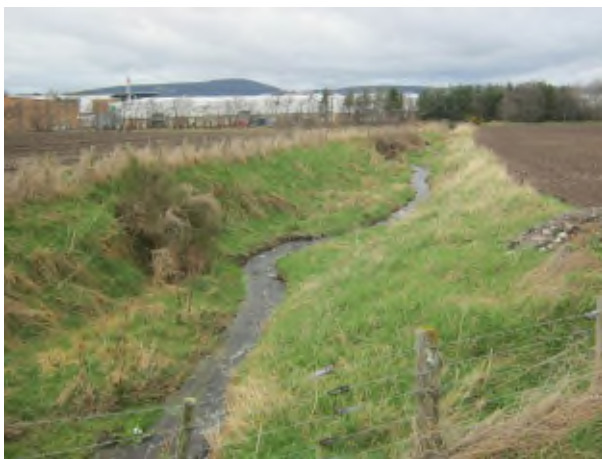
- 1.1.27 The burn flows through a predominantly straight planform with a large uniform cross-section measuring up to 4m wide and 1m deep immediately downstream of the Highland Main Line. Within its banks the burn is narrowing and latterly adjusting, creating a sinuous low flow channel within the confines of the banks (Plate 3). The channel is embanked along the majority of the upstream section (Plate 4).

Plate 3: channel laterally adjusting within its banks downstream of the railway

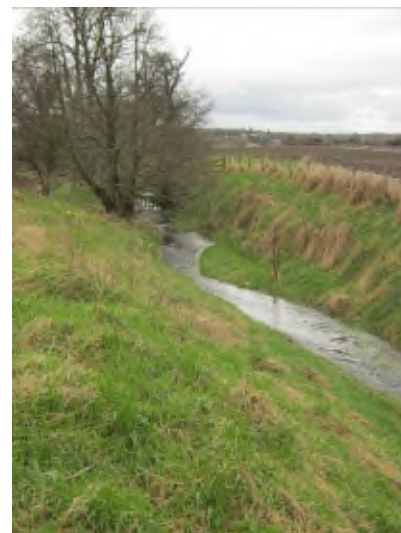
Plate 4: Embanked channel downstream of railway

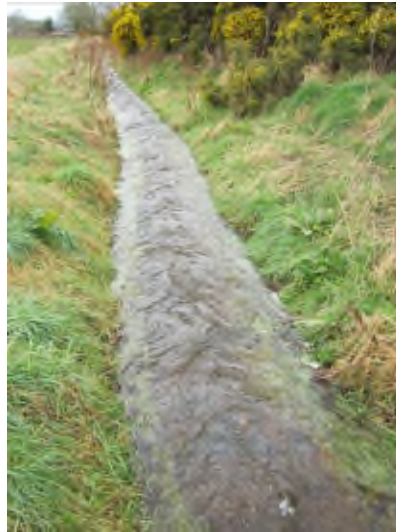
- 1.1.37 Tributary of Scretan Burn (2) is a small drainage channel forming the boundary of an agricultural field. The channel has a straight planform and a trapezoidal channel measuring approximately 1.5m wide. The channel is embanked on both sides and has a vegetated riparian buffer comprising grasses and gorse on the right bank only (Plate 5).
- 1.1.38 The predominant flow type is rippled flow and the substrate consists of silt.
- 1.1.39 SWF 05 is assessed as having a low sensitivity to disturbance.

Plate 5: Riparian vegetation on the right bank providing a buffer from agricultural land use.

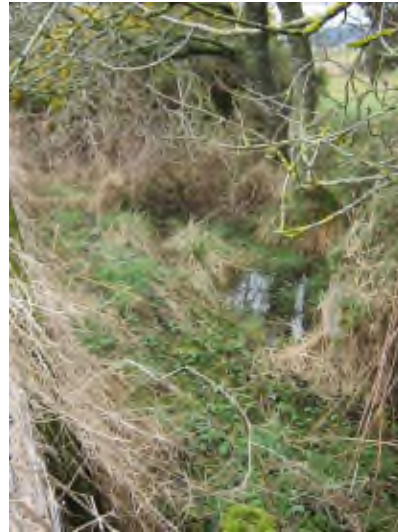
- 1.1.43 Indirect tributary of Scretan Burn has a continuous tree lining on both banks (Plate 6). The channel is fenced and has a small embankment (approximately 0.2m high) and a continuous vegetated riparian buffer, comprising grasses and shrubs present on both banks. Channel substrate is predominantly silt; however, several sections of the channel are dominated by terrestrial grass. The dominant flow type is smooth or pooled throughout the course of the channel.
- 1.1.44 SWF 06 is assessed as having a low sensitivity to disturbance.

Plate 6: Continuous tree lining on both banks of SWF 06.

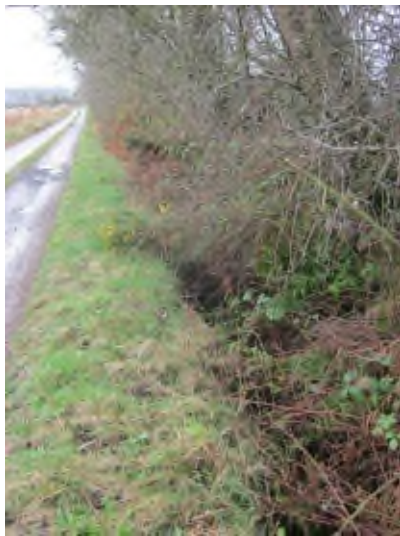
- 1.1.48 Unnamed drain consists of a road drain along an access track to Ashton Farm and a small field drain. The road drain was dry at the time of survey and overgrown with brambles (Plate 7). The channel consists of earth and has a continuous tree lining on the left bank. The field drain is a small straightened channel with a continuous tree lining on the right bank and an intermittent fence on the left banks. At the time of survey water within the channel was stagnant and substrate consisted of silt (Plate 8).

Plate 7: Dry road drain forming part of SWF 07

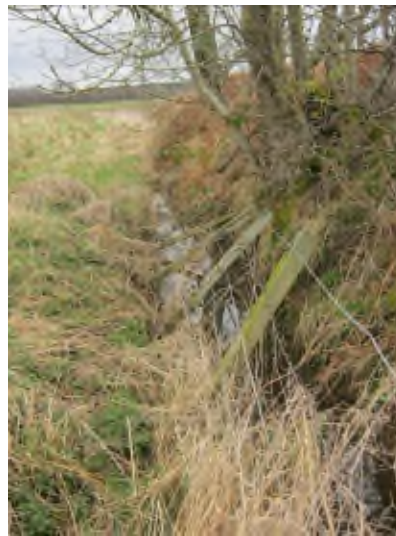
Plate 8: Field drain with stagnant water forming part of SWF 07

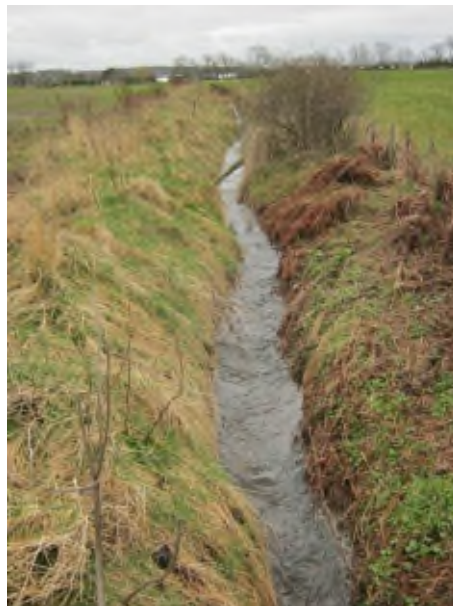
- 1.1.56 Cairnlaw Burn is a small field drain with a predominantly straightened planform along the majority of its course within the study area (Plate 9). The channel within the upstream section (adjacent to Ashton Farm) is embanked on both sides and appears to have very limited connectivity with the flood plain. The channel cross section at this location is trapezoidal and overdeep, with bank height measuring up to 1-1.5m high in some sections and up to 2m wide. Channel substrate consists predominantly of silt with some fine gravels and no deposits were observed during the site visit.

Plate 9: Straight planform and trapezoidal cross-section of SWF 08
