Project: **A9 DUALLING**
 PERTH TO INVERNESS
 Killiecrankie to Glen Garry

Drawing title: **Environmental Statement Water Features**

Drawing Status	FINAL
Scale	1:10,500 @ A3 DO NOT SCALE
Jacobs No.	B2140005
BIM No.	
Drawing number	Figure 11.1a
Rev	0

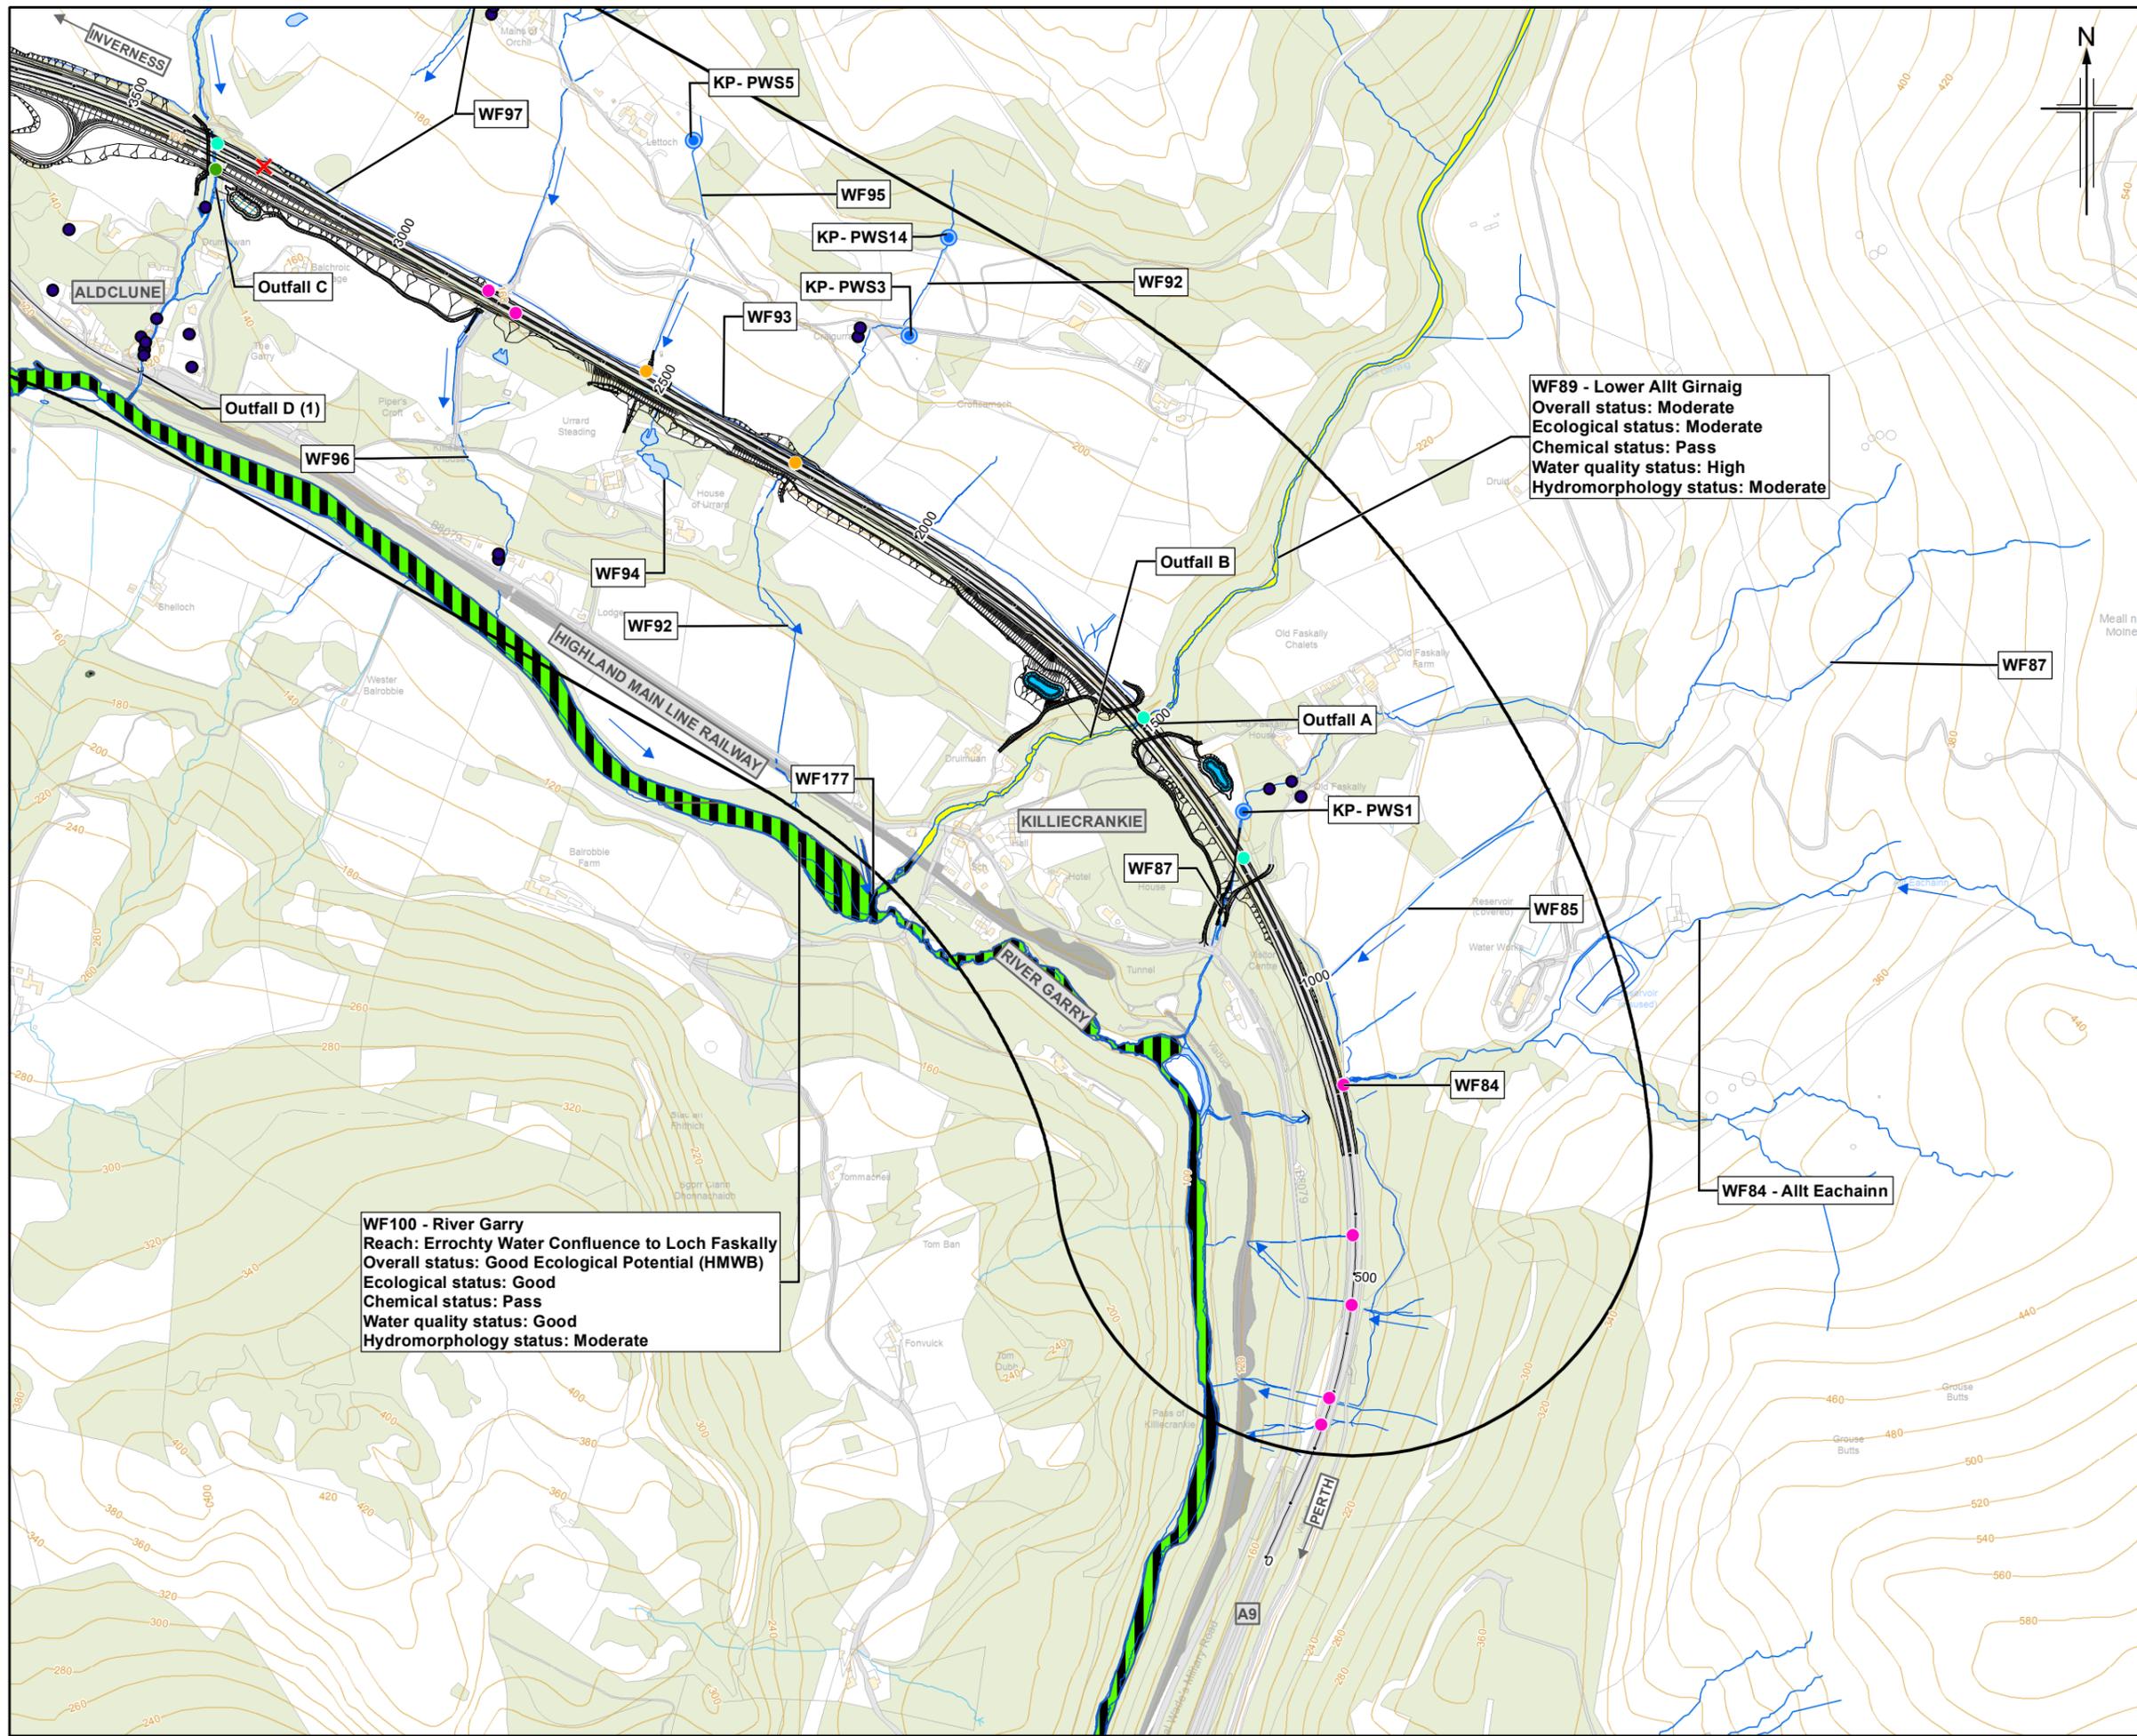
Figure 11.1a

WF100 - River Garry
 Reach: Errochty Water Confluence to Loch Faskally
 Overall status: Good Ecological Potential (HMWB)
 Ecological status: Good
 Chemical status: Pass
 Water quality status: Good
 Hydromorphology status: Moderate

WF89 - Lower Allt Gairnaig
 Overall status: Moderate
 Ecological status: Moderate
 Chemical status: Pass
 Water quality status: High
 Hydromorphology status: Moderate

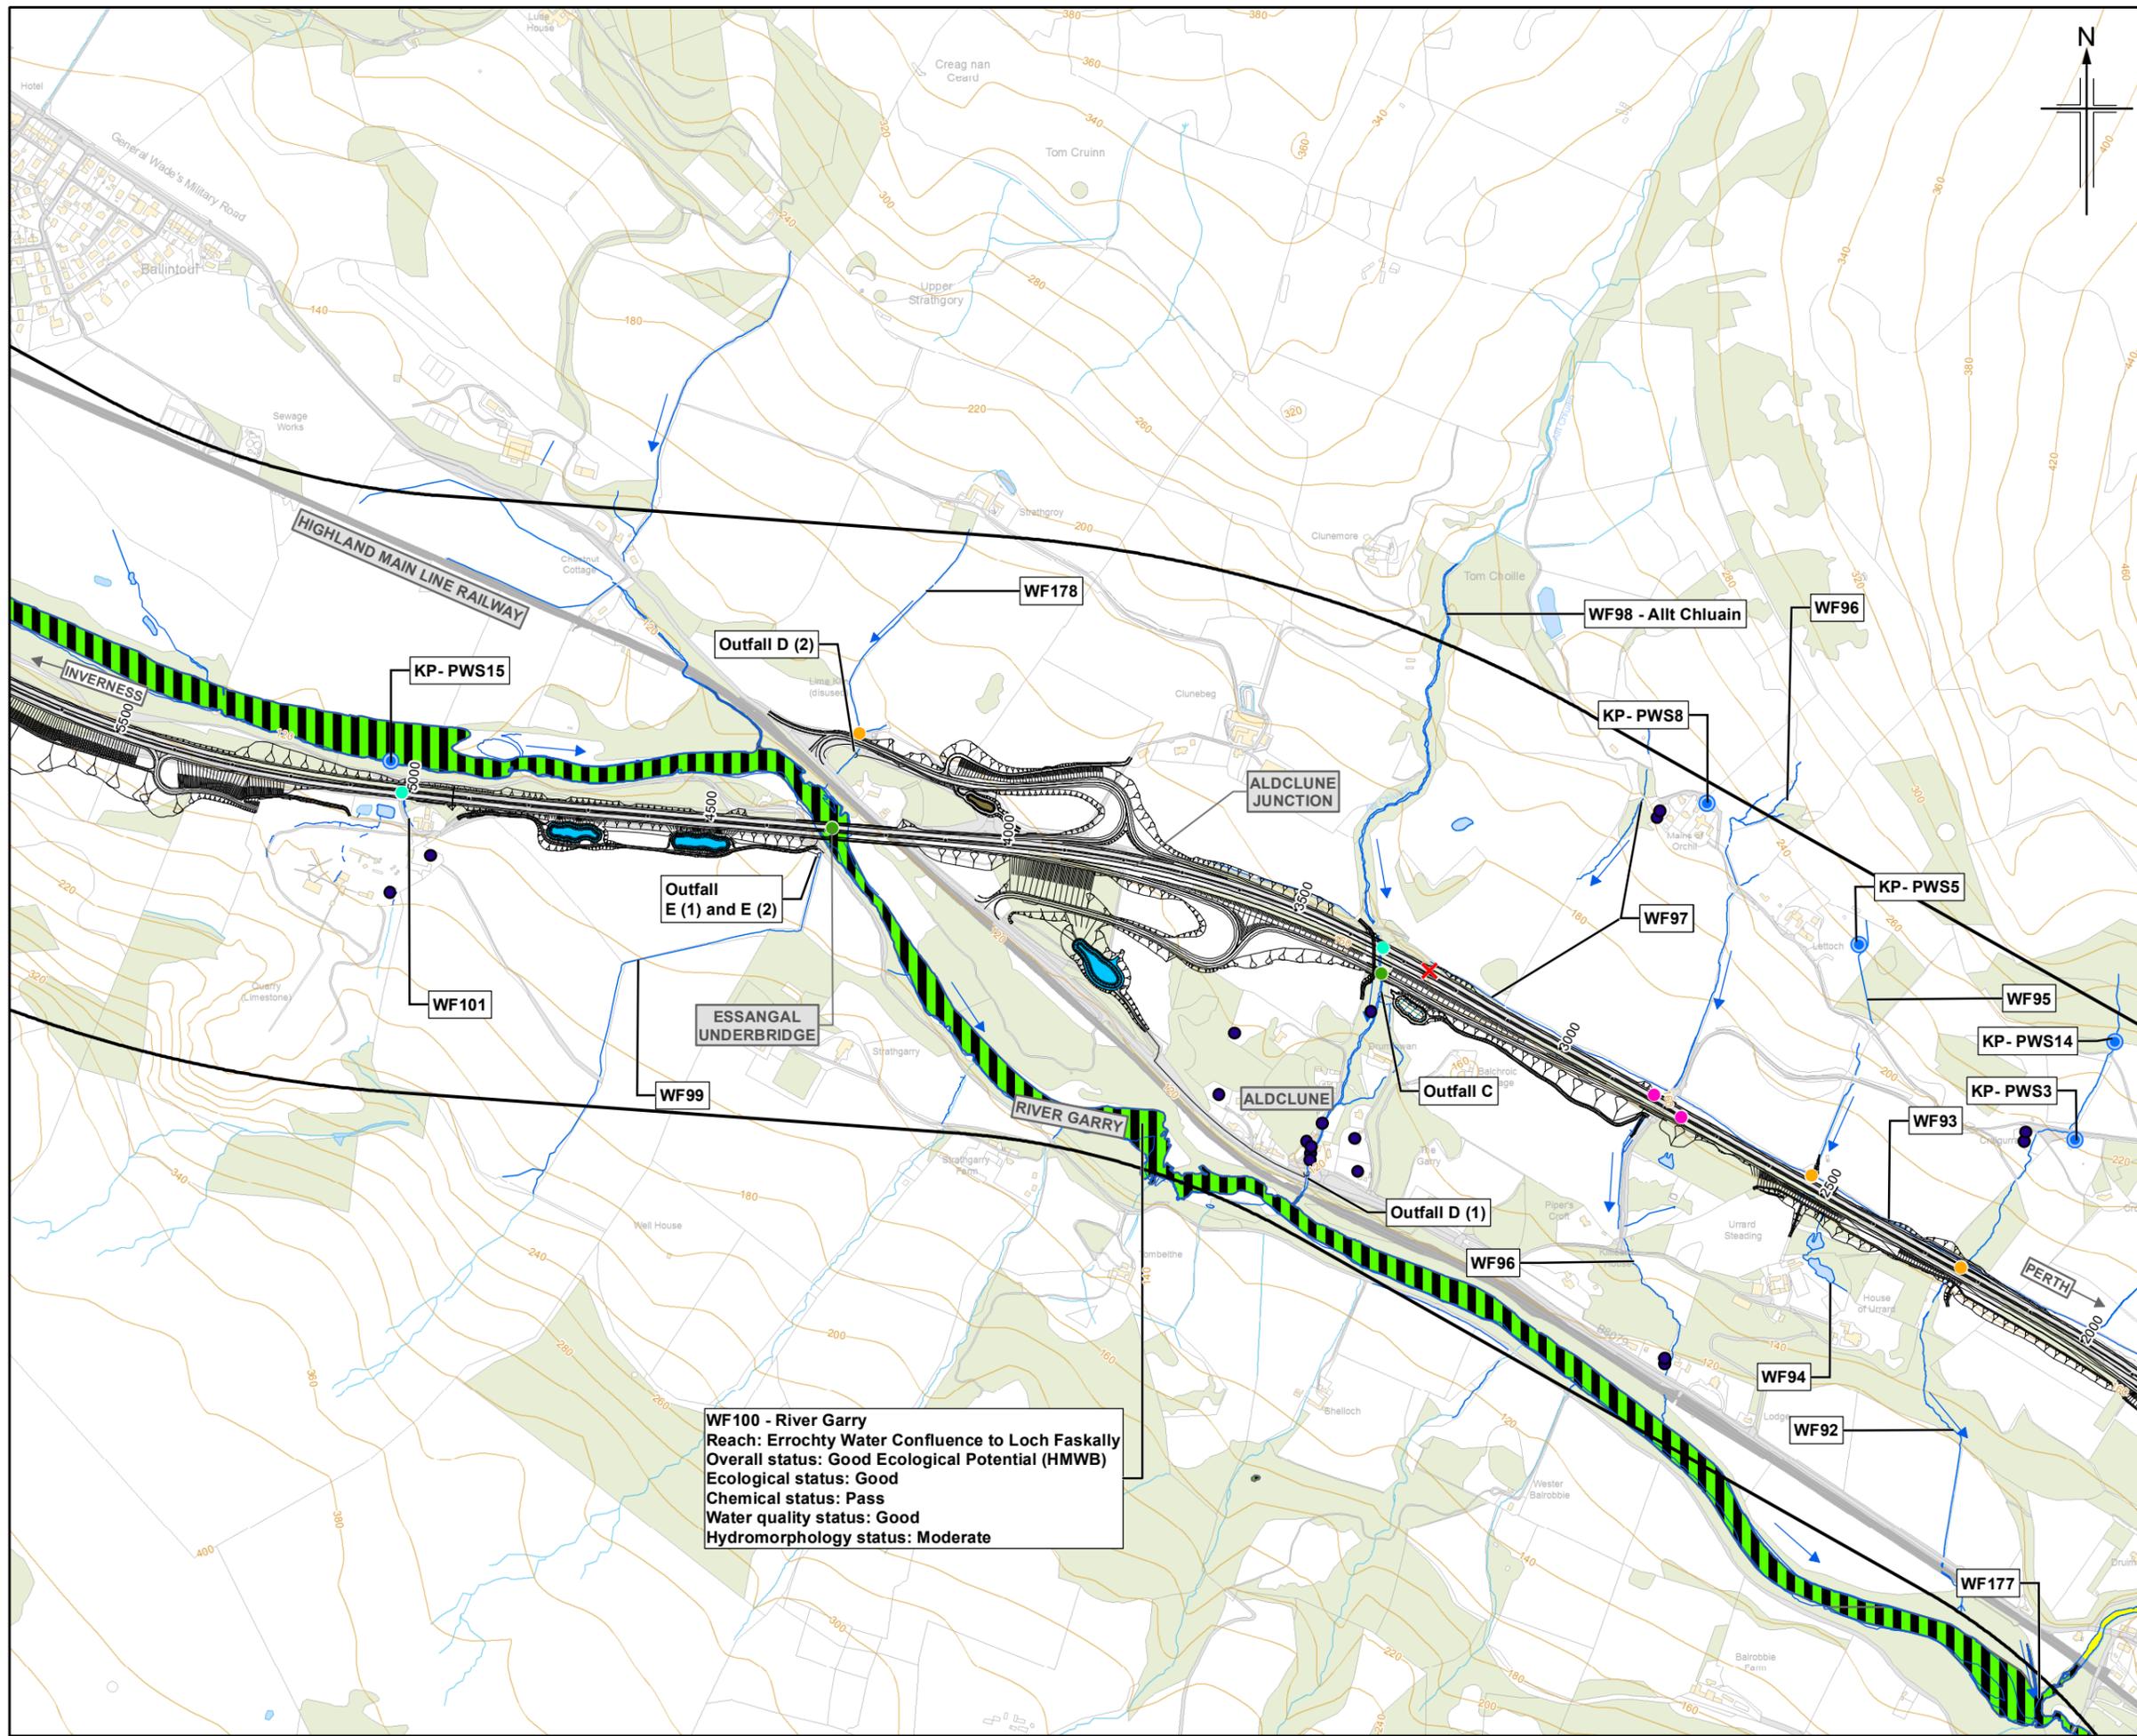
Drawing Status	FINAL
Scale	1:10,500 @ A3 DO NOT SCALE
Jacobs No.	B2140005
BIM No.	
Drawing number	Figure 11.1b
Rev	0

WF100 - River Garry
 Reach: Errochty Water Confluence to Loch Faskally
 Overall status: Good Ecological Potential (HMWB)
 Ecological status: Good
 Chemical status: Pass
 Water quality status: Good
 Hydromorphology status: Moderate

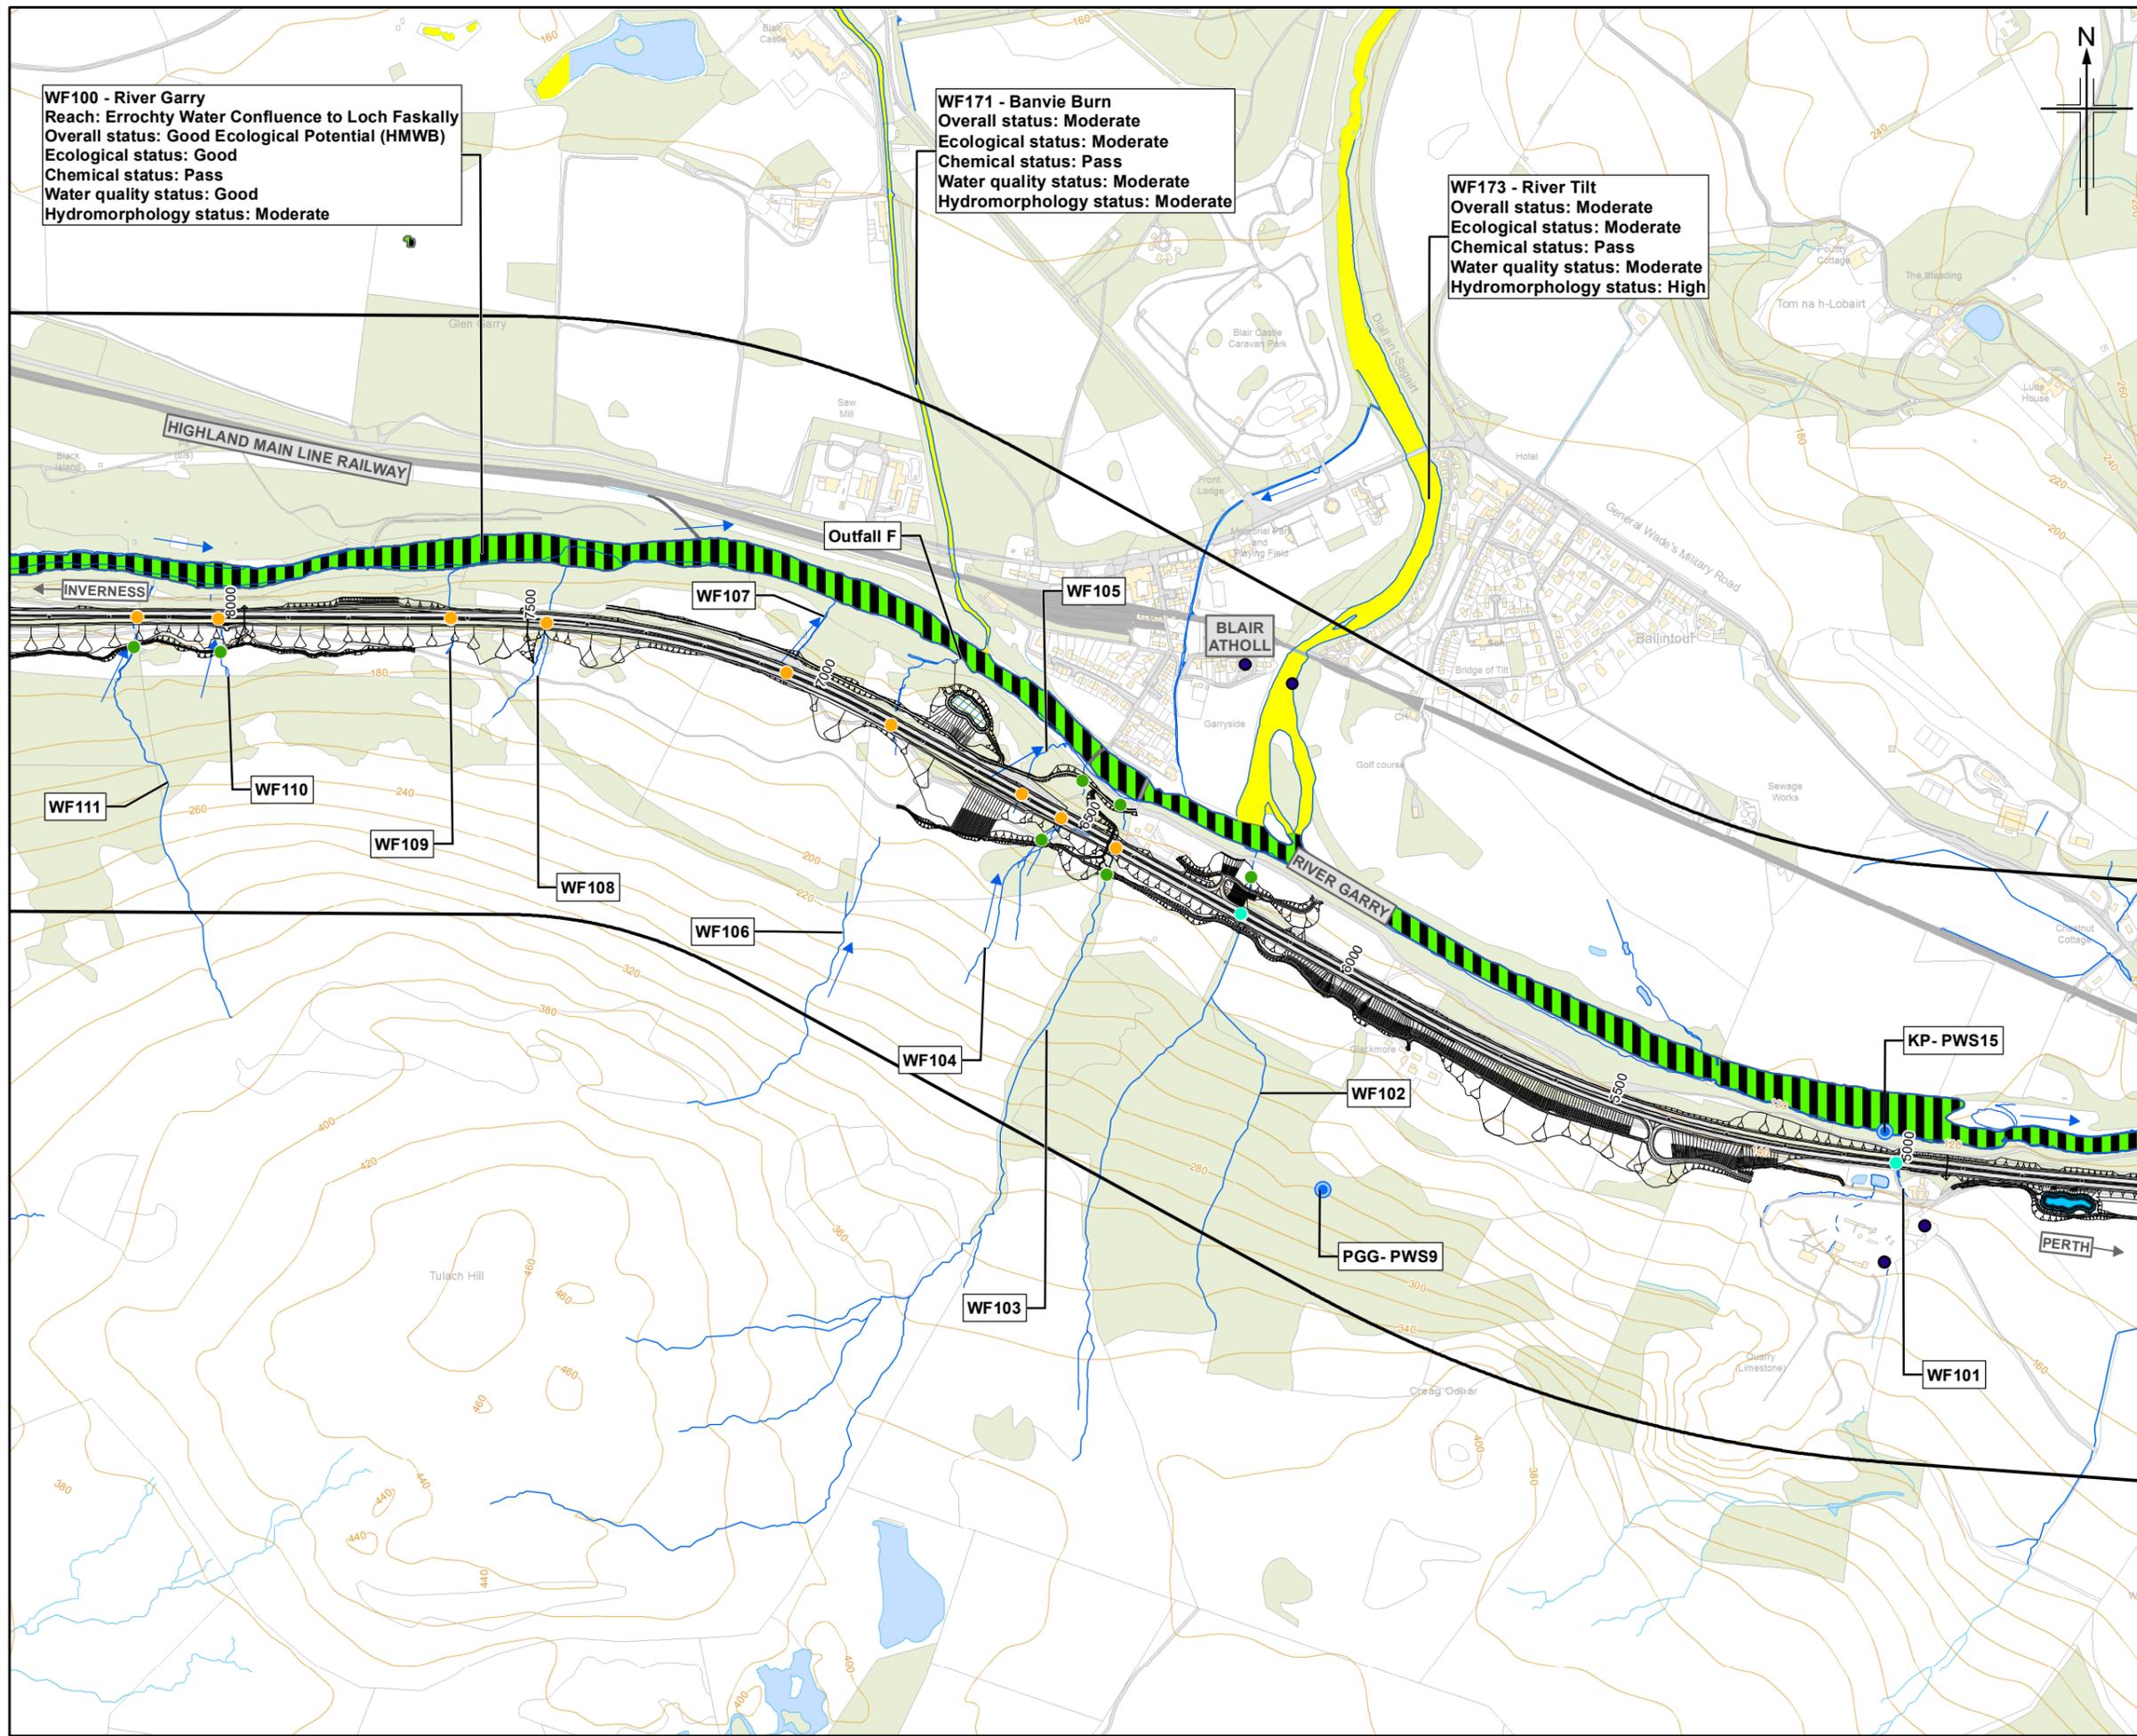
Figure 11.1c

WF100 - River Garry
 Reach: Errochty Water Confluence to Loch Faskally
 Overall status: Good Ecological Potential (HMWB)
 Ecological status: Good
 Chemical status: Pass
 Water quality status: Good
 Hydromorphology status: Moderate

WF171 - Banvie Burn
 Overall status: Moderate
 Ecological status: Moderate
 Chemical status: Pass
 Water quality status: Moderate
 Hydromorphology status: Moderate

WF173 - River Tilt
 Overall status: Moderate
 Ecological status: Moderate
 Chemical status: Pass
 Water quality status: Moderate
 Hydromorphology status: High

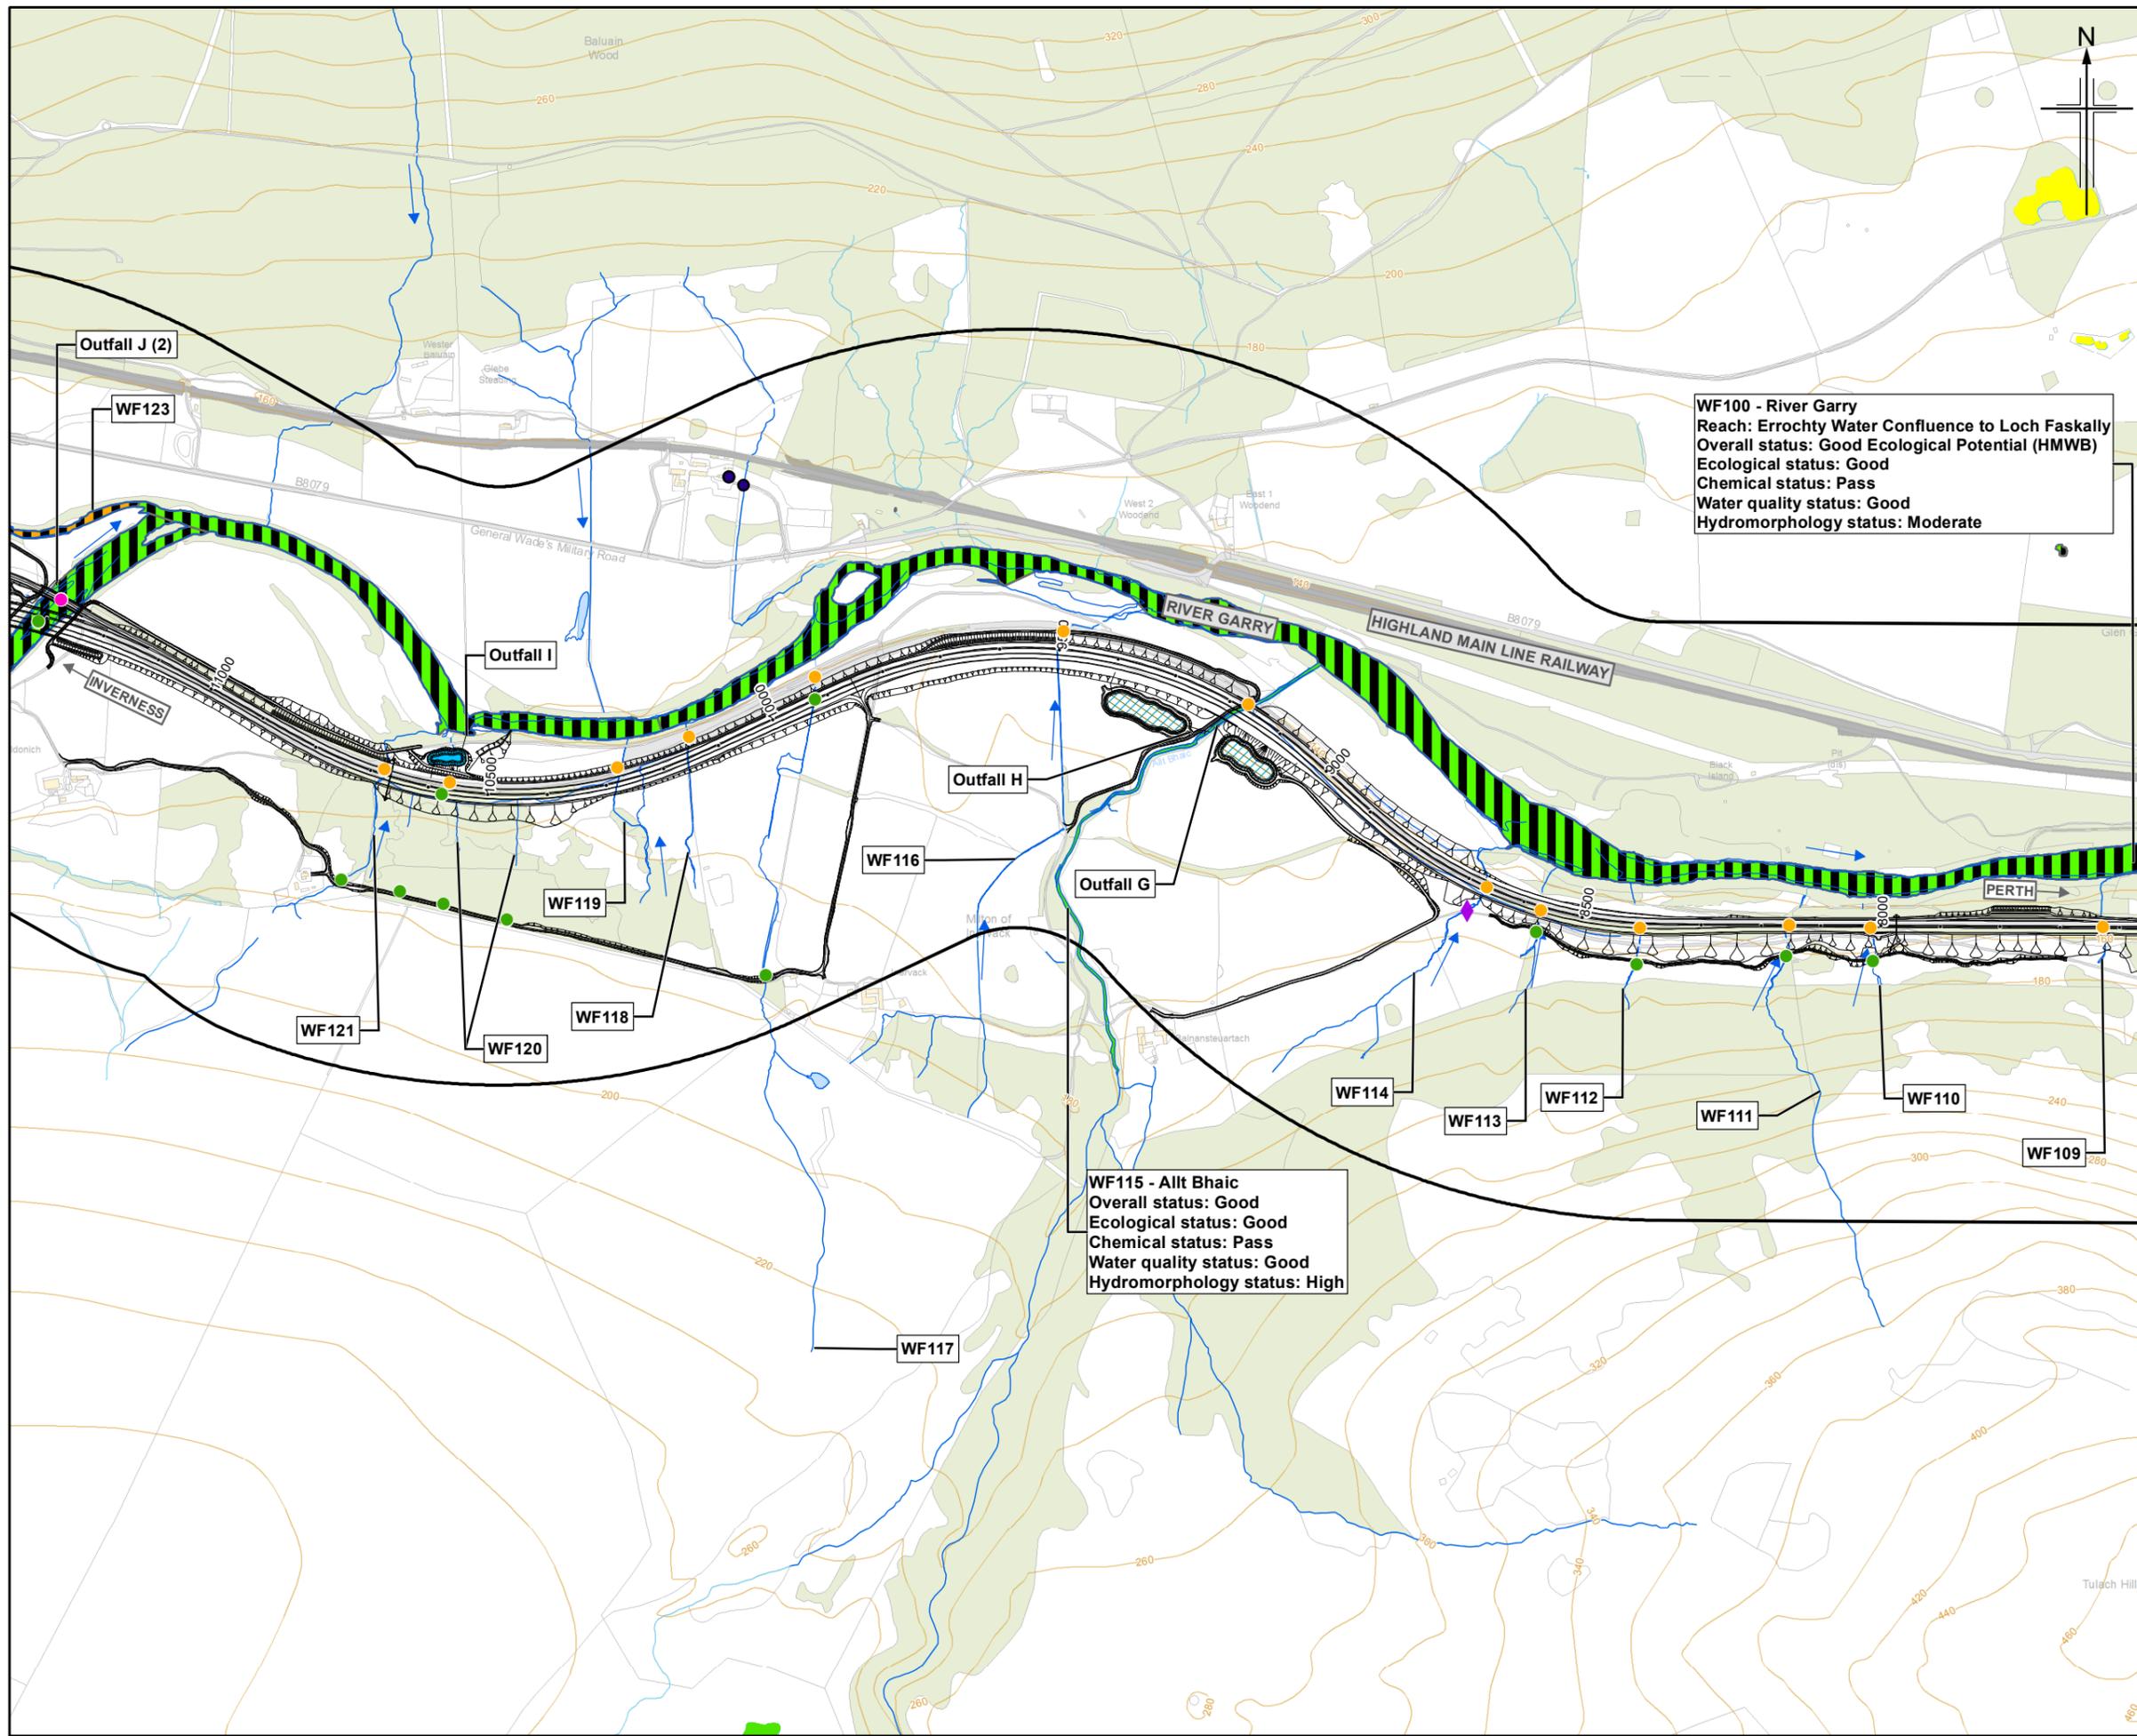
Figure 11.1d

WF100 - River Garry
 Reach: Errochty Water Confluence to Loch Faskally
 Overall status: Good Ecological Potential (HMWB)
 Ecological status: Good
 Chemical status: Pass
 Water quality status: Good
 Hydromorphology status: Moderate

WF115 - Allt Bhaic
 Overall status: Good
 Ecological status: Good
 Chemical status: Pass
 Water quality status: Good
 Hydromorphology status: High

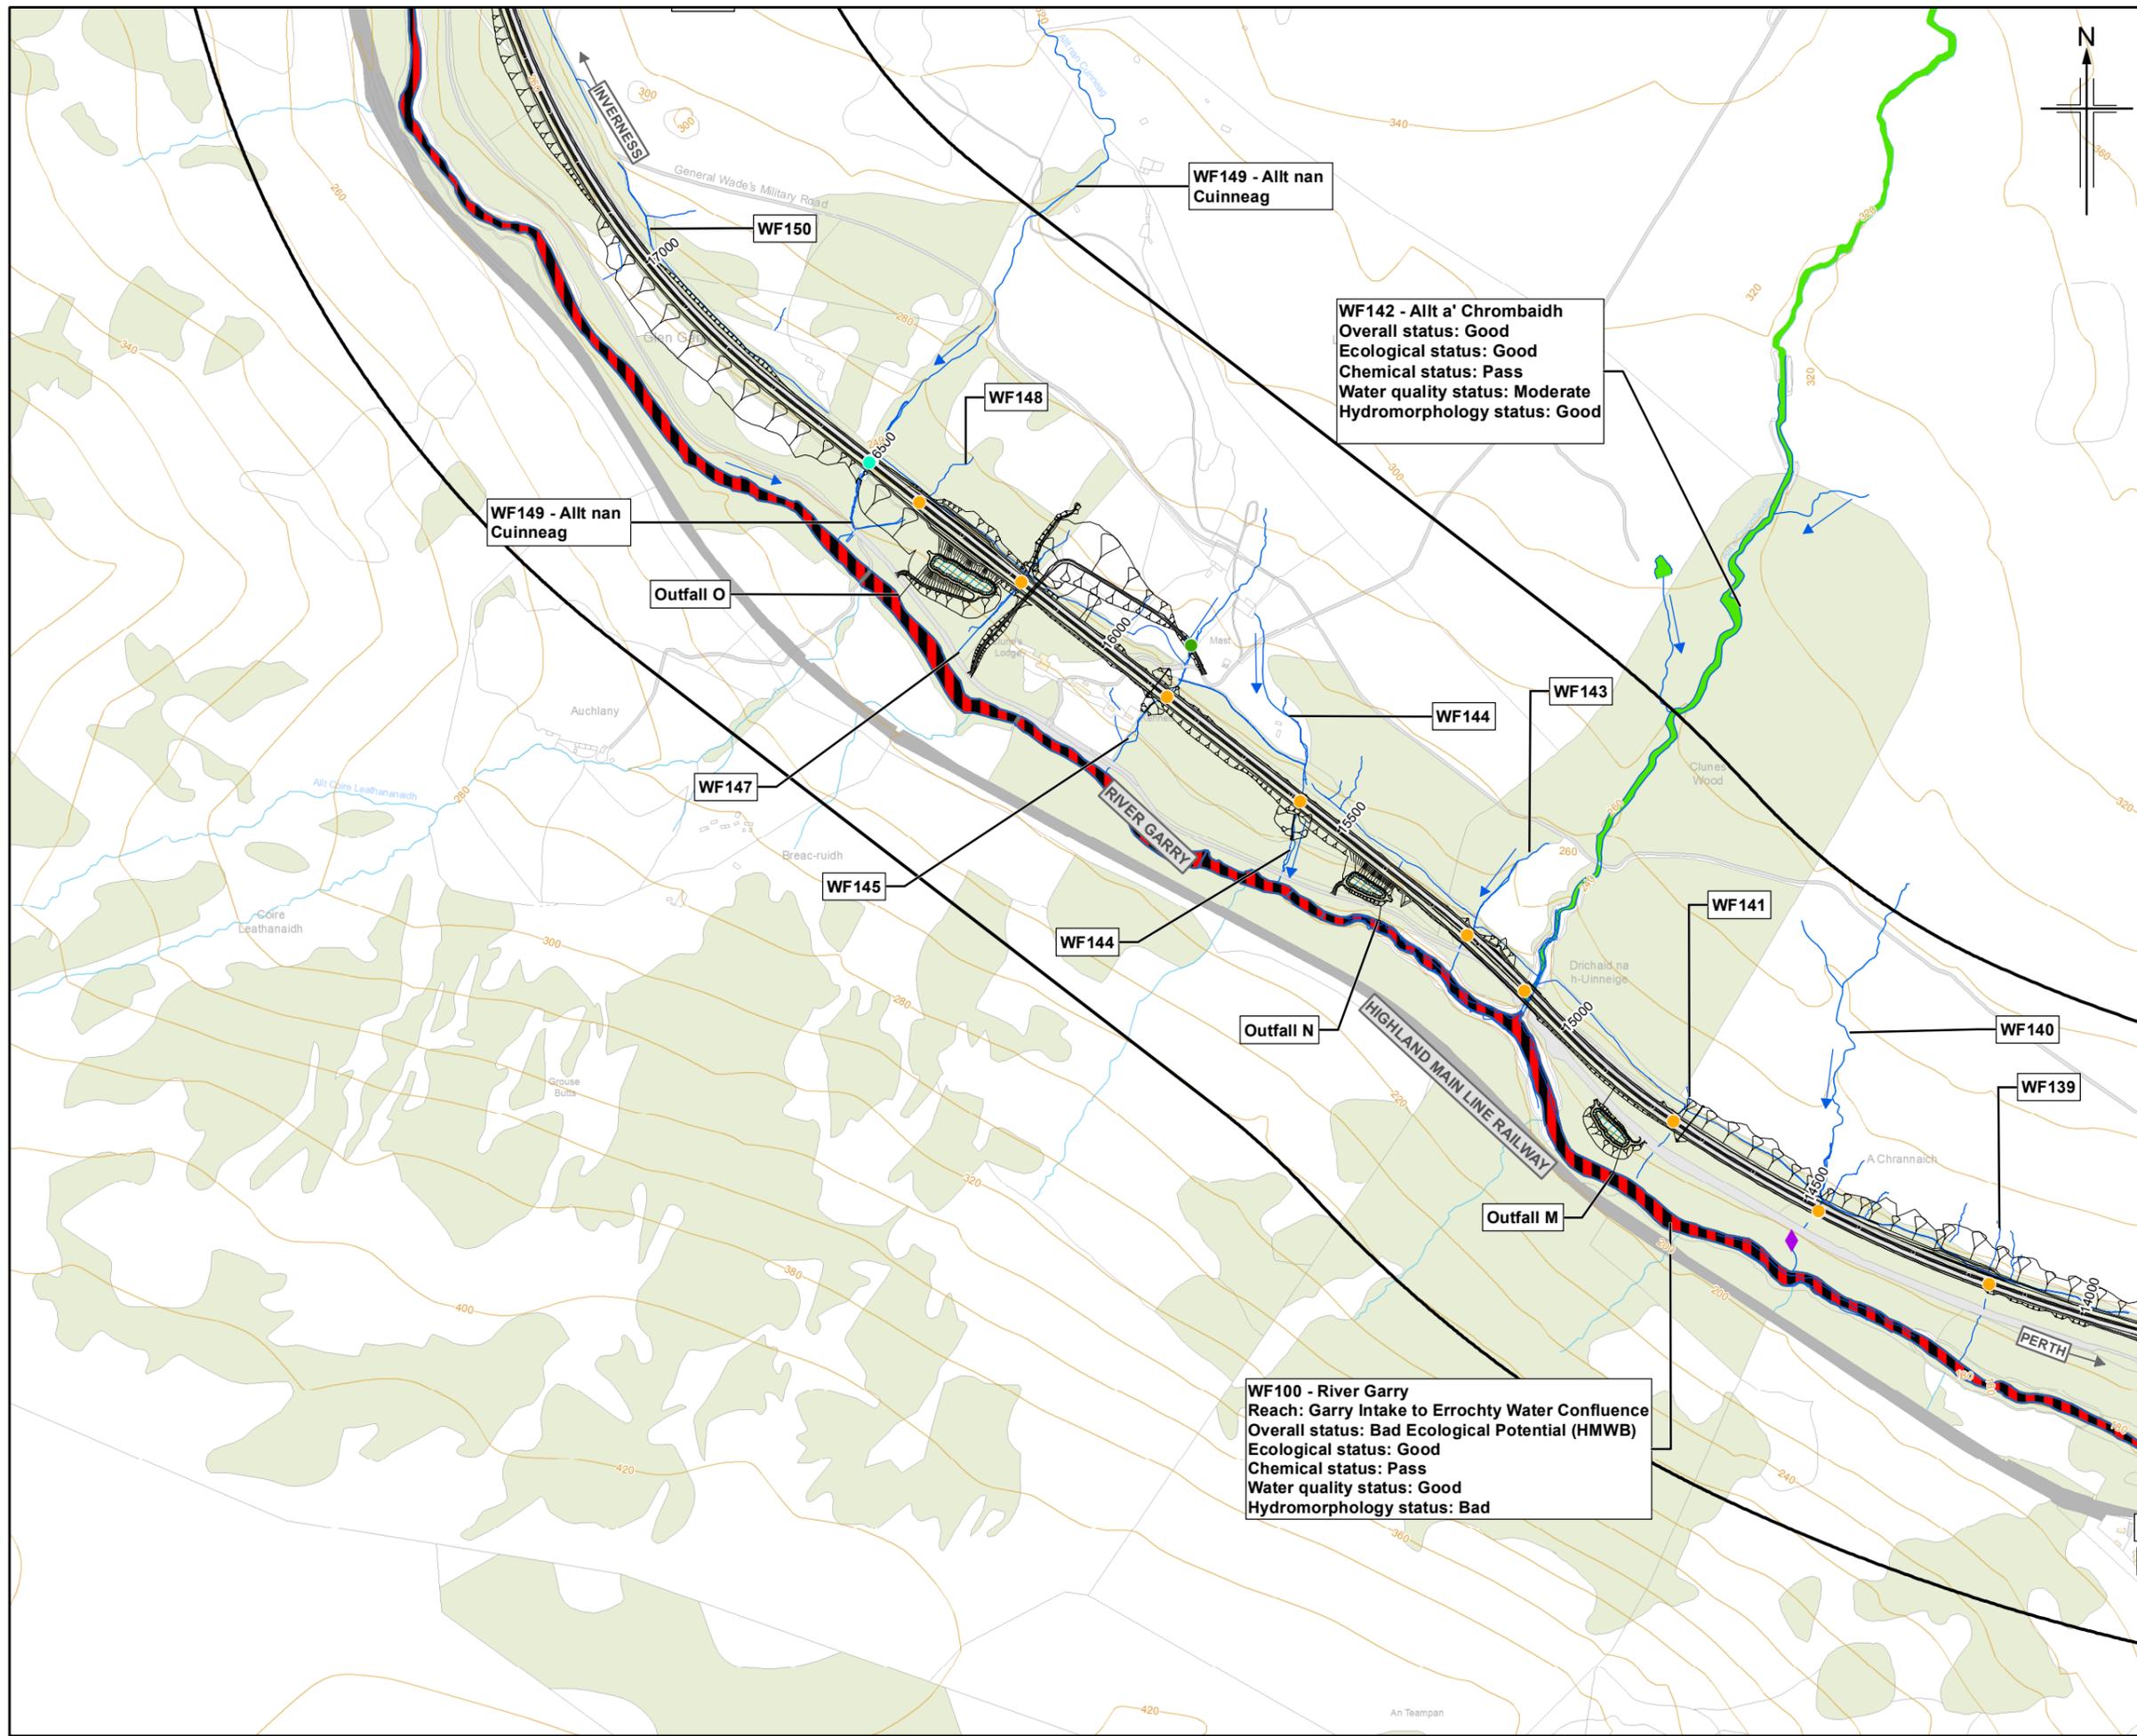
Figure 11.1f

WF100 - River Garry
Reach: Garry Intake to Errochty Water Confluence
Overall status: Bad Ecological Potential (HMWB)
Ecological status: Good
Chemical status: Pass
Water quality status: Good
Hydromorphology status: Bad

WF142 - Allt a' Chrombaidh
Overall status: Good
Ecological status: Good
Chemical status: Pass
Water quality status: Moderate
Hydromorphology status: Good

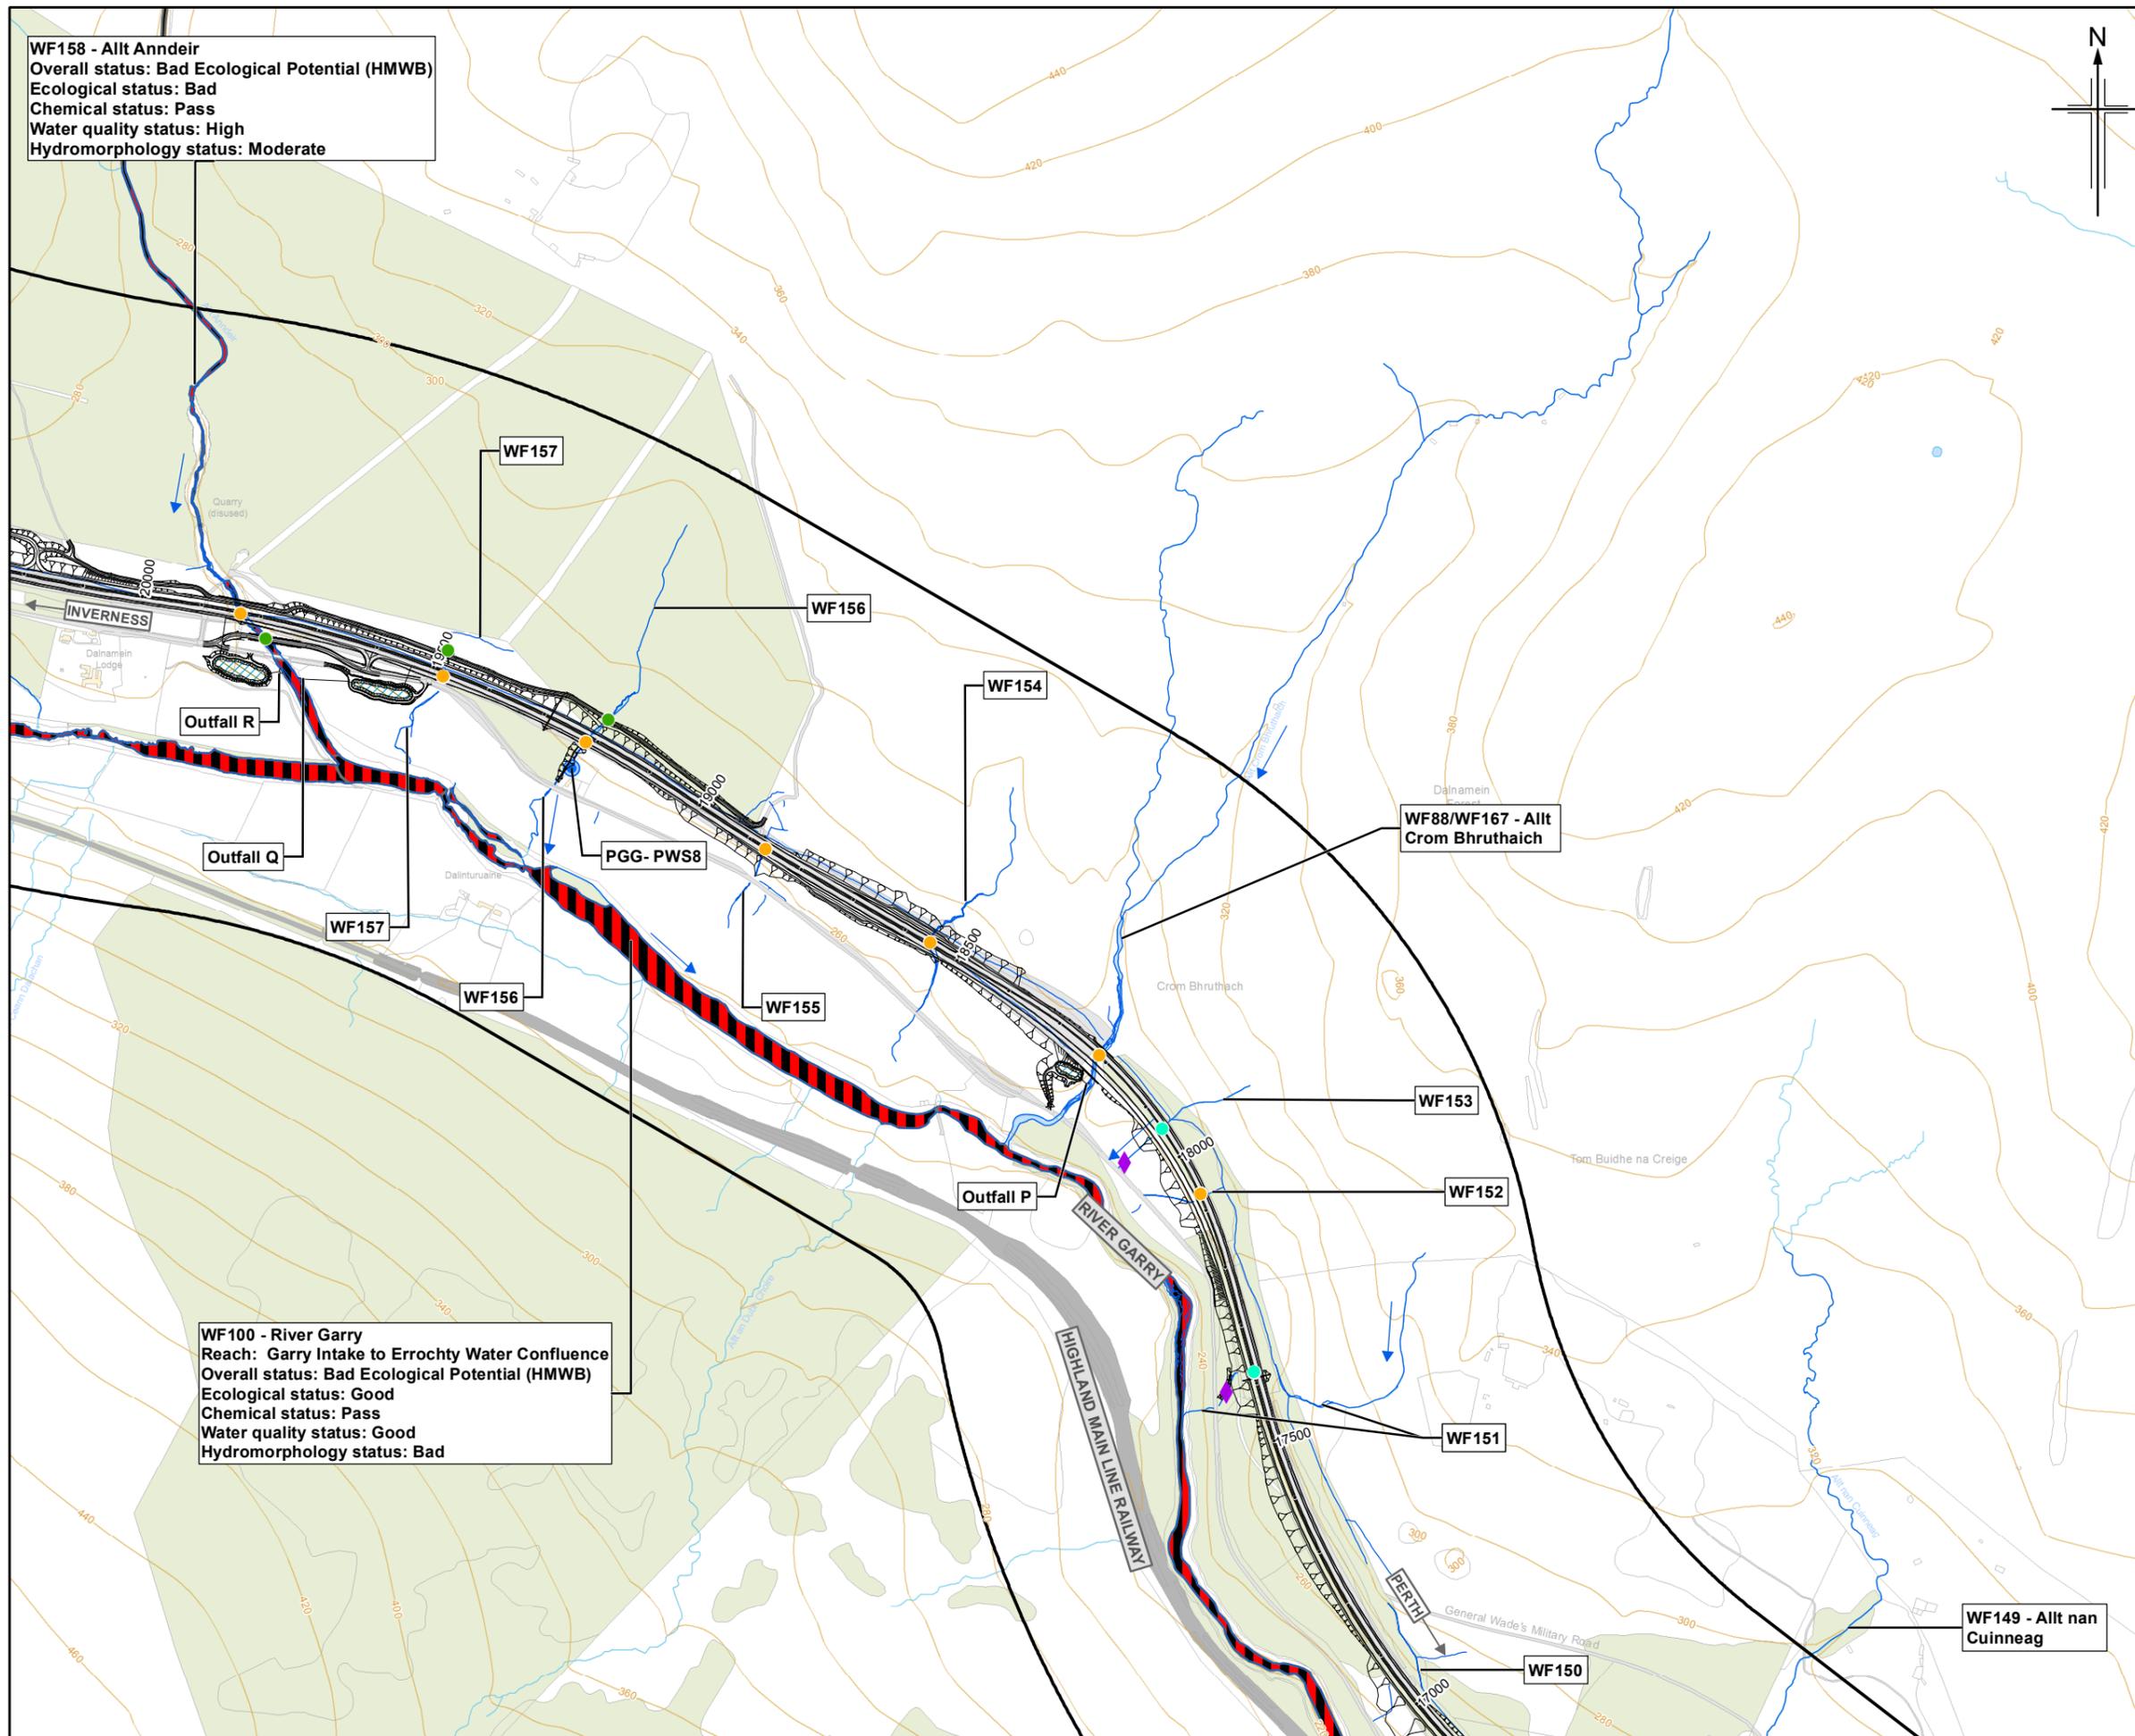
Figure 11.1g

WF158 - Allt Anndeir
 Overall status: Bad Ecological Potential (HMWB)
 Ecological status: Bad
 Chemical status: Pass
 Water quality status: High
 Hydromorphology status: Moderate

WF100 - River Garry
 Reach: Garry Intake to Errochty Water Confluence
 Overall status: Bad Ecological Potential (HMWB)
 Ecological status: Good
 Chemical status: Pass
 Water quality status: Good
 Hydromorphology status: Bad
