Project: **A9 DUALLING**
 PERTH TO INVERNESS
 Killiecrankie to Glen Garry

Drawing title: **Environmental Statement Water Features**

Drawing Status	FINAL
Scale	1:10,500 @ A3 DO NOT SCALE
Jacobs No.	B2140005
BIM No.	
Drawing number	Figure 11.1a
Rev	0

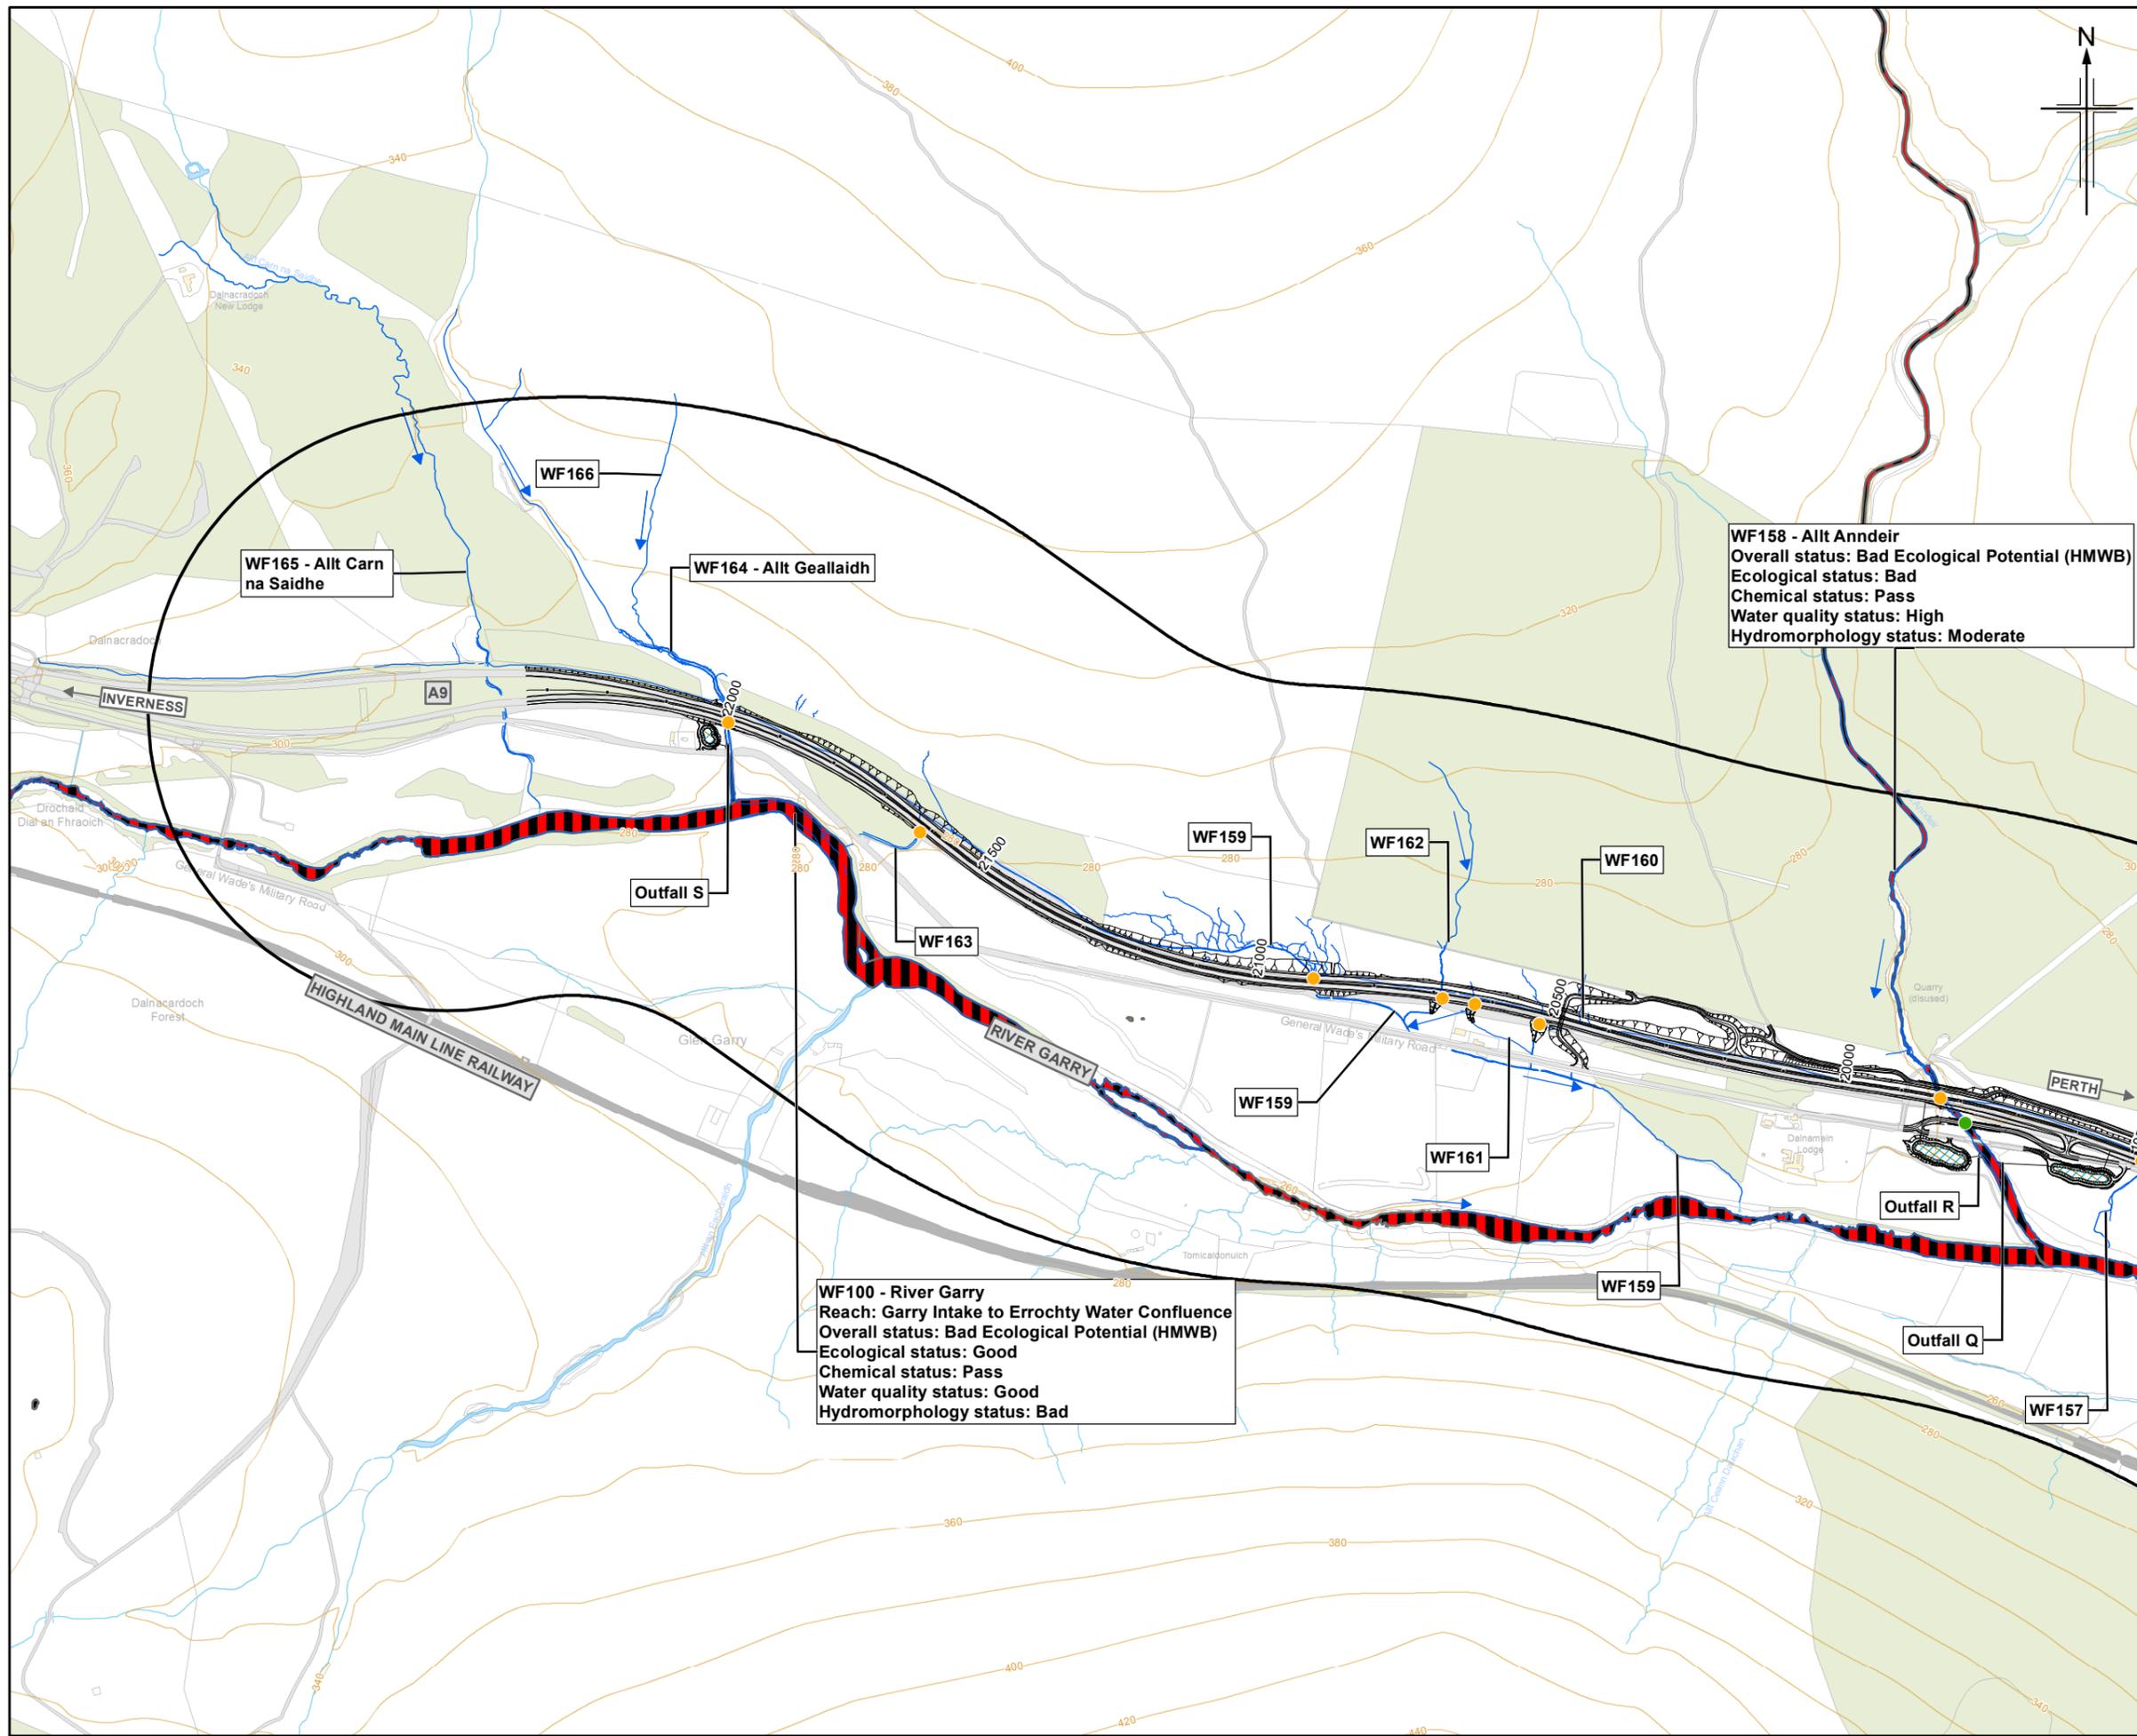
Figure 11.1h

WF158 - Allt Anndeir
 Overall status: Bad Ecological Potential (HMWB)
 Ecological status: Bad
 Chemical status: Pass
 Water quality status: High
 Hydromorphology status: Moderate

WF100 - River Garry
 Reach: Garry Intake to Errochty Water Confluence
 Overall status: Bad Ecological Potential (HMWB)
 Ecological status: Good
 Chemical status: Pass
 Water quality status: Good
 Hydromorphology status: Bad
