15 Cultural Heritage

- 15.1.1 This chapter presents a 'Design Manual for Roads and Bridges' (DMRB HA208/07) Stage 3 Environmental Impact Assessment (EIA) for Cultural Heritage. It considers the potential construction and operational impacts of Project 7 - Glen Garry to Dalwhinnie of the A9 Dualling Programme. The Proposed Scheme under assessment is described in **Chapter 5**.

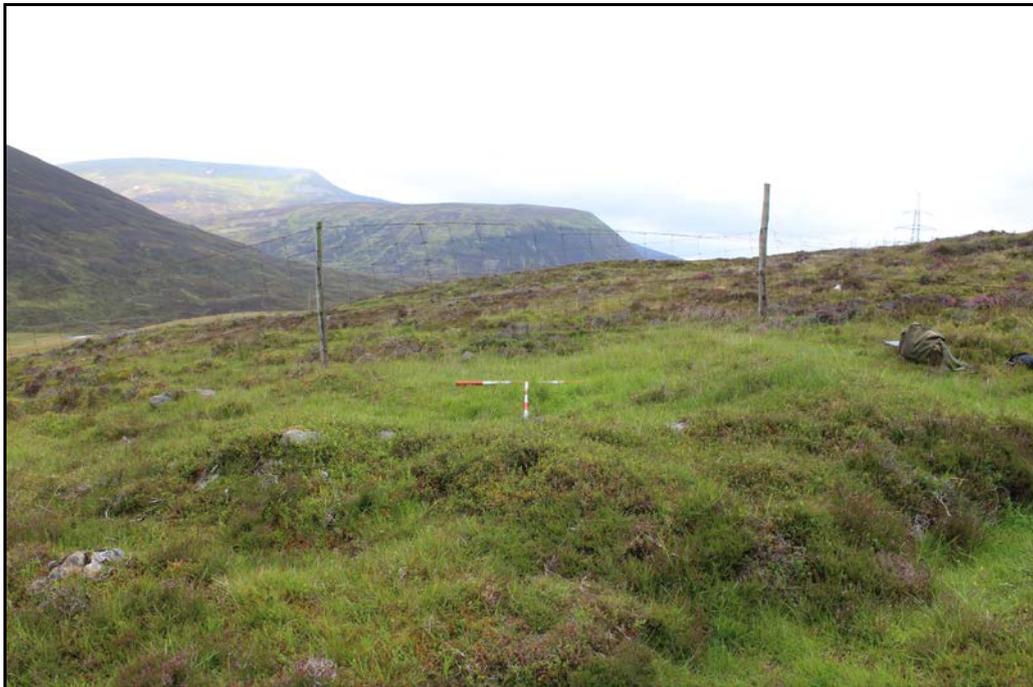
- 15.4.6 Shielings are roughly constructed huts, used seasonally (**Photograph 15.1** identifies remains). They are evidence of transhumance agriculture within the study area, where they were represented by a group of huts constructed of varying combinations of wood, stone and turf (Assets 7.6, 7.12, 7.16, 7.21, 7.22 and 7.25). The use of shielings seems to vary locally and seasonal exploitation of land can change with improved forms of land exploitation (Dalglish and

Photograph 15-1: Remains of dwelling/ shieling hut (7.22) looking south-east

- 15.5.9 Construction of the Proposed Scheme will partially remove surviving remains of shieling huts (Asset 7.22), through the construction of embankments or during topsoil stripping as part of the temporary works. The remains of one hut would likely be removed, the remains of a second hut would be partially removed and the remains of the third hut would remain. In consideration of the permanent removal of two of the three huts, the magnitude of the permanent impact has been assessed to be **Moderate** and the significance of impact has been assessed to be **Slight**.

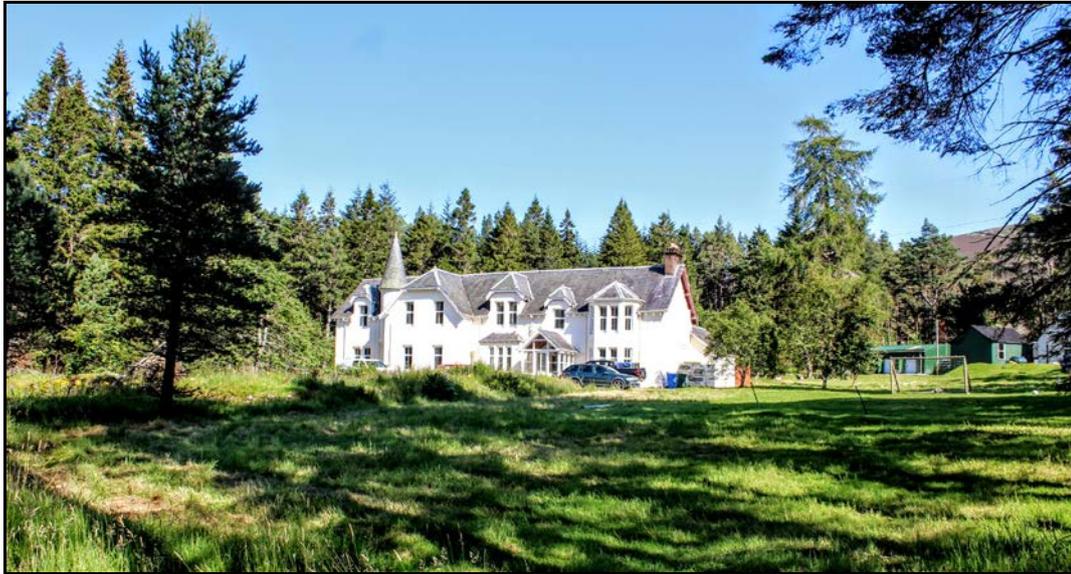
- 15.4.19 One historic building of medium value (Asset 7.18) was identified within the 200m study area and one historic building of medium value (Asset 7.27) was identified within the 1km study area. Drumochter Lodge (Asset 7.18) is a late 19th century hunting lodge built in approximately 1873 to a vernacular style with subtle baronial-architectural influences, and was designed by Alexander Ross (**Photograph 15.2**). The lodge is situated in a slightly elevated position overlooking the River Truim, but is set back from the existing A9. Users of the current A9 have glimpsed views of the lodge through existing screening, mainly when traveling from south-to-north. Due to the location of existing forestry and landscaping, the lodge is hidden from the A9 when traveling north-to-south. The building is surrounded by an undesignated landscape designed to facilitate Drumochter grouse shooting and is dominated by planting schemes of coniferous trees and rough grazing. Although the designed landscape has some constructed elements, such as the ha-ha to the west of the house, the majority of the planting is naturalistic and was designed to visually emphasize the contrast between the white-harled lodge and the Scottish landscape. In

Photograph 15-2: Drumochter Lodge (Asset 7.18) looking north-east

- 15.5.16 Construction will occur at the front entrance to Drumochter Lodge (Asset 7.18). Although the fabric of the building would not be physically altered by the Proposed Scheme, the relationship between the principle elevation of the lodge and the wider landscape overlooking the River Truim valley will be permanently altered and this area of the historical grouse shooting ground will be severed from the lodge building. The proposed screening bund in front of the lodge will cut off views from the ground level of the lodge out of the estate. Views across the landscape from the first floor level will be retained, although the proposed screening bund and raised level of the widened A9 will be a modern addition. The raising of embankments, creation of an access road and underpass and the removal of the existing entrance would create an adverse visual impact. There will also be construction noise from the operation of construction plant resulting in the entrance to the lodge being compromised. Although there will be increased noise from construction machinery, with standard construction mitigation measures there are no significant impacts predicted due to increased noise levels. The temporary works would be highly visible during construction. The lodge is set back from the road amongst forestry which currently limits the views out and therefore the main views affected are those viewing the property from the surrounding area and A9. The Proposed Scheme will also remove a section of the ha-ha. Despite considerable alteration to the wider landscape surrounding the lodge and reduction in size of the designed landscape; the spatial relationship between the lodge building, kennels and core of the designed landscape will be retained and remained intact. In consideration of these factors, the

- 15.5.20 The Proposed Scheme will result in adverse visual impacts on the setting of Drumochter Lodge (Asset 7.18) from outside viewers due to the new road embankments to the west and the introduced elements of the access road and underbridge structure to the north. The change of entrance to the lodge will modify the assets current setting and view and curtail views to the west. Although some of the existing vegetation will be removed, new tree and vegetation planting will establish by years 15-25. In consideration of this, the magnitude of the permanent impact has been assessed to be **Major** and the significance of impact has been assessed to be **Moderate**.

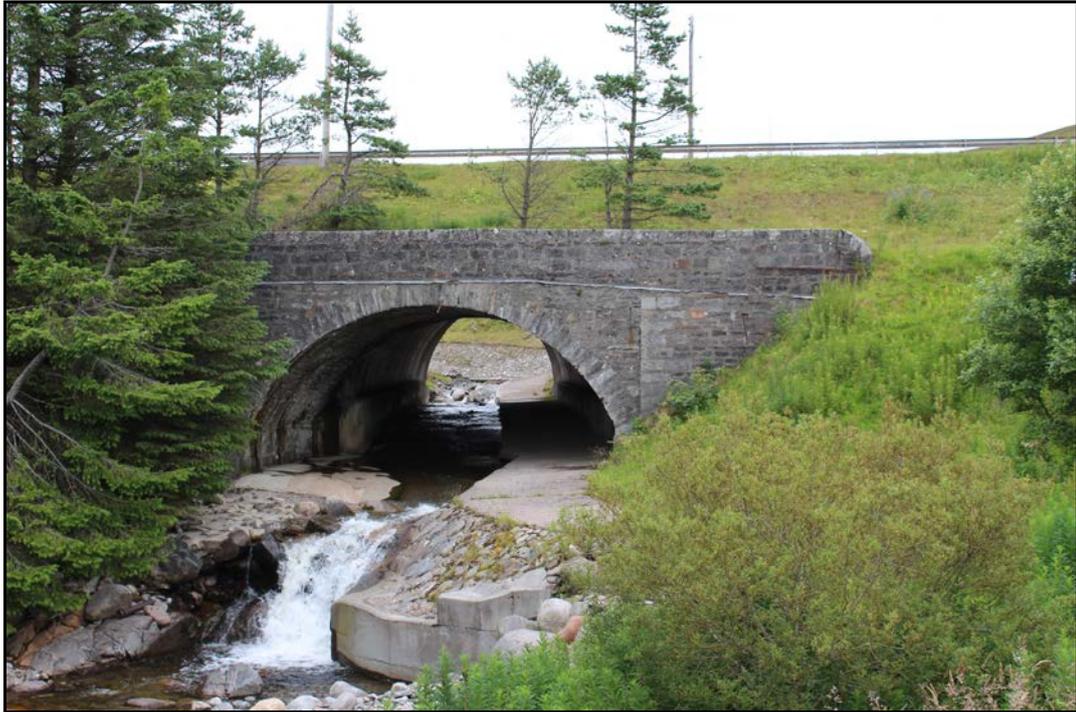
- 15.4.22 A total of eight historic buildings of low value were identified within the study area.
- 15.4.23 Four bridges of local interest are located within the study area (Assets 7.4 (**Photograph 15.3**), 7.5, 7.17 and 7.19). These bridges could provide information to local infrastructure and construction method research and therefore have been assessed to be of **low value**.

Photograph 15-3: Dalnaspidal Bridge (Asset 7.4) looking south-east

- 15.5.15 Construction of the Proposed Scheme will result in the removal of Dalnaspidal Bridge (Asset 7.4) and Dubhaig Bridge (Asset 7.17). In consideration of the total removal of these assets, the magnitude of the permanent impacts have been assessed to be **Major**. In consideration of the local significance of the asset and limited information about bridge construction methods that would be gained from the asset, the significance of impact has been assessed to be **Moderate**.

- 15.6.7 Consideration shall be given to retain the stone from Dalnaspidal Bridge (Asset 7.4) and use the material as cladding on the replacement structure.
- 15.6.8 To mitigate potential impacts on the setting of Drumochter Lodge (Asset 7.18), landscaping and appropriate planting shall reduce the impact of the Proposed Scheme on the asset in line with proposals detailed in **Chapter 13**. To mitigate potential impacts on the entrance, frontage and ha-ha, Historic Building Recording (Basic) shall be carried out in line with '*Historic Building Recording Guidance*' (ALGAO: Scotland 2013) and in accordance with '*Understanding Historic Buildings: a guide to good recording practice*' (HE, 2016) in order to record the existing asset, including its setting. Consideration shall be given to retaining stonework from the ha-ha to re-use in the embankment.
