Appendix 11.1

Water Features Survey

- 1.1.1 The Water Features Survey is a baseline study that identifies key water features that may be affected by the Proposed Scheme for Project 9, Crubenmore to Kincaig. The format of the Water Features Survey comprises a schedule and a plan. The schedule (**Section 4**) lists key information about each feature in **Drawings 11.1 – 11.12 in Volume 3** (i.e. the Plan). This information is used to inform the Design Manual for Roads and Bridges (DMRB) Stage 3 Environmental Impact Assessment (EIA).

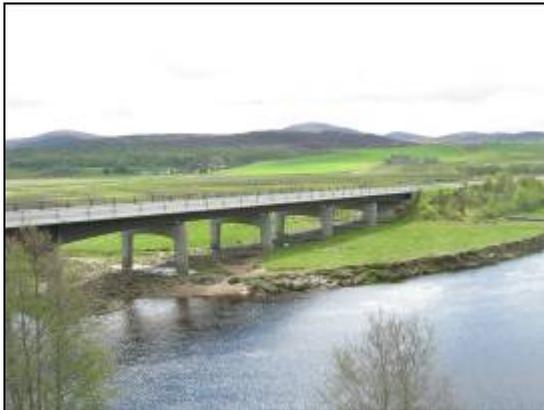
Photographs 1: River Spey Crossing (MW9.1/ Hydro ID 152)

A) Looking towards Spey crossing from north embankment

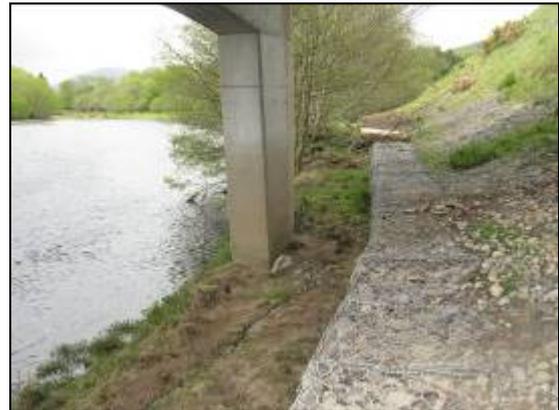
- 3.1.27 Aerial photography and historic mapping indicates numerous meander cut-offs and abandoned channels; within Project 9 this is notable around Ballochbuie Island east of the A9 Spey crossing at Kingussie. Right-hand bank undercutting into agricultural land is noted west of the Spey crossing as the river approaches the existing bridge. Deposition of material ranging from pebble to boulder is evident on the floodplain beneath the crossing. Bank protection has been implemented with stone gabions on the left bank below the bridge.

B) Existing erosion protection on left bank of Spey

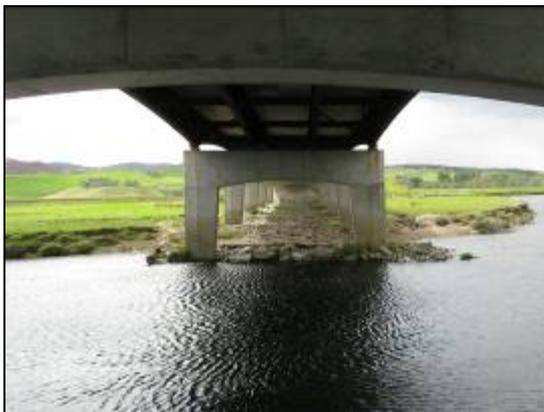
C) Looking south beneath existing crossing from left bank of Spey.

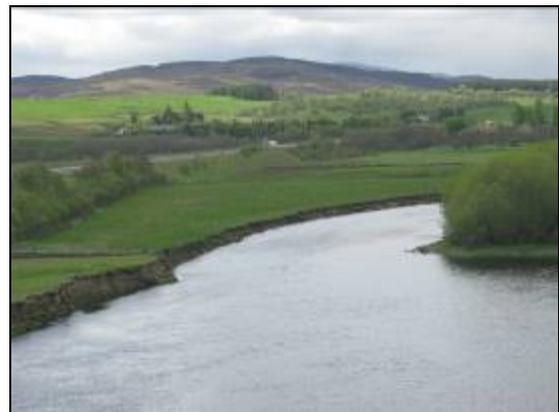
D) Looking upstream from north bank of Spey crossing

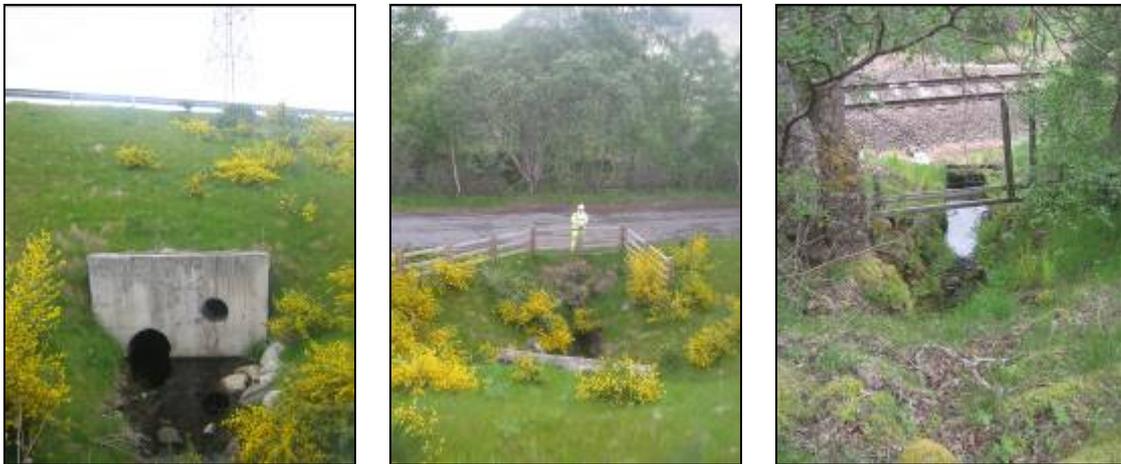
Photographs 2: *Unnamed watercourse (W9.1/ Hydro ID 134)*

A) Downstream of A9 looking east B) Downstream of A9 looking west to NCN7 C) Upstream of HML looking west

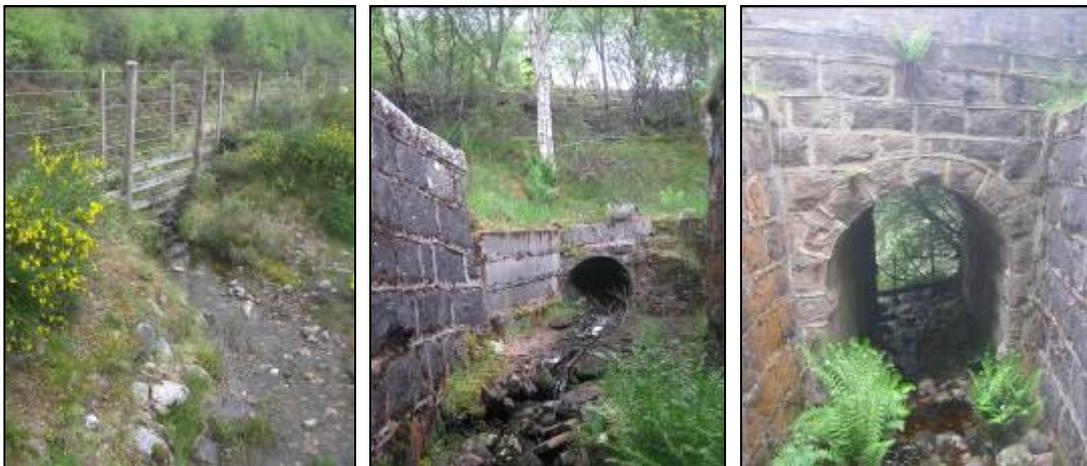
Photographs 3: *Unnamed watercourse (W9.3/ Hydro ID 136)*

A) Upstream of A9 looking west

B) Downstream of NCN7 looking east

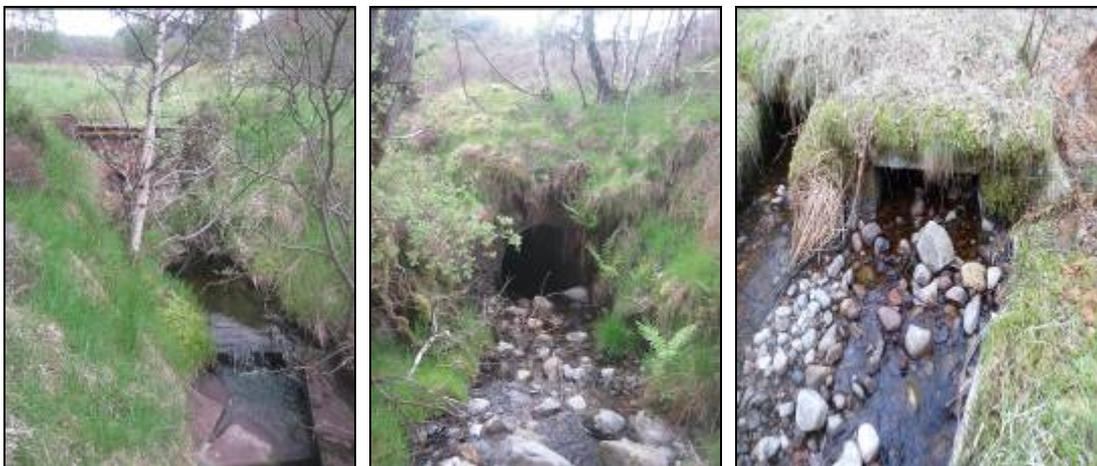
Photographs 4: *Allt Torr an Daimh (MW9.2/ Hydro ID 138_2)*

terraced deposits before joining the main watercourse. Part of the channel (approx. 80m upstream of the road) is lined with concrete slabs constructed into cascade steps, with a deteriorated metal sluice of a disused dam that will impede sediment transport. The upper part of the catchment may have a substantial sediment source from shallow hillslope failure or widespread erosion, but this is unlikely to transfer successfully through the large, flat peaty area in the mid-catchment which has formed in a depression created by a former glacial meltwater channel. Therefore, an overall **Medium** sensitivity value has been assigned for hydromorphology.

A) Metal sluice upstream of A9 B) Upstream of A9 looking towards inlet C) Downstream outlet under A9 looking east

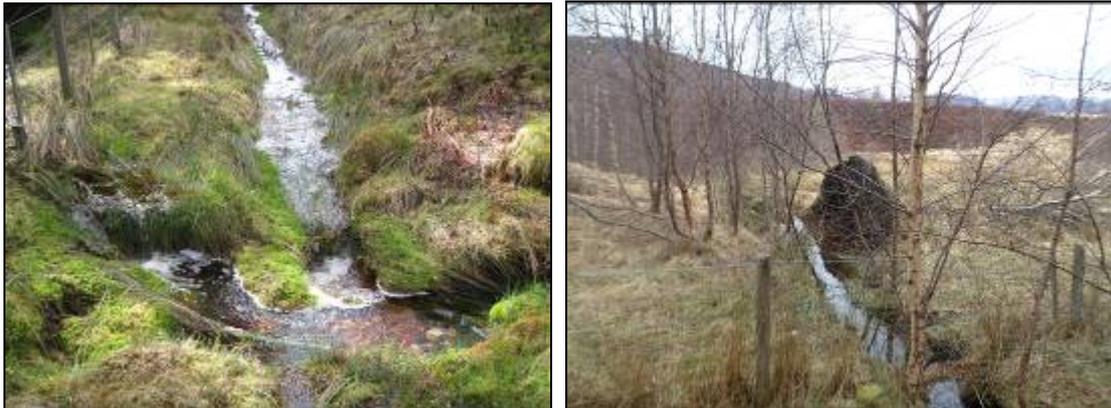
Photographs 5: Unnamed watercourse (W9.49a/ Hydro ID 139_2)

A) Upstream of A9 inlet looking west

B) Looking downstream from A9 outlet

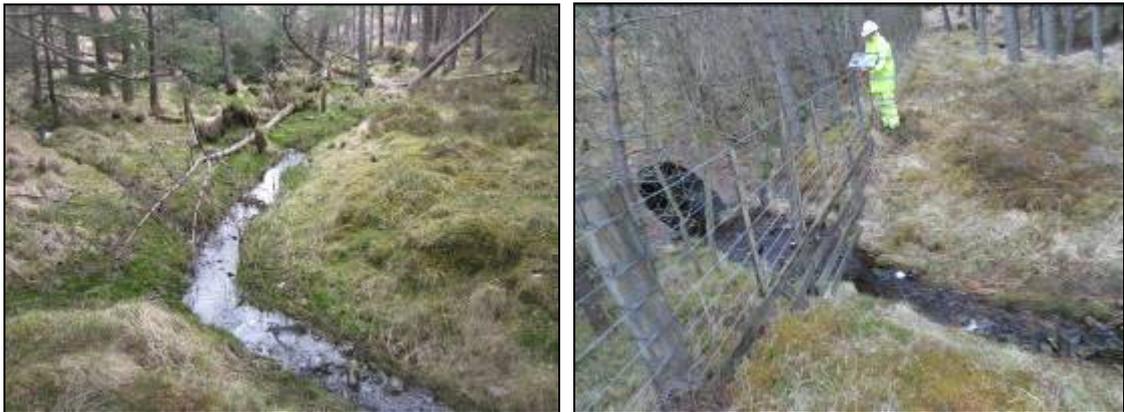
Photographs 6: Unnamed Tributary of Caochan Riabhach (W9.5/ Hydro ID 140)

A) Upstream of A9 crossing in forestry plantation

B) Downstream of A9 crossing

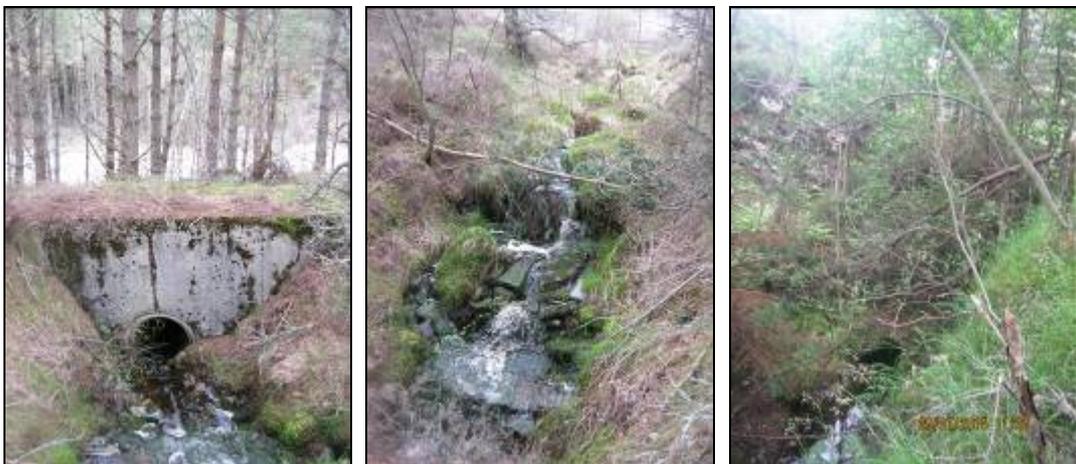
Photographs 7: Caochan Riabhach (MW9.3/ Hydro ID 142)

A) Upstream looking towards A9

B) Looking upstream from A9 inlet

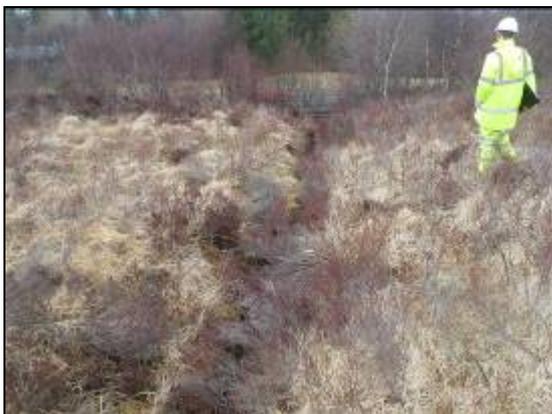
Photographs 8: Unnamed watercourse (W9.7/ Hydro ID 143)

A) Upstream looking towards A9

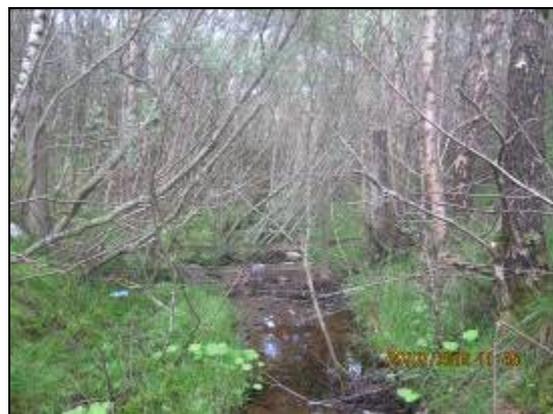
B) Downstream of A9 crossing looking north

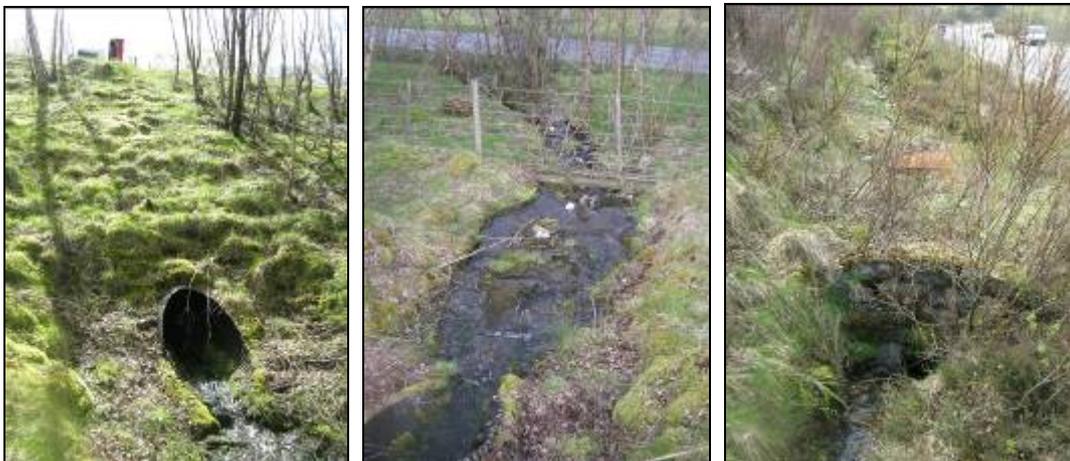
Photographs 9: *Unnamed watercourse (W9.7a/ Hydro ID 144_1)*

A) Outlet of A9 crossing

B) Looking downstream from A9 outlet

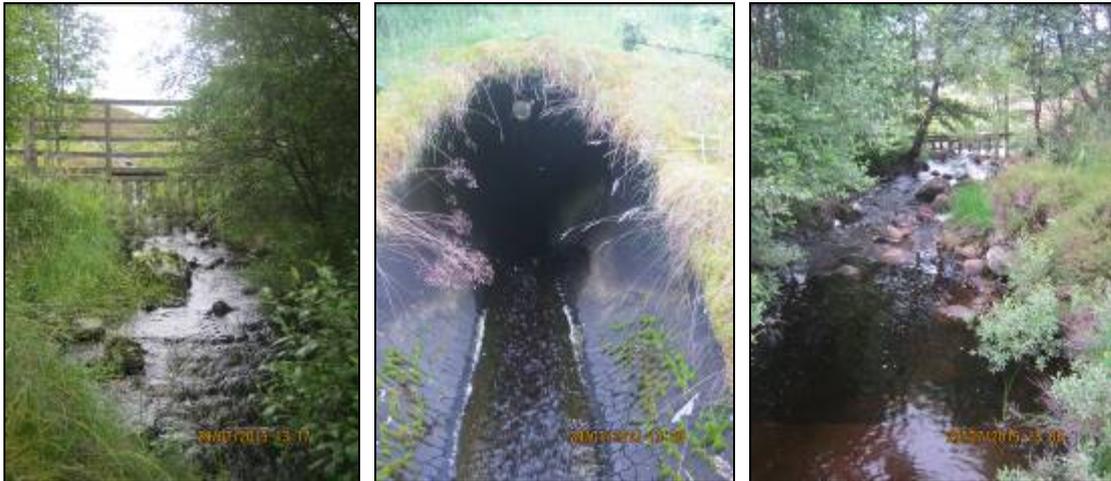
Photographs 10: Allt Eoghainn (MW9.4/ Hydro ID 145)

A) Upstream of A9

B) Downstream of A9 outlet

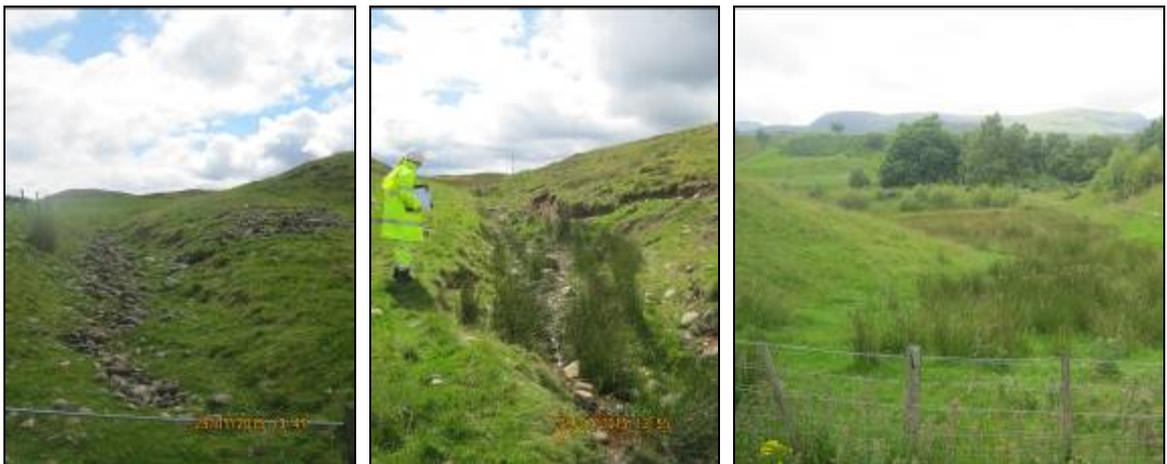
Photographs 11: Unnamed watercourse (W9.11/ Hydro ID 146)

A) Incised dry channel upstream of A9 B) Incised dry channel upstream of A9 C) Downstream of A9

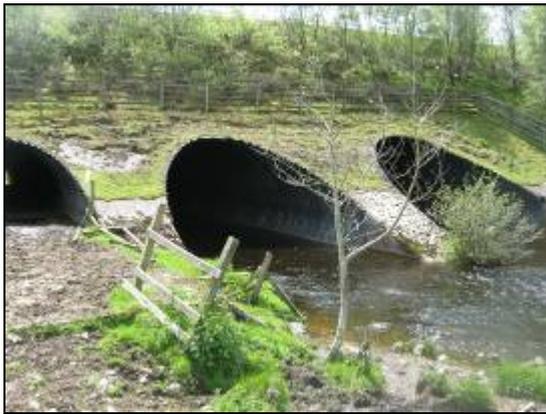
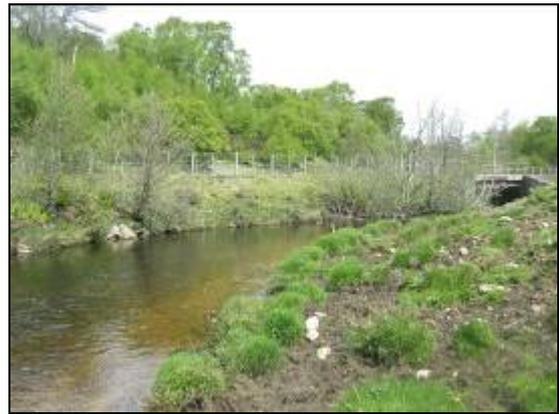
Photographs 12: Milton Burn/ Inverton Burn (MW 9.6/ Hydro ID 147)

A) Crossing at A9 under two bridging culvert (third is underpass) B) Downstream of A9 looking toward access crossing

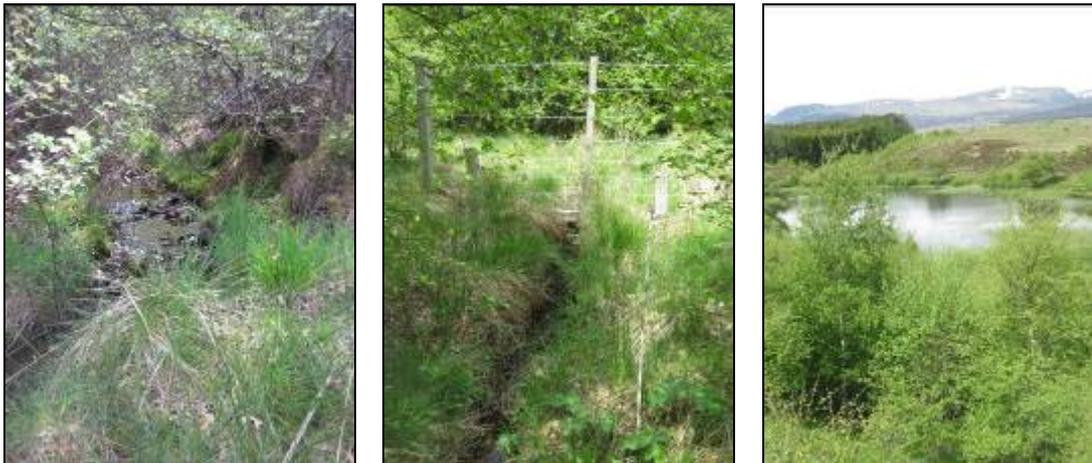
Photographs 13: Unnamed watercourse (W9.15/ Hydro ID 148)

A) Upstream of A9 crossing

B) Narrow channel downstream of A9

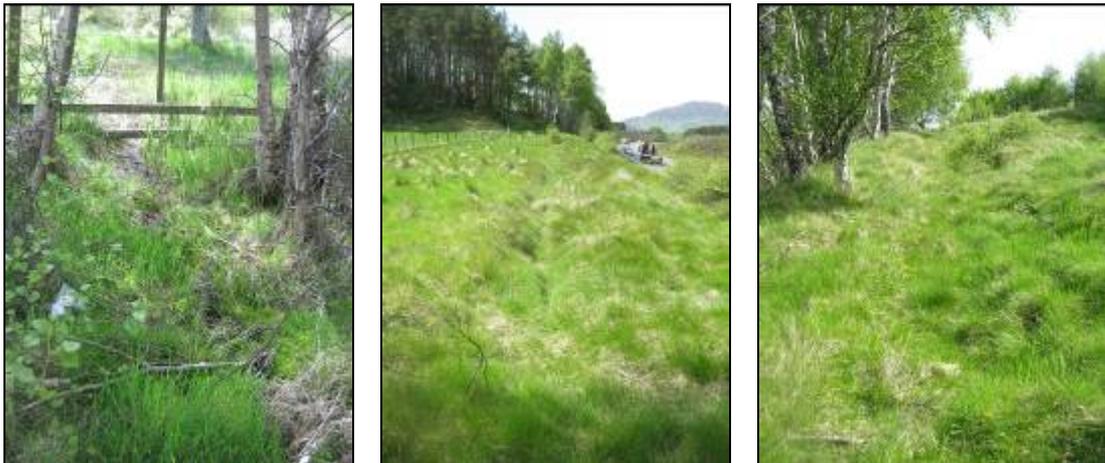
Photographs 14: Unnamed watercourse (W9.15a/Hydro ID 149)

A) Inflow channel upstream of A9

B) Upstream ephemeral roadside channel

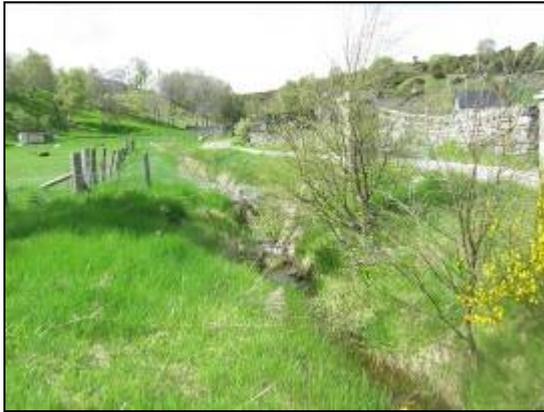
Photographs 15: Unnamed watercourse (MW 9.11/ Hydro ID 155)

A) Upstream of A9 crossing

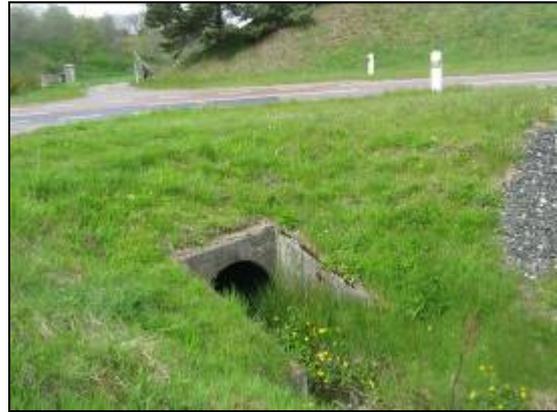
B) Downstream of A9 outlet

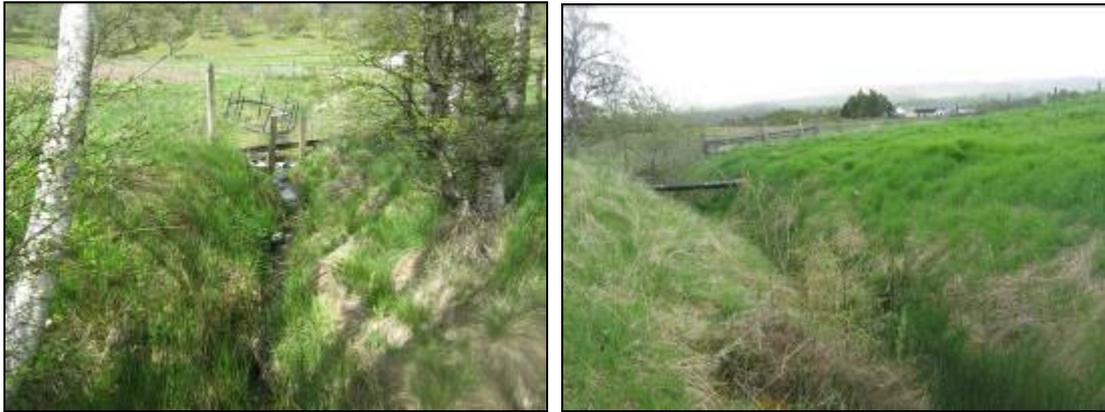
Photographs 16: Unnamed watercourse (W9.26/ Hydro ID 156)

A) Upstream of A9 crossing

B) Downstream of A9 outlet

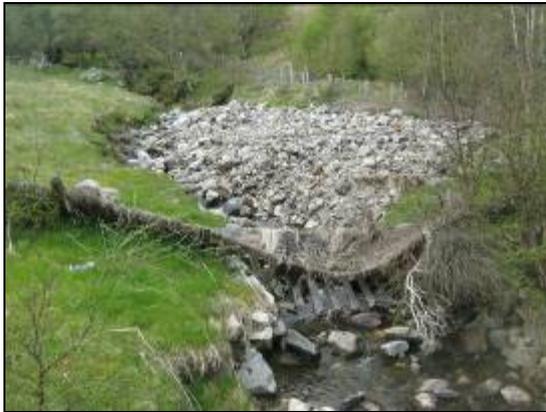
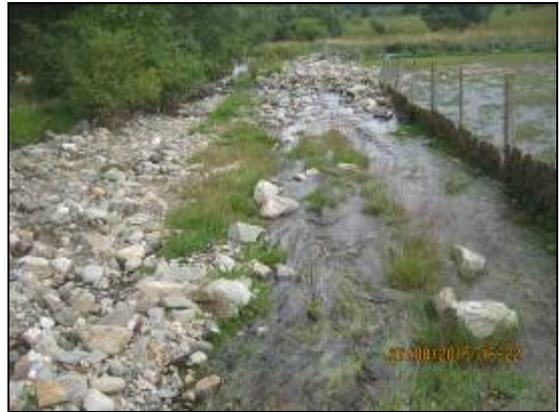
Photographs 17: *Allt Cealgach (MW 9.12/ Hydro ID 157)*

A) Large volume of deposited materials upstream of A9 crossing B) Out-of-bank flow and deposition of material downstream of A9

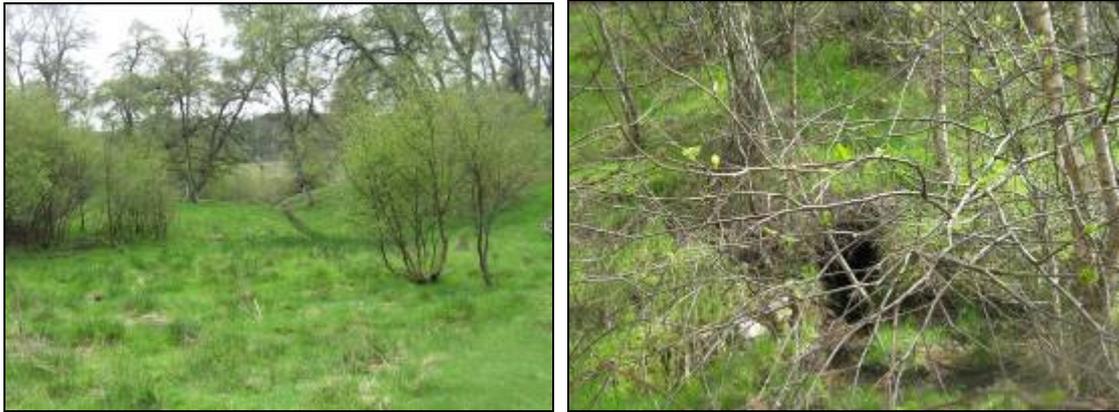
Photographs 18: Unnamed watercourse (W9.62/ Hydro ID 158)

A) Flat boggy area downstream of A9 crossing

B) Heavily vegetated inlet upstream of A9

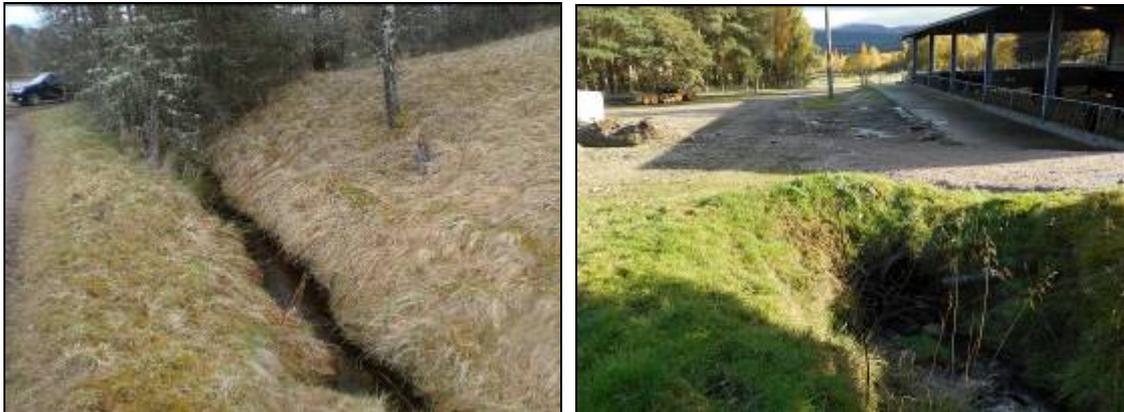
Photographs 19: Unnamed watercourse (W9.27/ Hydro ID 159)

A) Channel upstream of A9 by Lynvoan Cottage access

B) Channel downstream of A9 flowing through Chapelpark

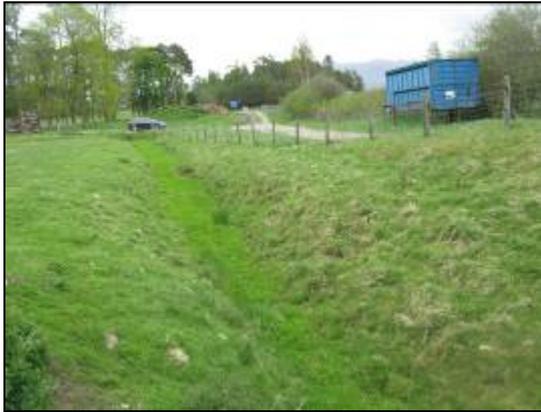
Photographs 20: Unnamed watercourse (W9.30/ Hydro ID 161)

A) Ephemeral drainage channel upstream of A9

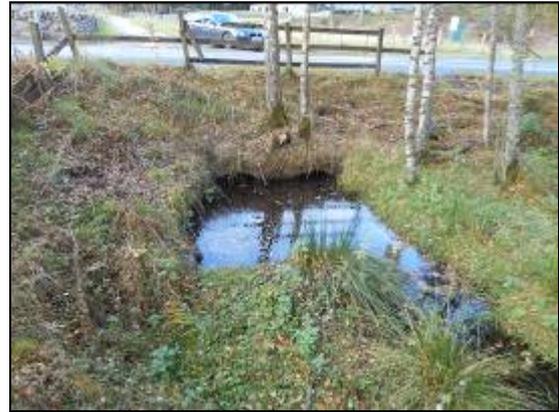
B) 'Issues' and 'Sinks' area downstream of Chapelpark and B9152

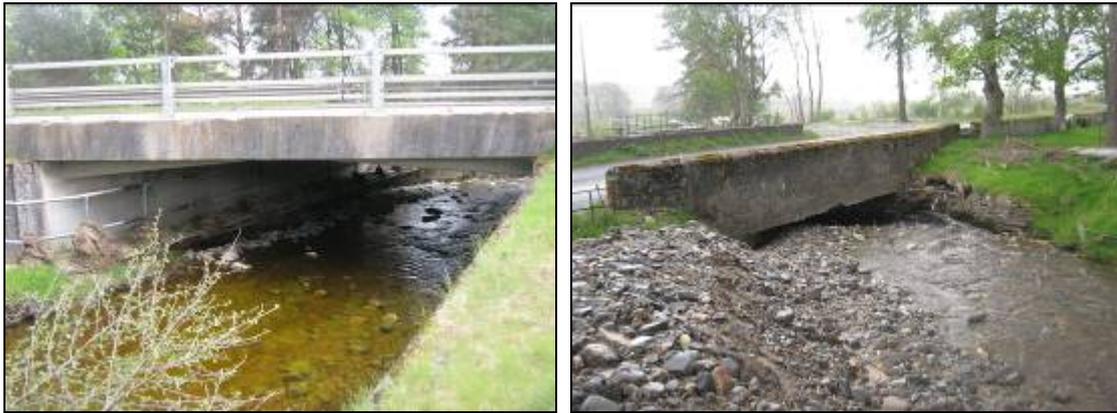
Photographs 21: Raitts Burn (MW 9.14/ Hydro ID 162)

A) Upstream of A9 crossing (looking south)

B) Upstream of B9152 – large volume of sediment constricting flow

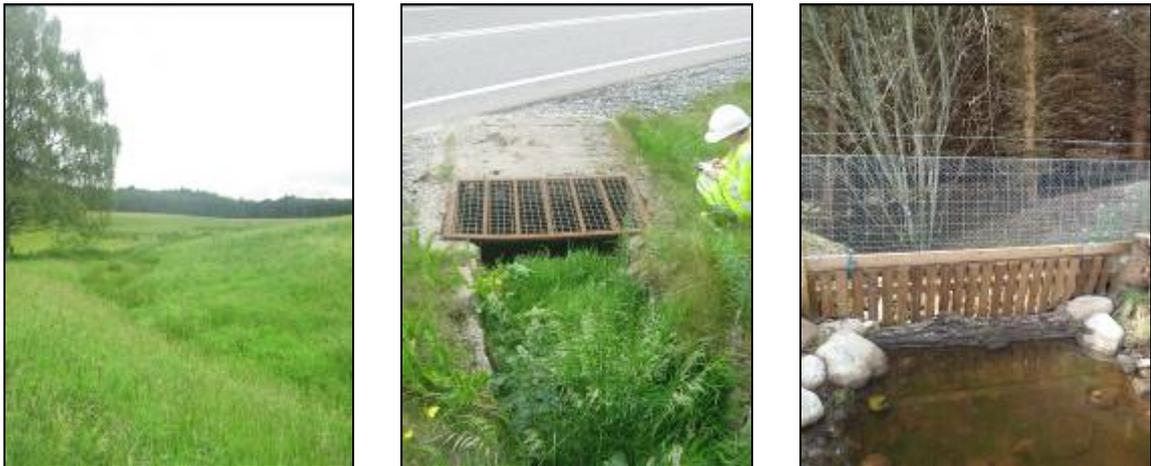
Photographs 22: Unnamed watercourse (W9.34/ Hydro ID 165)

- 3.1.129 A dam downstream of the A9 will impede low flow (still likely to overtop during heavy rainfall events). No hydrological or flooding issues have been identified for this watercourse; therefore, a **Low** sensitivity has been assigned.

A) Upstream of A9 crossing (looking north) B) Drop chamber on upstream side of A9 C) Dam downstream of A9

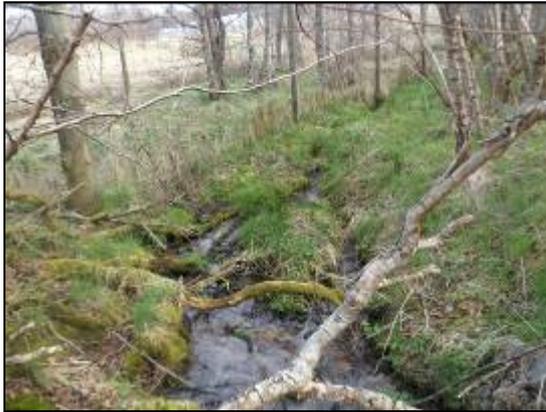
Photographs 23: Unnamed watercourse (W9.35/ Hydro ID 166)

A) Upstream of A9 crossing (lower section of field drain in woods)

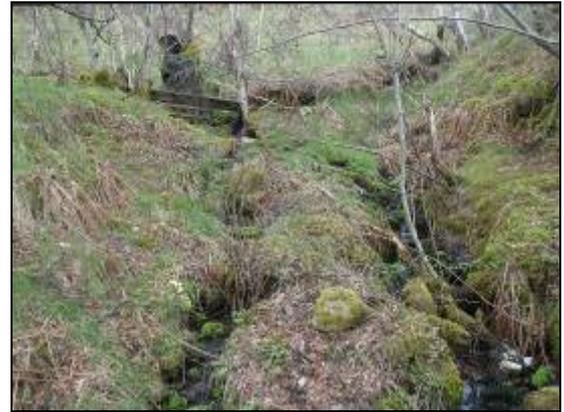
B) Outlet of A9 culvert at top of steep embankment

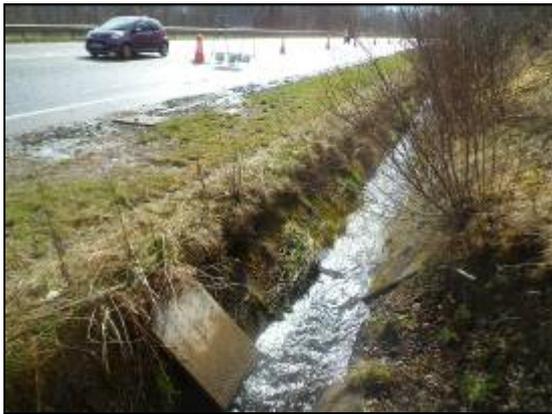
Photographs 24: Unnamed watercourse (W9.39/ Hydro ID 168)

A) Roadside drainage upstream of A9 drop chamber

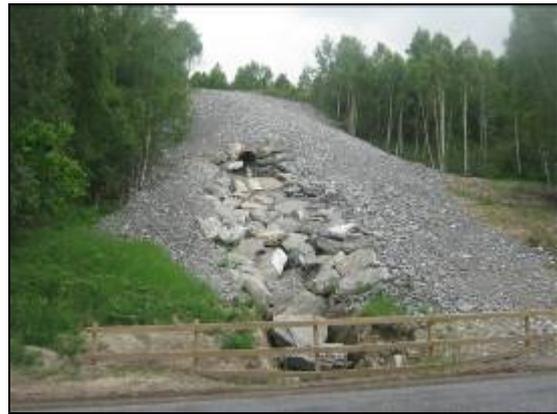
- 3.1.136 Major engineering works have taken place recently (2015) on the section of watercourse downstream of the existing crossing due to a landslip caused by heavy rain. The upper two-thirds of the watercourse are now contained in an extended (comparative to previous conditions) pipe. It outfalls onto an existing cascade, now incorporating scour protection to prevent further erosion at the point of discharge. The upper section of the embankment slope is now covered in granular rockfill as part of remedial works. The historic instability of this channel has resulted in a **Medium** sensitivity value for hydromorphology being assigned.

B) Outlet of A9 culvert at mid-point on re-engineered cutting

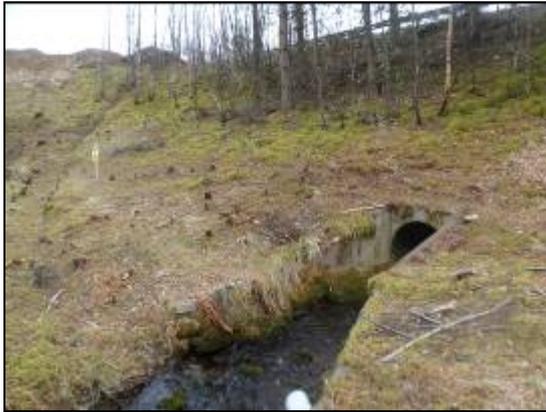
Photographs 25: Unnamed watercourse (MW 9.17/ Hydro ID 170)

A) Upstream of A9 crossing (looking south)

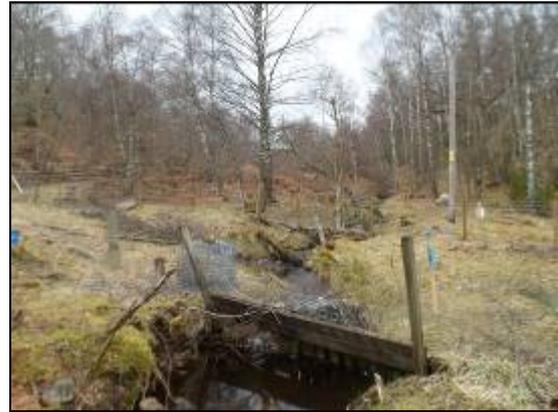
B) Upstream of A9 crossing (looking north)
