# Appendix 11.4

## Hydromorphology Assessment Part 3

**Annex 11.4.3 - Hydromorphological Catchment Assessment - 117**

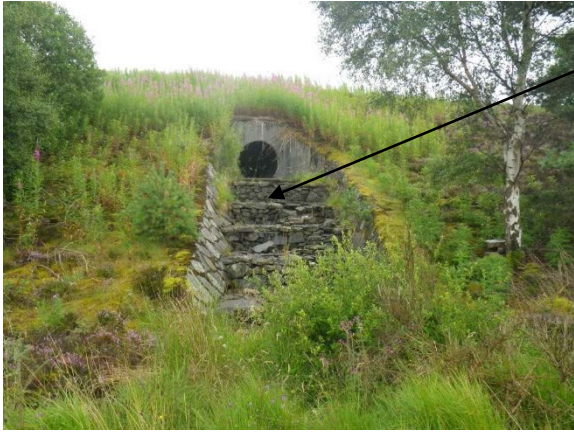
Photograph 11.4.3.106- Upstream to cascade

Comment on sediment source potential in catchment		Limited	
Comment on sediment supply potential to crossing		No evidence of sediment delivery to culvert	
<b>Morphology and Process- Reach upstream of crossing</b>	Channel morphology	Engineered	
	Predominant sediment size	-	
	Unvegetated bars	No	
	Vertical incision	None	
	Deposition	None	
	Lateral migration/bank erosion	None	
	Presence and nature of infrastructure (Map 1d)	No	
	Infrastructure type (see Drawing 11.4.3.1 d, Catchment 119)	No	
Channel realignment	No		
<b>Morphology and Process- At crossing</b>	Channel morphology	Engineered	
	Predominant sediment size	-	
	Estimated discharge at 1:200 event (m <sup>3</sup> /s)	1.4	
	Unvegetated bars	No	
	Vertical incision	None	
	Deposition	None	
	Lateral migration/bank erosion	None	
Damaged/unstable drains or armouring	Yes	Limited amount of damage to cascade - blocks loosened and possible scour at base (but difficult to see)

<b>Morphology and Process- Reach downstream of crossing</b>	Channel morphology	Plane bed	
	Predominant sediment size	fine	
	Unvegetated bars	No	
	Vertical incision	Low	
	Deposition	None	
	Lateral migration/bank erosion	None	
	Presence and nature of infrastructure (Map 1d)	None	
	Infrastructure type (see Drawing 11.4.3.1 d, Catchment 119)	Railway	Channel realigned to join others to pass under railway at one single point.
Channel realignment	Yes	See above	
<b>Summary behaviour</b>	Little happening at this crossing, except that there may be opportunities to improve the substantial 2m drop u/s of the culvert and there is limited damage to the cascade d/s of the culvert and possible scour at its base. Relatively low priority.

Cascade

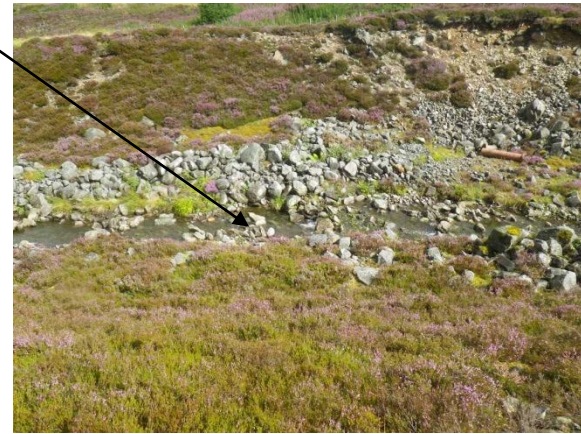
Photograph 11.4.3.109-Channel

Channel incision due to step

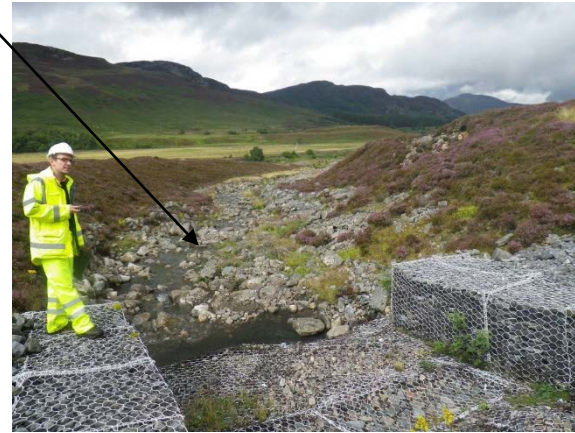
Photograph 11.4.3.113- Downstream

Wave bed forms formed by reworking of gravel in gabions

Step-pool channel

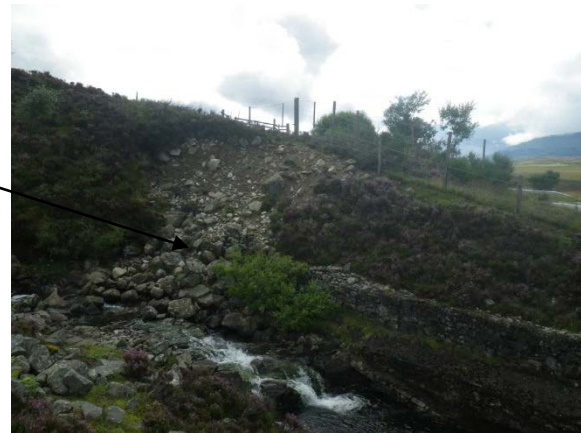
Photograph 11.4.3.119-Left bank

Bedrock

Valley side erosion, causing small failure adding sediment to the channel

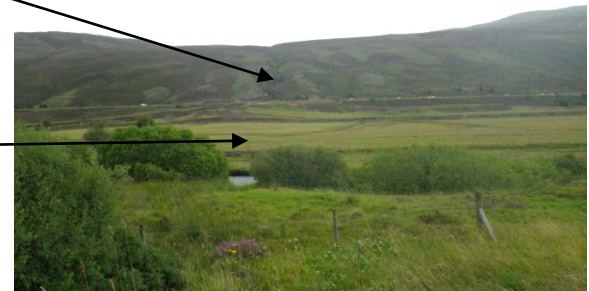
Photograph 11.4.3.123- Catchment

Steep, confined channel

Low lying floodplain downstream of crossing

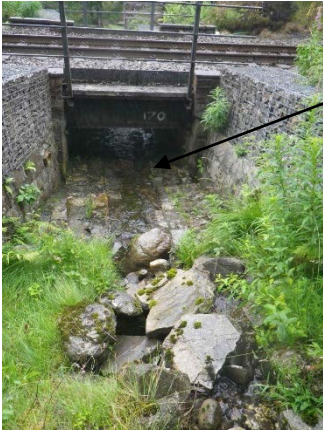
Photograph 11.4.3.126-Downstream

Railway crossing

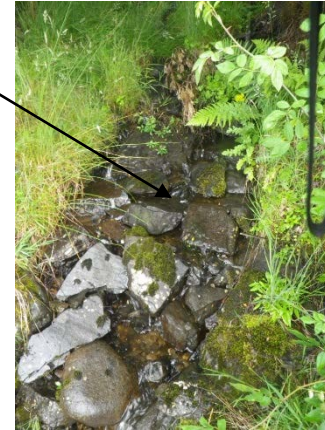
Photograph 11.4.3.127-Upstream

Cascade upstream of railway crossing

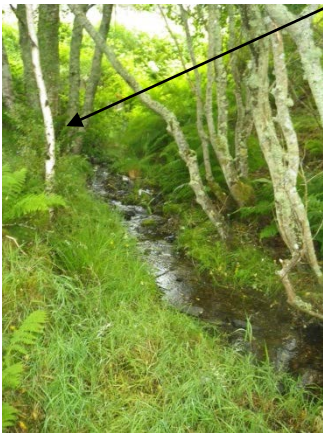
Photograph 11.4.3.128-Upstream

Crossing exit

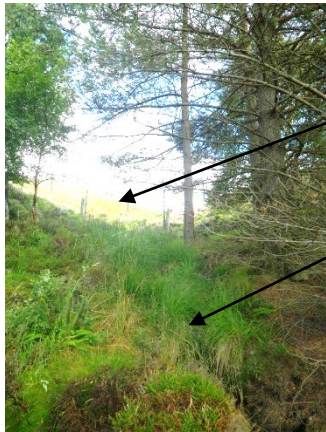
Photograph 11.4.3.130-  
Upstream embankment

Moorland catchment

Steep channel gradient

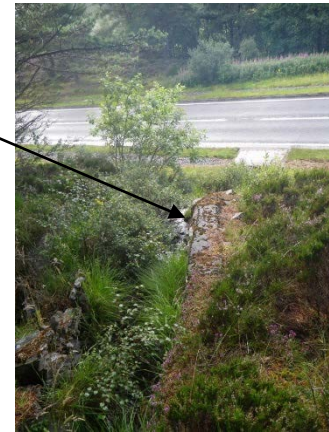
Photograph 11.4.3.131-  
Looking down embankment

Cascade

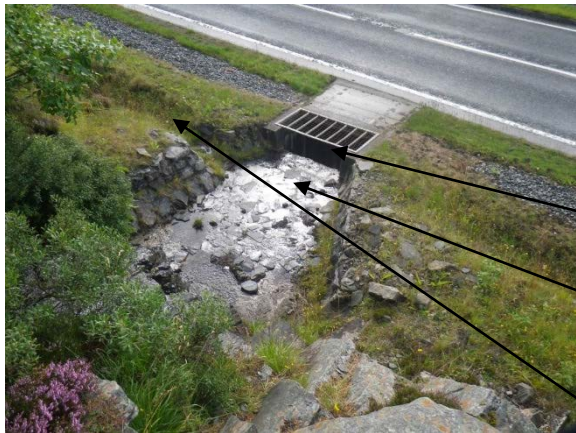
Photograph 11.4.3.132-Downstream to catchpit

Crossing entrance

Catch pit

Drain

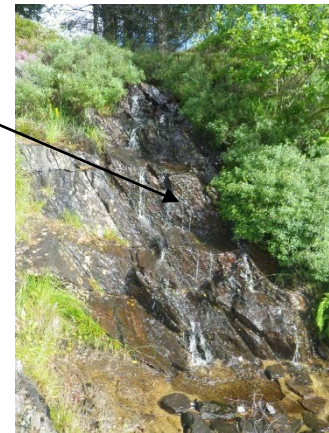
Photograph 11.4.3.133

Bedrock cascade down embankment

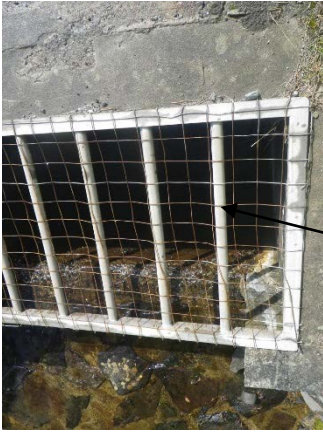
Photograph 11.4.3.134

Crossing  
entrance to  
catch pit

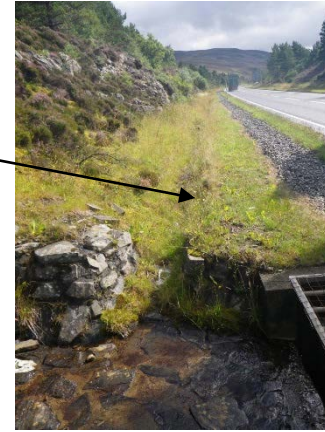
Photograph 11.4.3.135

Drain

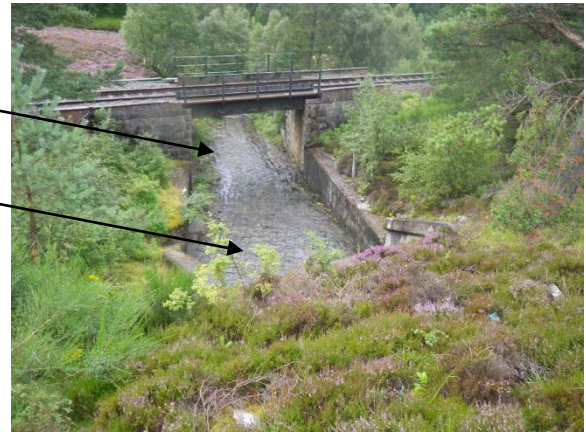
Photograph 11.4.3.137 - Downstream

Railway crossing

Paved channel bed

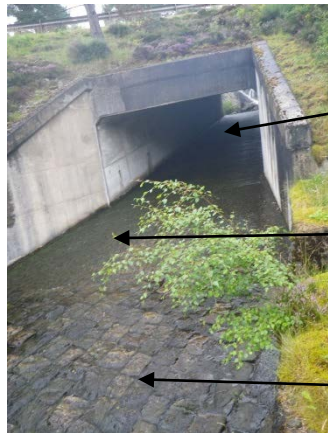
Photograph 11.4.3.138 - Upstream to crossing exit

A9 crossing exit

Very steep concrete channel

Paved channel bed

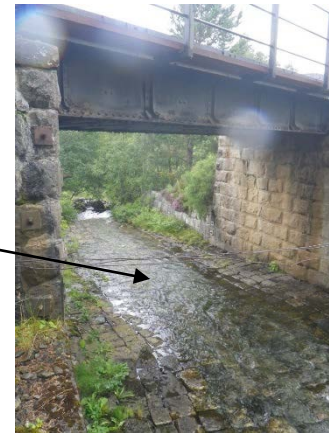
Photograph 11.4.3.139 - Downstream under railway crossing

Railway crossing

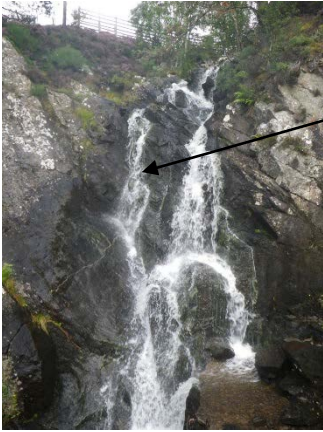
Photograph 11.4.3.140

Bedrock fall

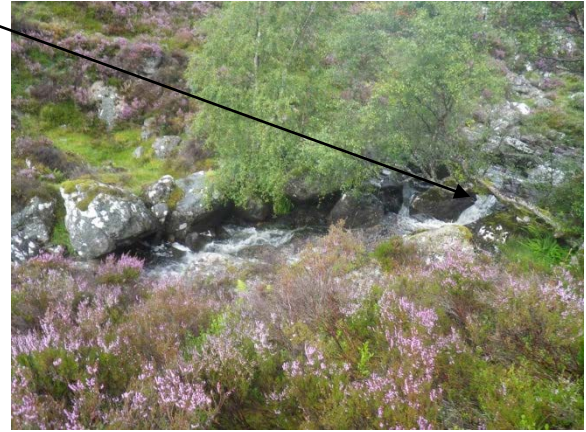
Photograph 11.4.3.141-Bedrock channel upstream of crossing

Cascade

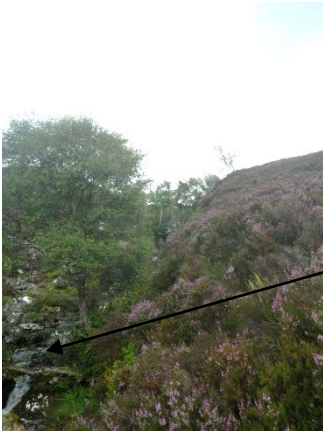
Photograph 11.4.3.142- Upstream of crossing

Steep channel

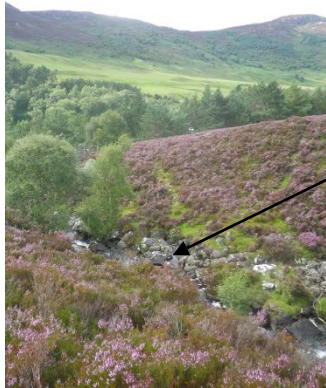
Photograph 11.4.3.144 -  
Downstream

Cascade

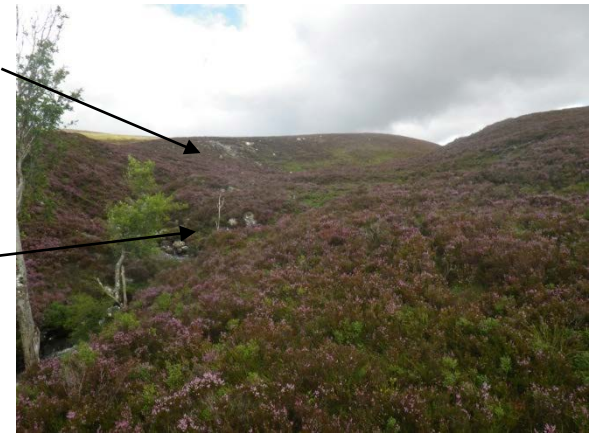
Photograph 11.4.3.145 – Upstream- Steep catchment

Moorland  
catchment

Cascade

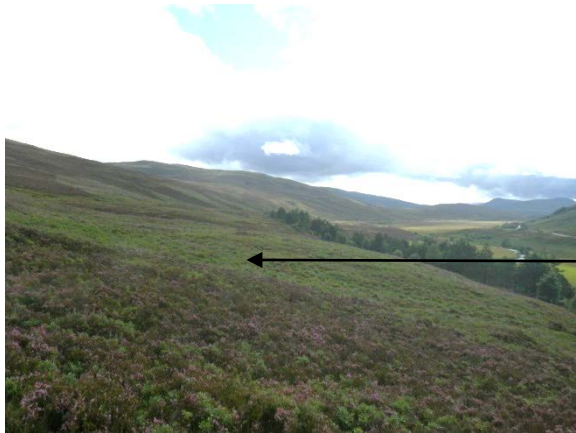
Photograph 11.4.3.146- Catchment looking  
south

Moorland  
catchment

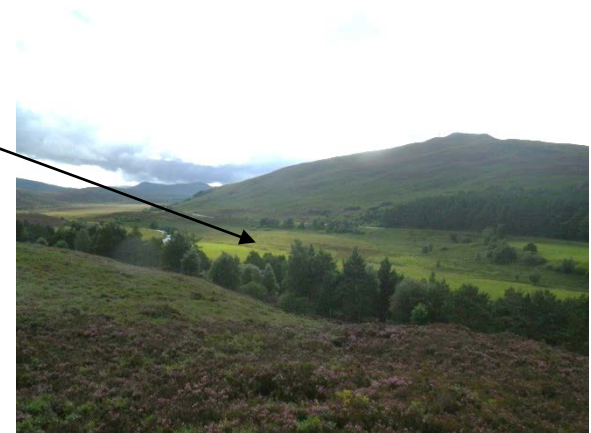
Photograph 11.4.3.147- Catchment

Truim  
floodplain
