# Appendix 11.4

## Hydromorphology Assessment Part 3

**Annex 11.4.3 - Hydromorphological Catchment Assessment - 12**

| REV | SUIT | DATE | DESCRIPTION | BY | APP |
|---|---|---|---|---|---|
| <b>PROJECT 7 GLEN GARRY TO DALWHINNIE EIA</b><br><b>Drawing 11.4.3.1 Catchment 12 Catchment Overview</b> | | | | | |

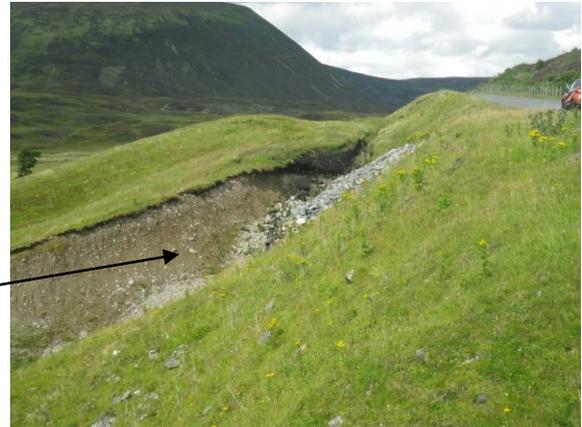
Photograph 11.4.3.46-Downstream of NMU crossing

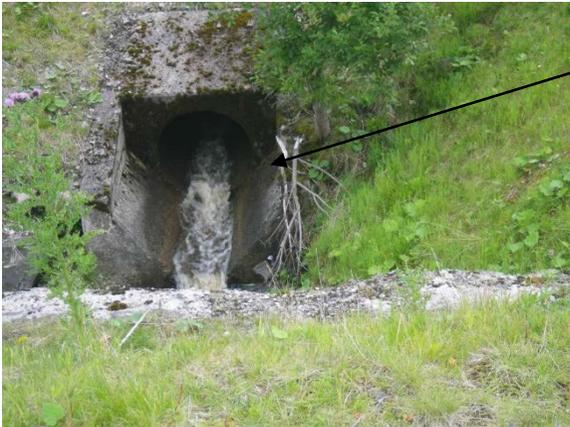
Outfall of NMU crossing

Photograph 11.4.3.49- Upstream

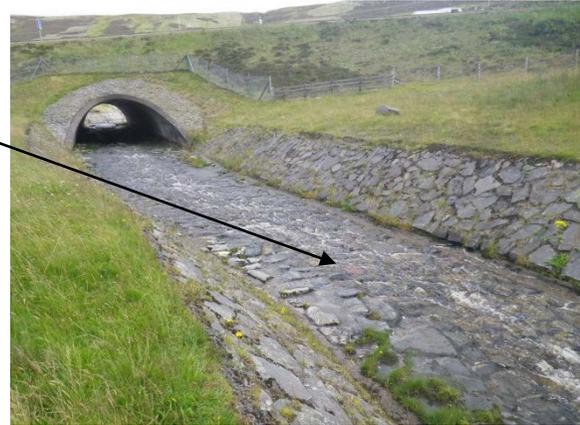
Pitched bed and banks

Photograph 11.4.3.52-Upstream to culvert exit

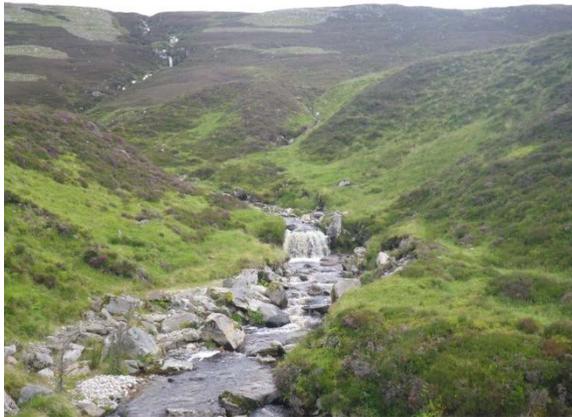
Photograph 11.4.3.57- Cascade morphology in confined channel

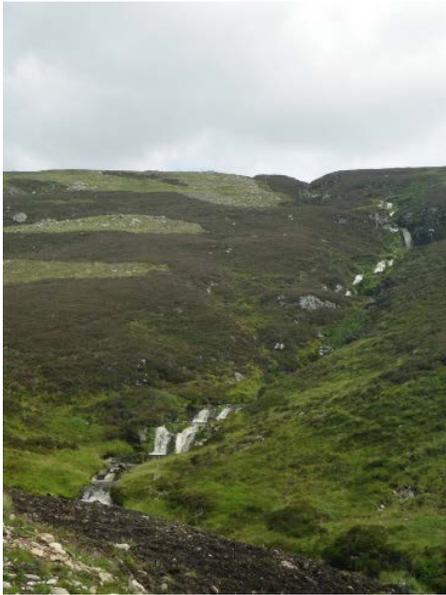
Photograph 11.4.3.59-Upstream to bedrock falls

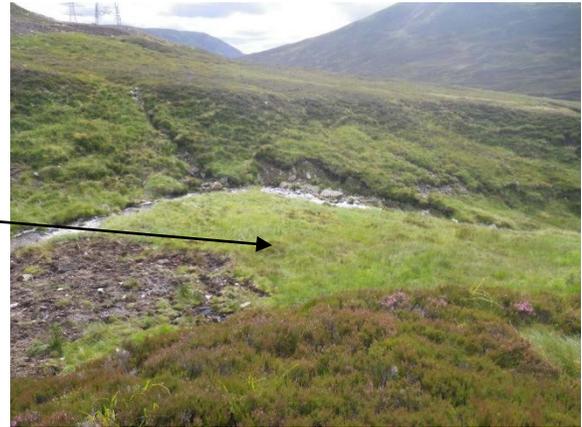
Photograph 11.4.3.60-From valley top towards channel

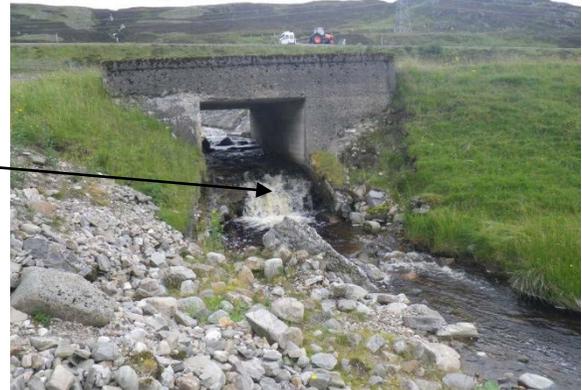
Photograph 11.4.3.62-Upstream to small road crossing

Local erosion

Crossing fixing bed level

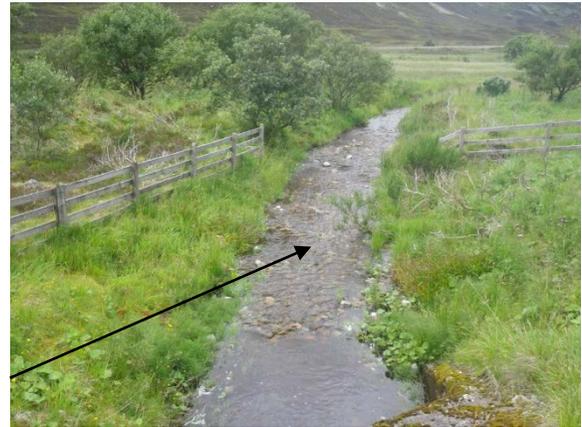
Gravel and cobble  
plane bed channel

Photograph 11.4.3.64-Downstream of crossing

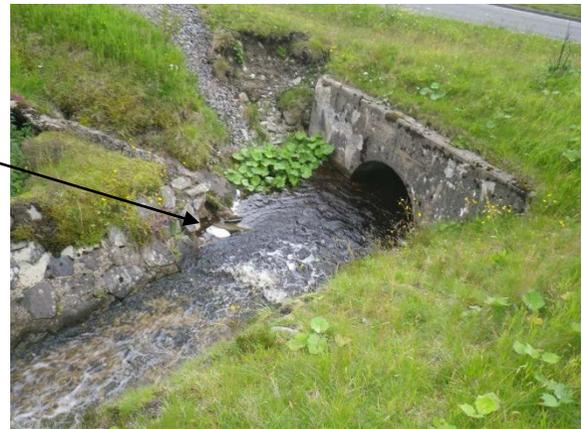
Photograph 11.4.3.66- Culvert entrance

Some scour

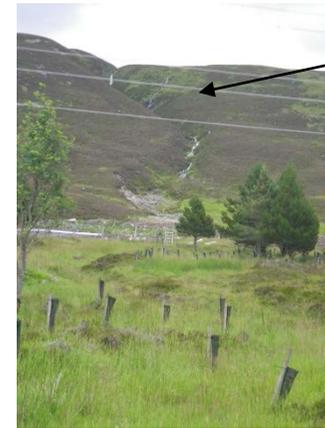
Steep upper catchment

Photograph 11.4.3.68- Upstream to catchment

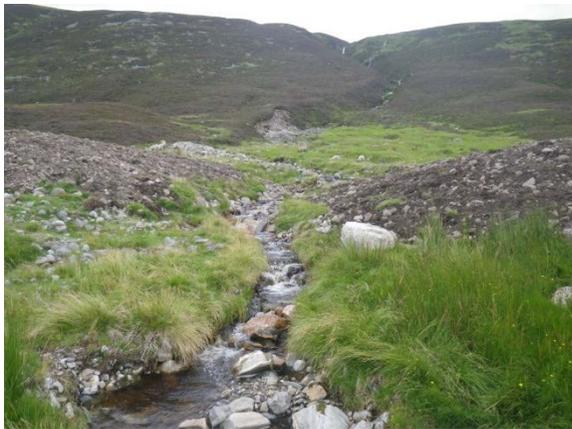
Photograph 11.4.3.69-Cascade morphology

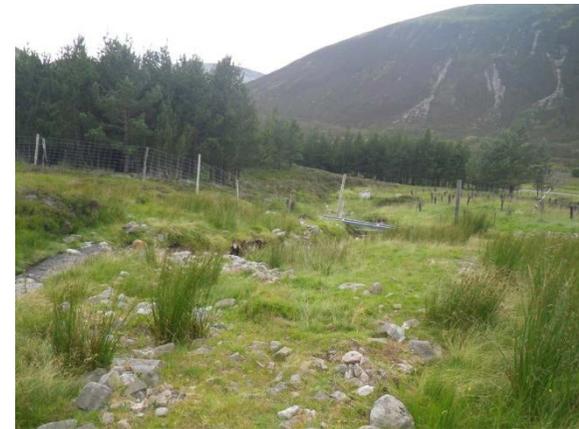
Photograph 11.4.3.70-Downstream- Low gradient channel

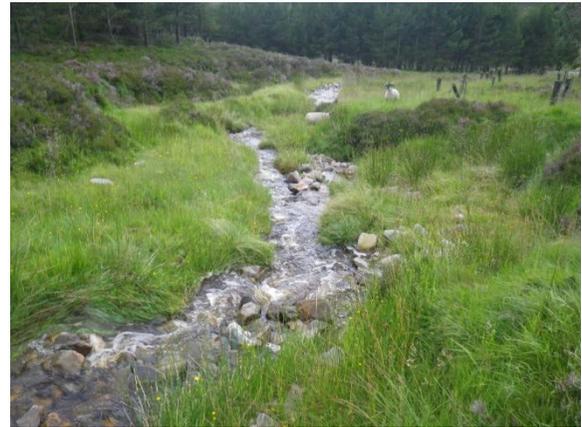
Photograph 11.4.3.72-Reduced channel slope downstream

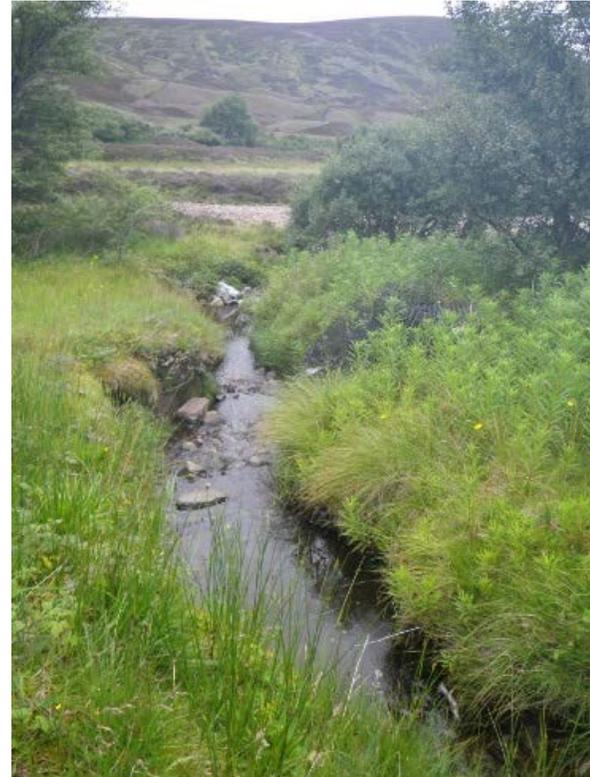
Photograph 11.4.3.78-Downstream of crossing 43-  
short section of plane bed river
