Appendix 11.4

Hydromorphology Assessment Part 2

Hydromorphology Catchment Baselines

Spey Catchment Overview

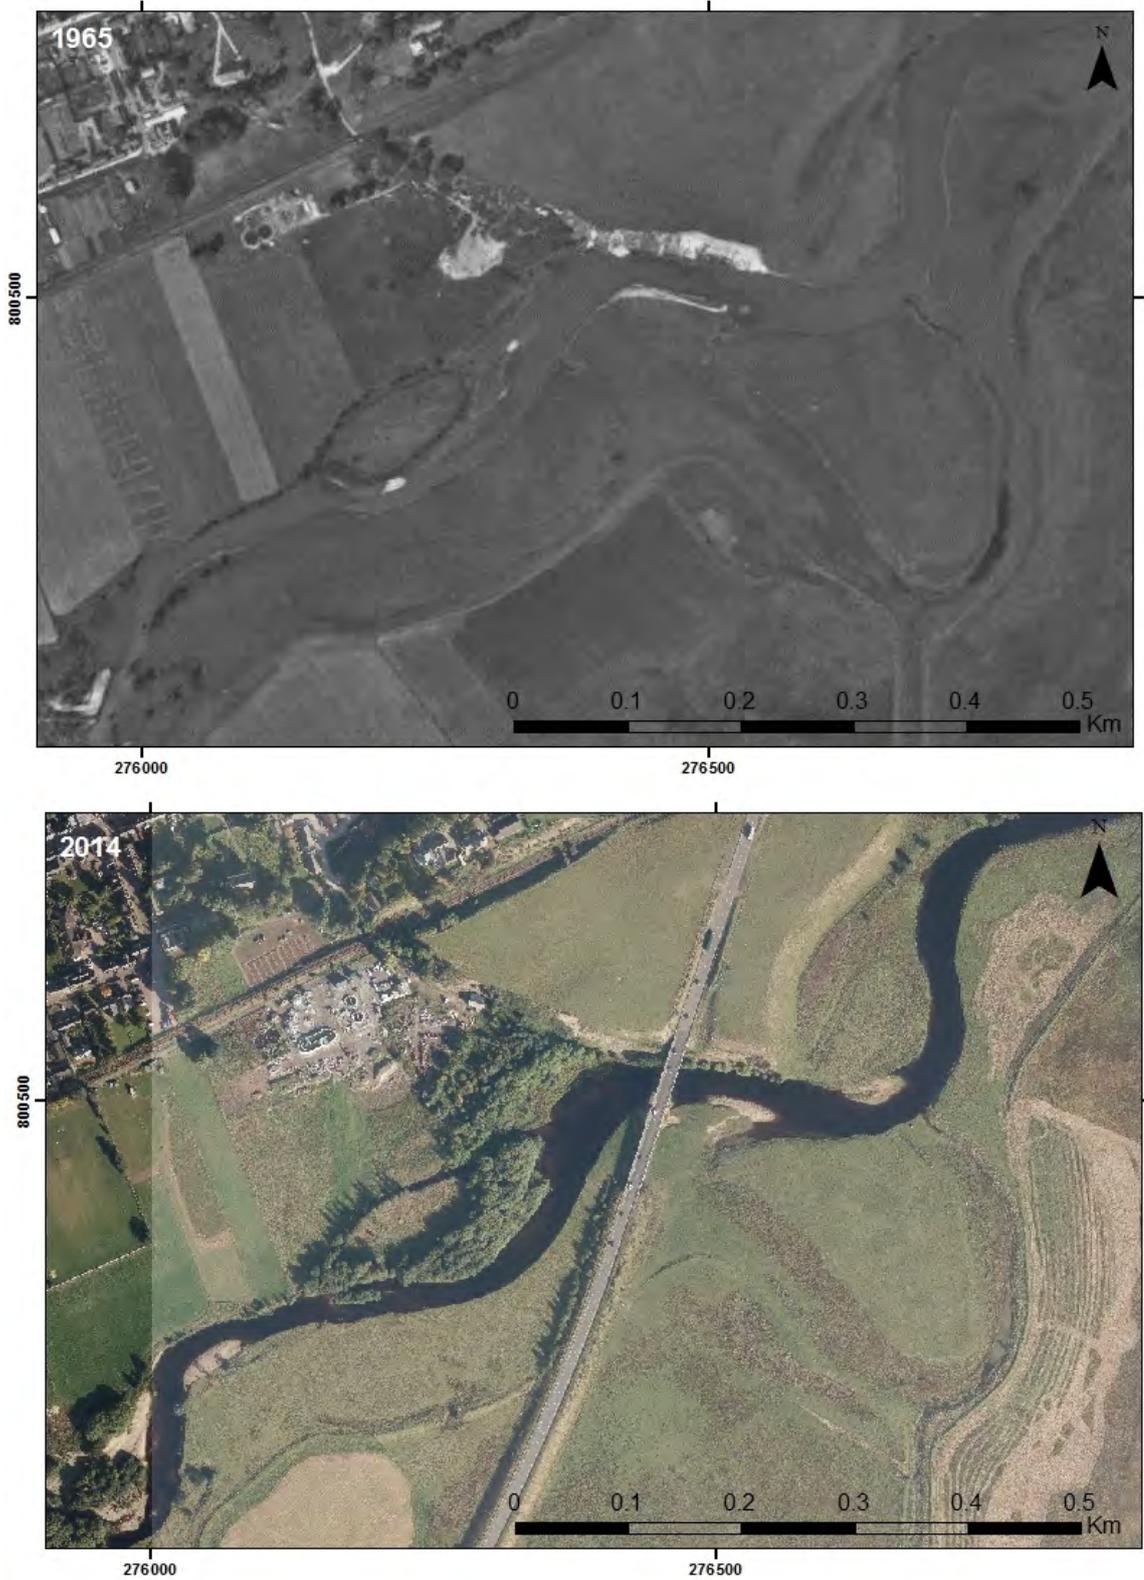
Figure 8: Aerial photography from 1965 (pre-A9) and 2014

- 11.4.4.38 Analyses of historical OS maps and aerial imagery of the A9 Spey crossing, covering the period 1870 to 2014, has been undertaken in GIS to document changes in the river planform (Figures 7 and 8). This demonstrates how the channel has migrated across its floodplain over time, where erosion and deposition have occurred and where any longer-term evolutionary patterns or trends have emerged.

- Between 2008 and 2014 the channel narrows further, with the island continuing to grow. It should be noted that a general pattern of channel narrowing can be seen along much of Spey upstream of Kingussie, and this is attributed to the regulation in flow associated with the hydropower schemes in the catchment. The flow regulation reduces the frequency of smaller, channel forming flows (<50 m³/s or circa 1:2 year flow events) (Gilvear, 2004). The reduction in flood frequency-magnitude due to flow regulation also reduces the 'self-

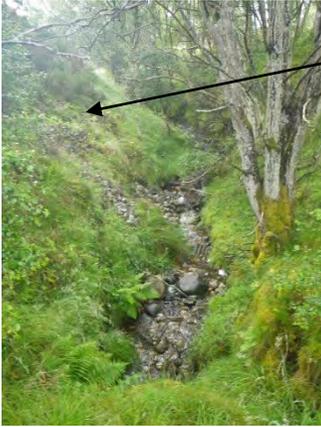
Photograph 11.4.4.1- Upstream

Channel confined by steep valley sides

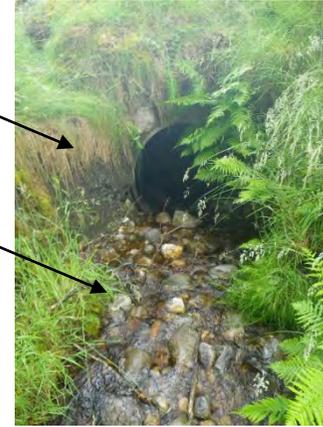
Photograph 11.4.4.2- Downstream

Culvert entrance

Cobbles and gravels

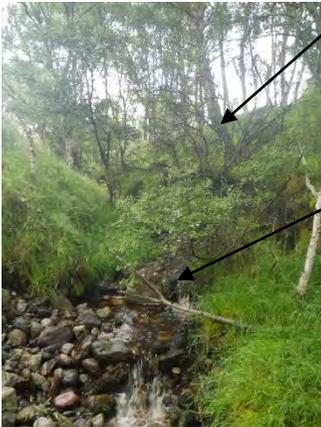
Photograph 11.4.4.3- Upstream

Wooded valley

Cascade

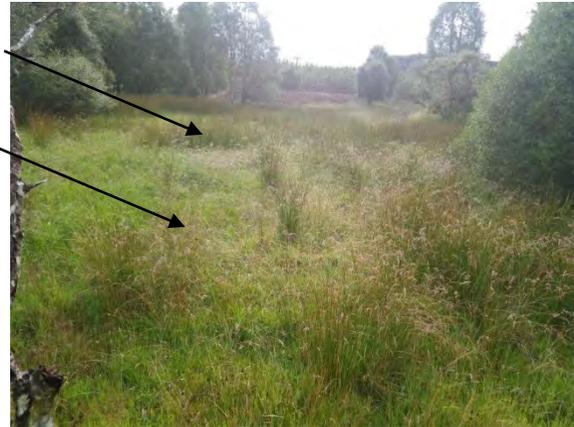
Photograph 11.4.4.4- Upstream

Pond/wetland

Open floodplain

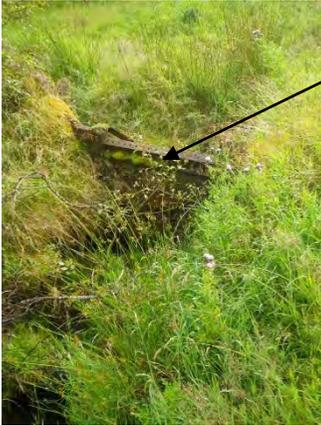
Photograph 11.4.4.5-
Upstream

Sluice
controlling flow
to channel

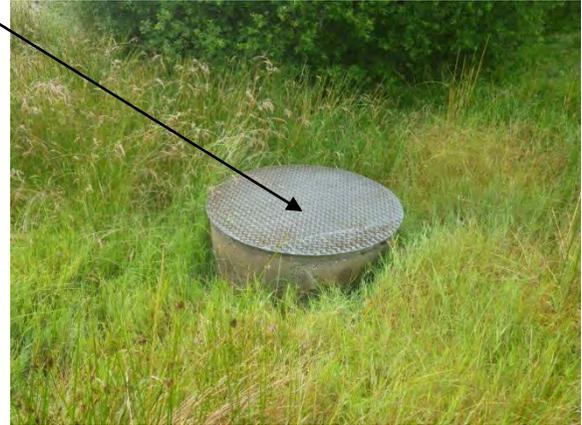
Manhole

Photograph 11.4.4.6- Manhole in wetland area,
upstream of crossing

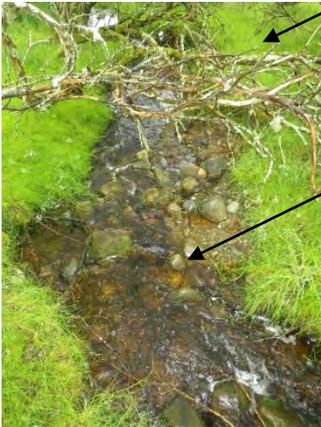
Wooded
floodplain

Boulders and
gravel in
channel

Photograph 11.4.4.7- Low
channel banks

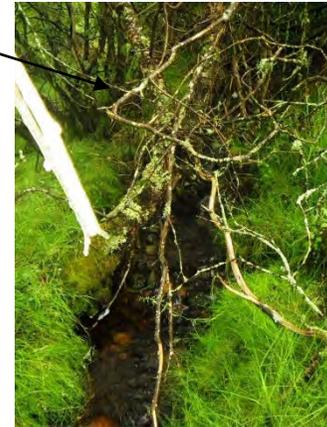
Photograph 11.4.4.8

Wooded
floodplain

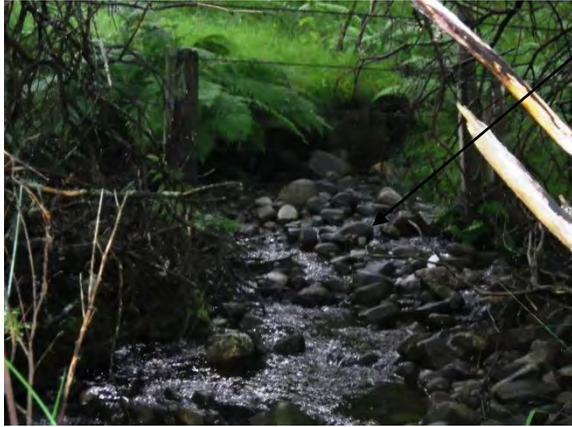
Photograph 11.4.4.9

Cobble and
boulder
deposition

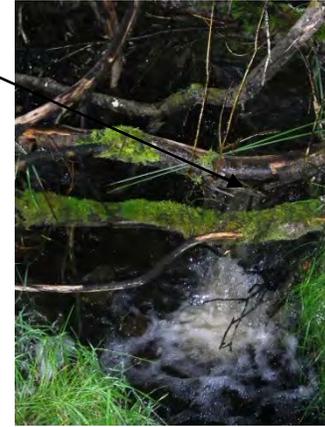
Photograph 11.4.4.10

Deposition
behind wood
debris

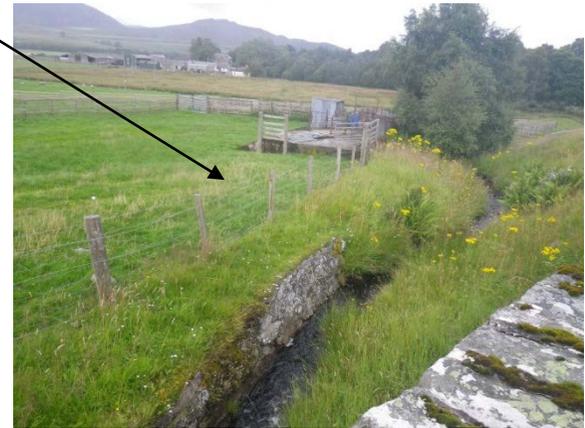
Photograph 11.4.4.13- Downstream

Incised channel
in open valley

Open
floodplain

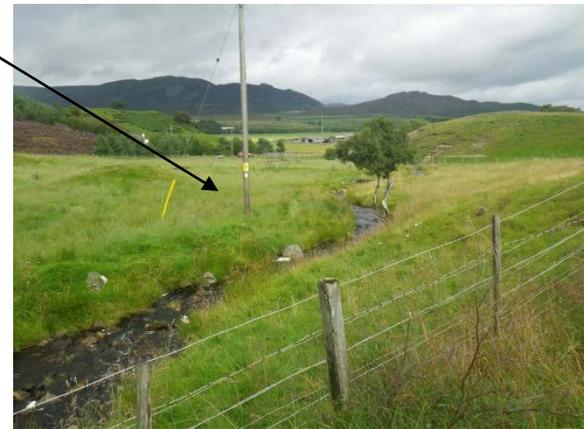
Photograph 11.4.4.15- Downstream

Plane bed
channel

Open
floodplain

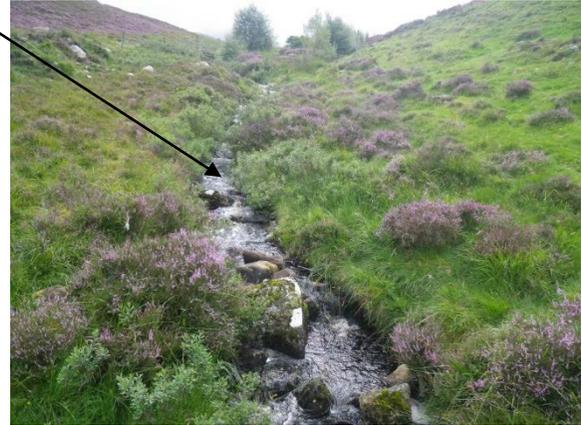
Photograph 11.4.4.17- Looking upstream

Step-pool morphology

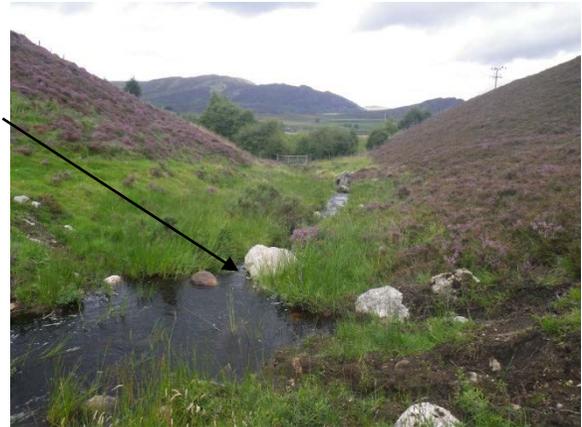
Photograph 11.4.4.19- Looking downstream towards crossing

Step-pool morphology

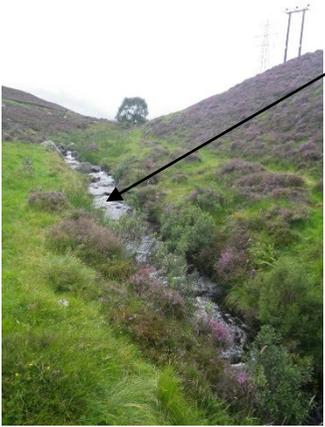
Photograph 11.4.4.20

Step-pool morphology
